## CERTAIN 2013-2015 MODEL YEAR FLEX, MKS, MKT, TAURUS AND POLICE INTERCEPTOR SEDAN VEHICLES — FUEL PUMP CONTROL MODULE INSPECTION AND REPAIR

### OVERVIEW

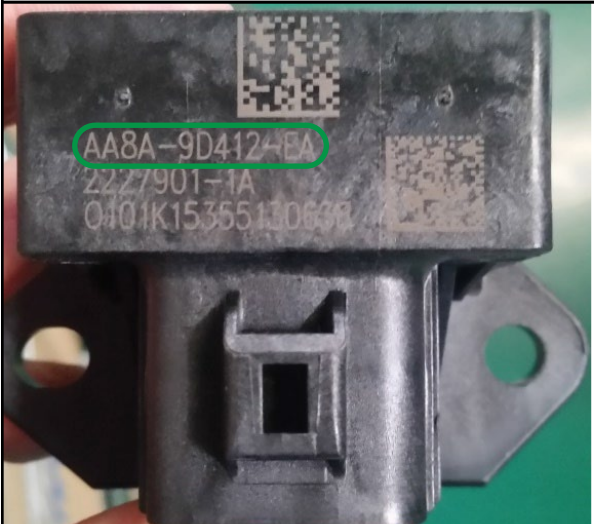
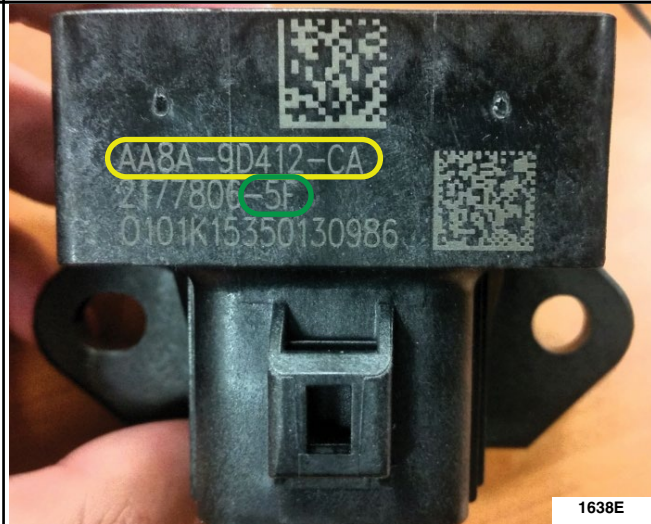
FIGURE 1

ENGINEERING PART NUMBER AA8A-9D412-EA	ENGINEERING PART NUMBER AA8A-9D412-CA
<ul style="list-style-type: none"> <li>• ALL PARTS OK TO USE</li> </ul>	<ul style="list-style-type: none"> <li>• SUPPLIER SUFFIX -5, -50, -51, -52, -5F, -5F0, -5F1, -5F2 ARE OK TO USE</li> </ul>

1. Remove the fuel pump control module. Please follow the Workshop Manual (WSM) procedures in Section 303-04.
2. Inspect the engineering part number and, if necessary, the supplier part number suffix on the fuel pump control module. See Figure 1.
  - If either (A) the engineering part number is AA8A-9D412-EA, OR (B) the engineering part number is AA8A-9D412-CA and the supplier part number suffix is -5, -50, -51, -52, -5F, -5F0, -5F1, or -5F2, module replacement is not required. Reinstall the original fuel pump control module. Please follow the WSM procedures in Section 303-04. No additional service is required.
  - If the module does not meet either criteria, proceed to Step 3.
3. *Install a new fuel pump control module. Please follow the WSM procedures in Section 303-04.*
