CERTAIN 2015-2016 MODEL YEAR TRANSIT VEHICLES EQUIPPED WITH A 3.2L ENGINE — FUEL INJECTION PUMP REPLACEMENT

OVERVIEW

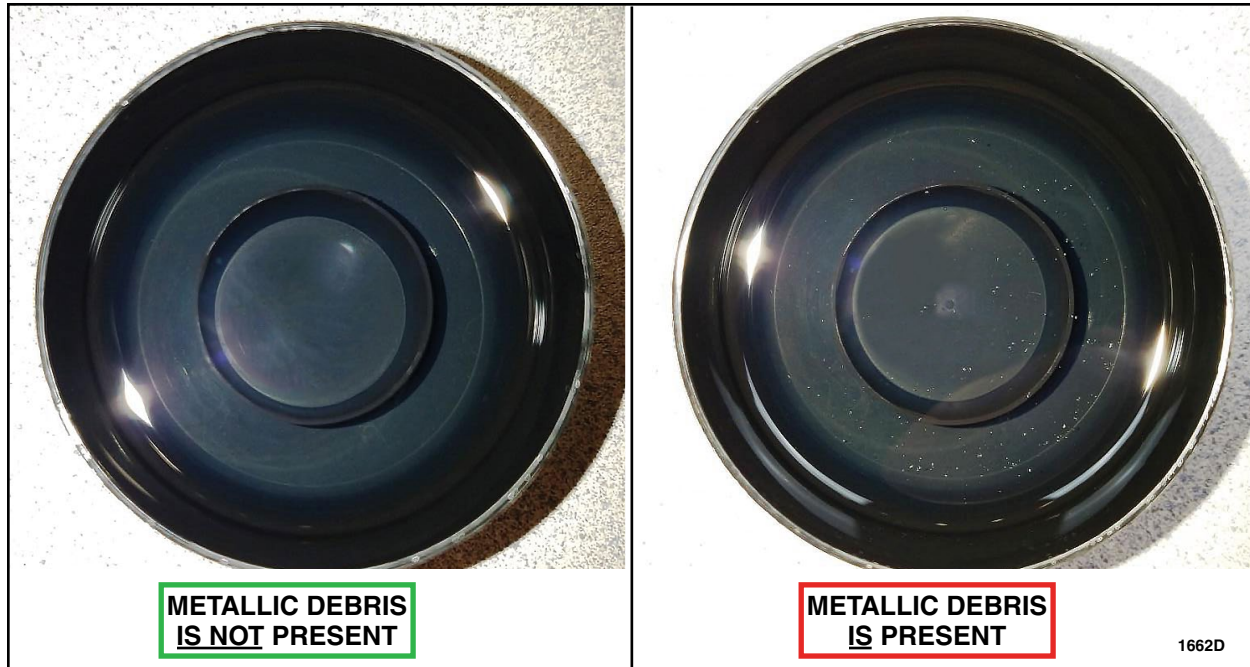
FIGURE 2

3. Inspect the fuel sample for the presence of metallic debris. See Figure 2.

NOTE: If metallic debris is present in the fuel sample it will settle to the bottom and look like fine metallic dust throughout the sample. See Figure 2.

- If metallic debris **is not** present, replace the fuel injection pump. Please follow the WSM procedures in Section 303-04C.
- If metallic debris **is** present, please follow the Diesel Fuel System Contamination Repair/Flushing procedures in Workshop Manual (WSM) Section 310-00C, General Procedures.
