David J. Johnson  
 Director  
 Service Engineering Operations  
 Ford Customer Service Division

**SUBJECT:** **Safety Recall 16S41 – Supplement #2**  
 Certain 2010-2012 Model Year Escape and 2010-2011 Model Year Mariner Vehicles  
 with a 3.0L Engine  
 Fuel Delivery Module Flange Replacement

## CERTAIN 2010-2012 MODEL YEAR ESCAPE AND 2010-2011 MODEL YEAR MARINER VEHICLES WITH A 3.0L ENGINE — FUEL DELIVERY MODULE FLANGE REPLACEMENT

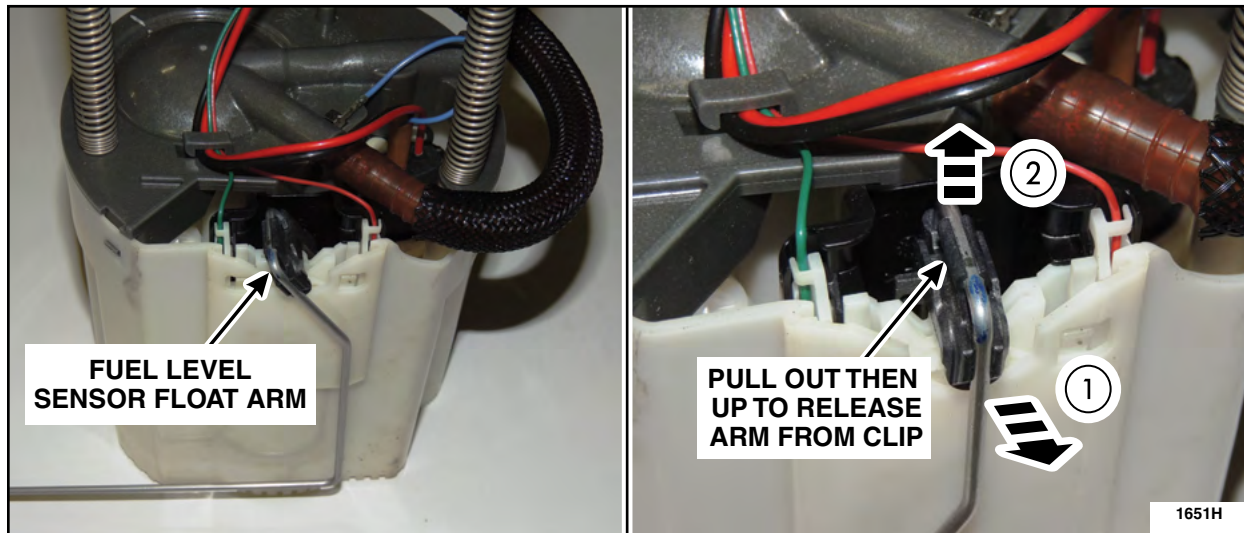
FIGURE 1

1. Remove the fuel delivery module (FDM) from the vehicle. Please follow the procedures in Workshop Manual (WSM) Section 310-01.
2. Disconnect the float arm from the fuel level sensor. See Figure 1.

10. Connect the FDM electrical connectors. See Figure 2.
11. Install the float arm onto the fuel level sensor. See Figure 1.
12. Reinstall the FDM. Please follow the procedures in WSM Section 310-01.

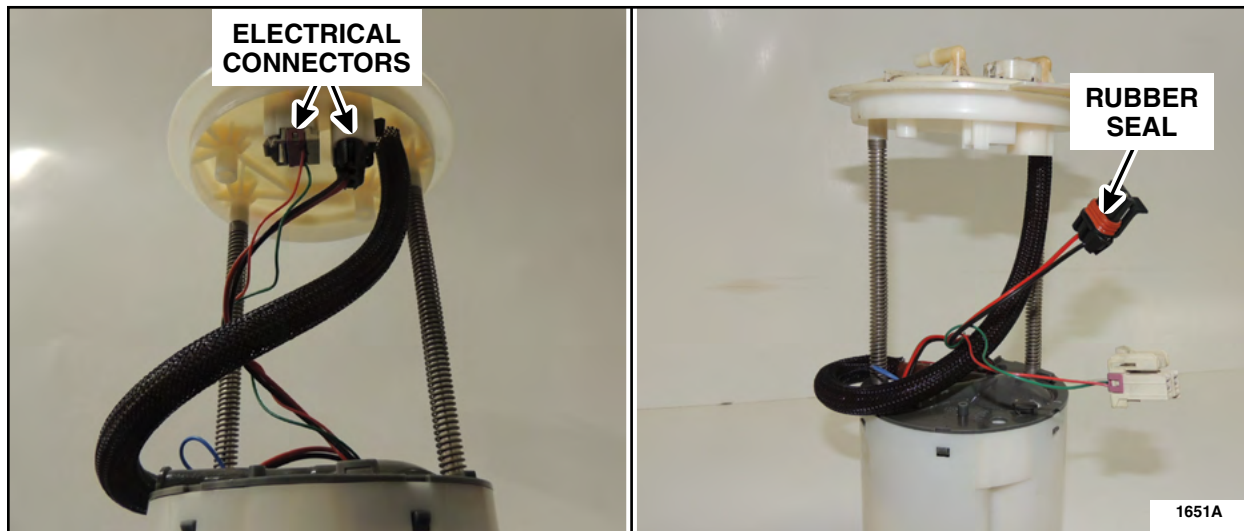
FIGURE 2

**NOTE:** Do not pull on the wires when disconnecting the electrical connectors.

**NOTE:** Be sure the rubber seal stays with the black connector during removal and installation.

3. Disconnect the FDM electrical connectors. See Figure 2.

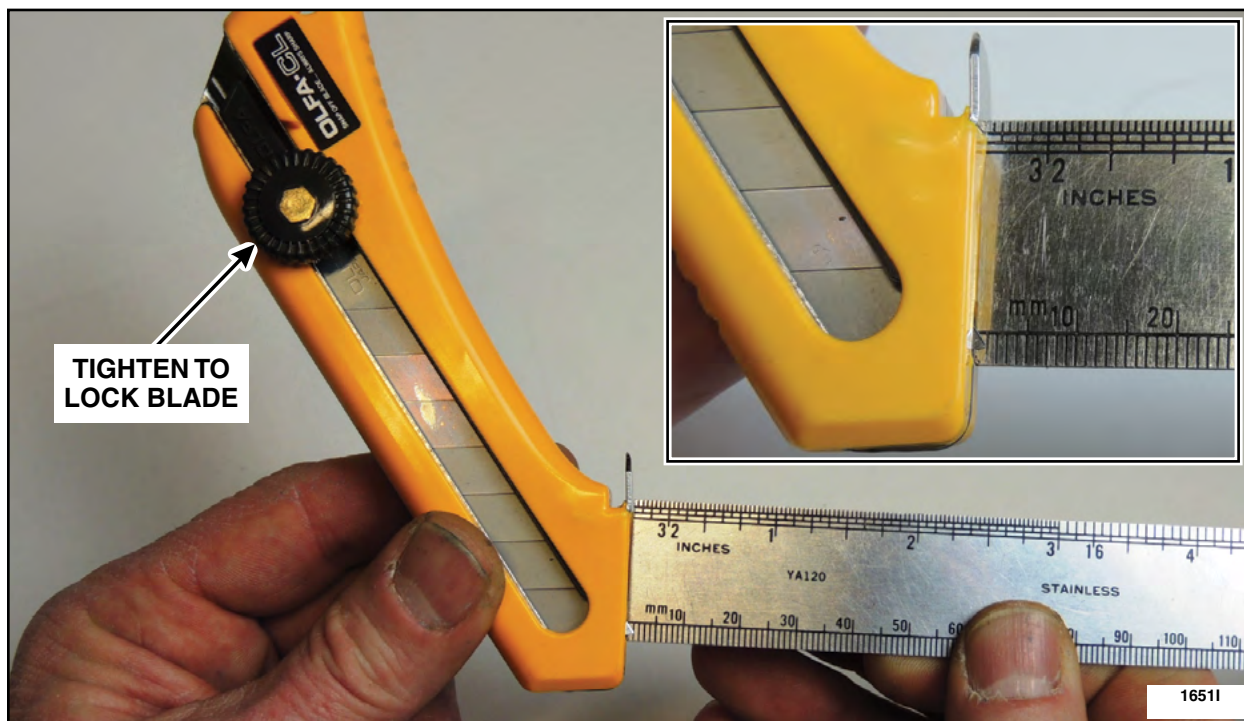
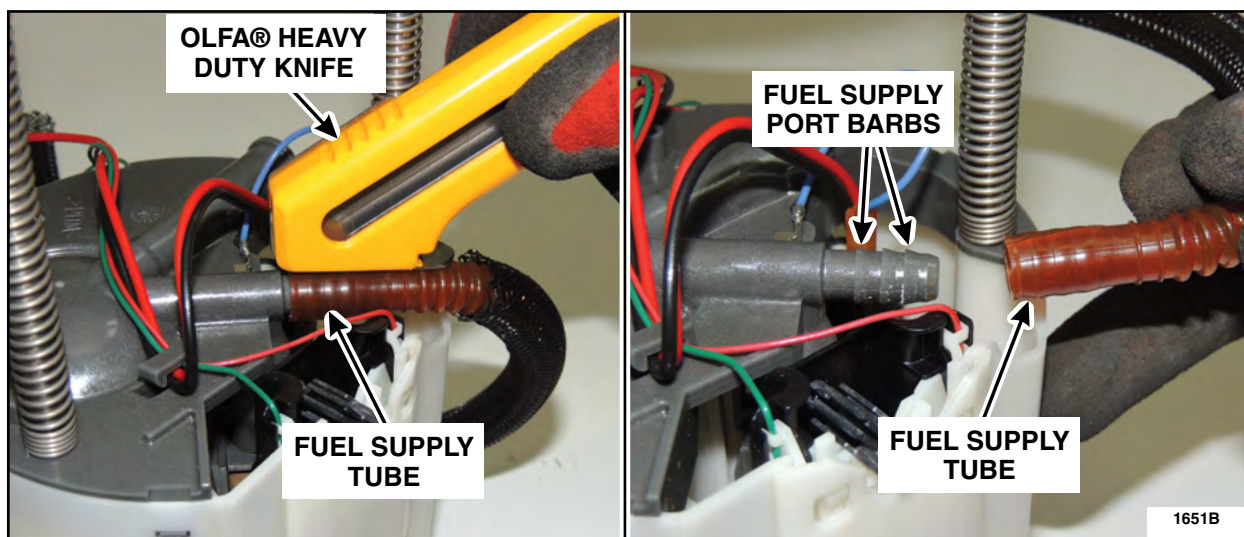
- Using an adjustable blade tool (Olfa® heavy duty knife shown) set to 1/16 in (1 mm) depth, carefully cut the fuel supply tube to release it from the supply port. See Figures 3 and 4.

**NOTICE:** Use caution not to cut or damage the barbs on the fuel supply port when cutting the fuel supply tube.

**NOTE:** Cut or damaged barbs on the fuel supply port may result in a long crank or hard start concern due to fuel pressure bleed down.

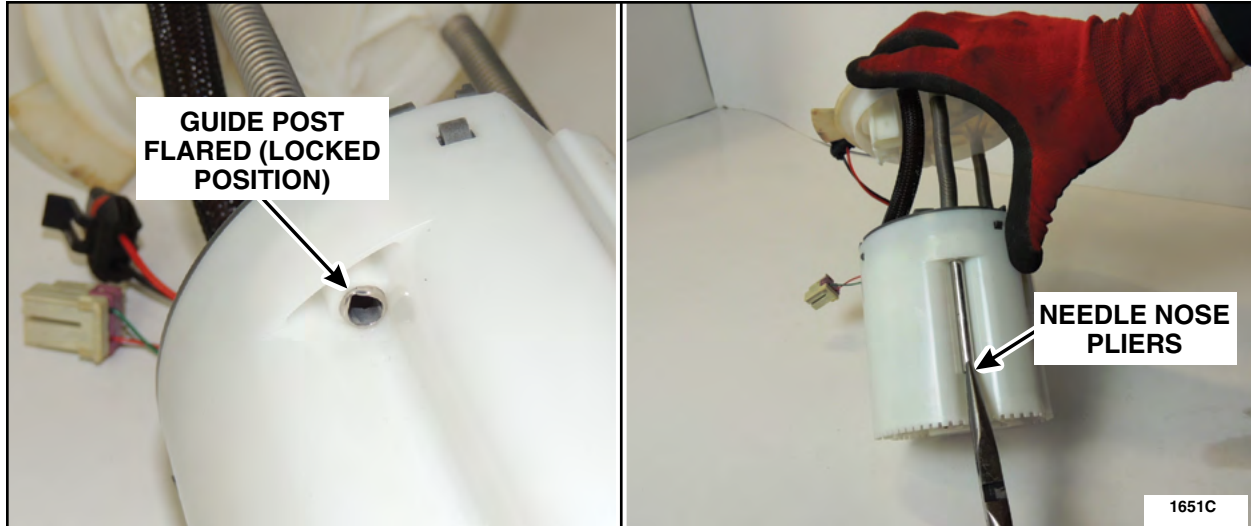
FIGURE 5

5. Using a pair of needle nose pliers, round the lower flared portion of the guide post. When the guide post on each side of the FDM has been sufficiently rounded, the upper flange can be removed. See Figure 5.

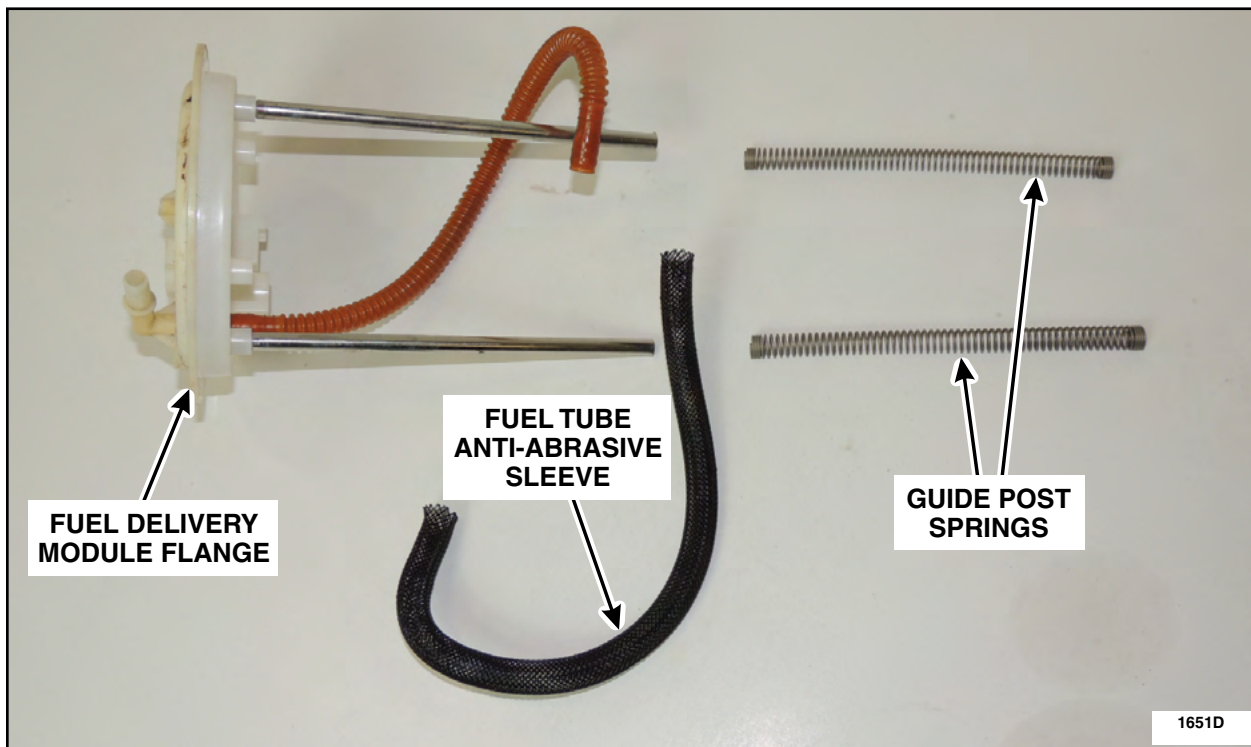
FIGURE 6

6. Remove the guide post springs and the fuel tube anti-abrasive sleeve from the old FDM flange. See Figure 6.

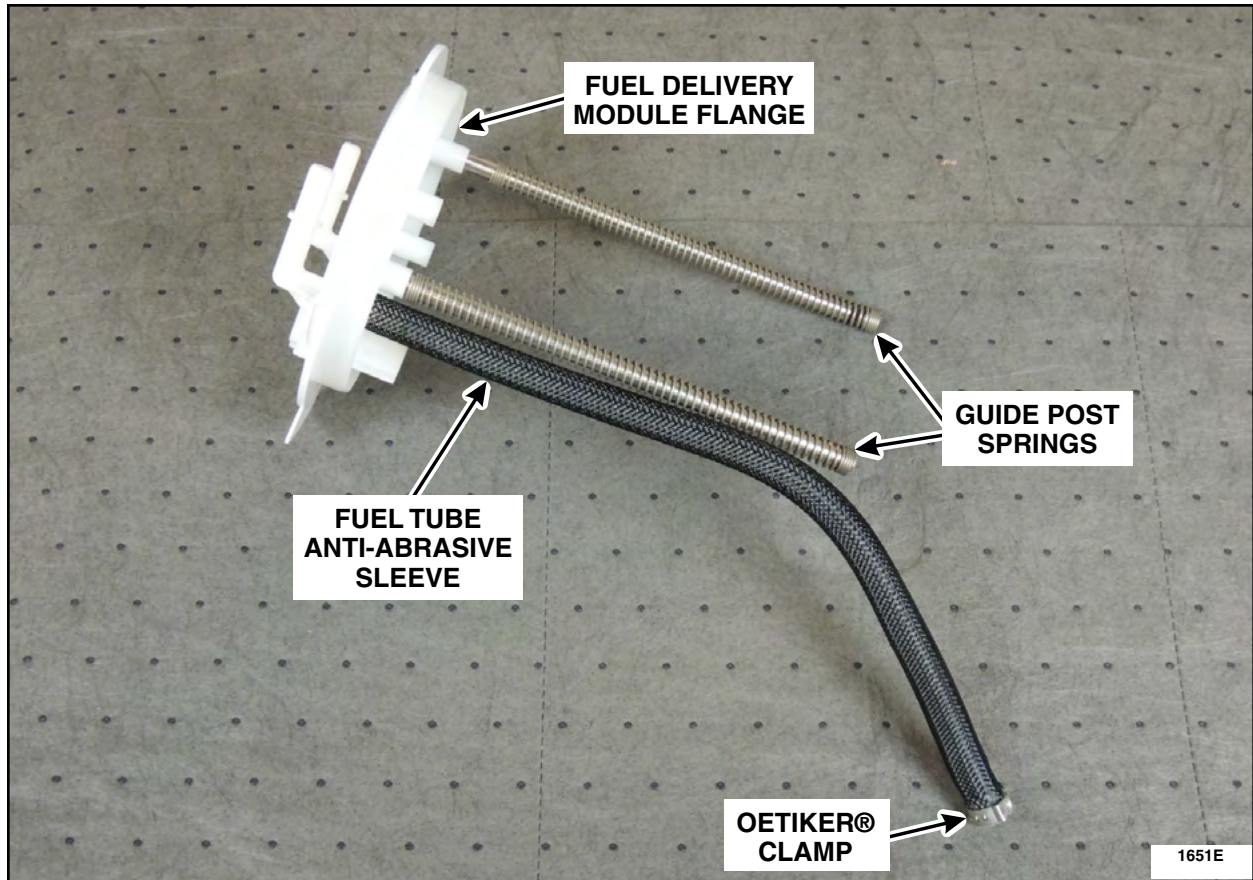
FIGURE 7

7. Install the guide post springs and the fuel tube anti-abrasive sleeve onto the *new* FDM flange.  
See Figure 7.

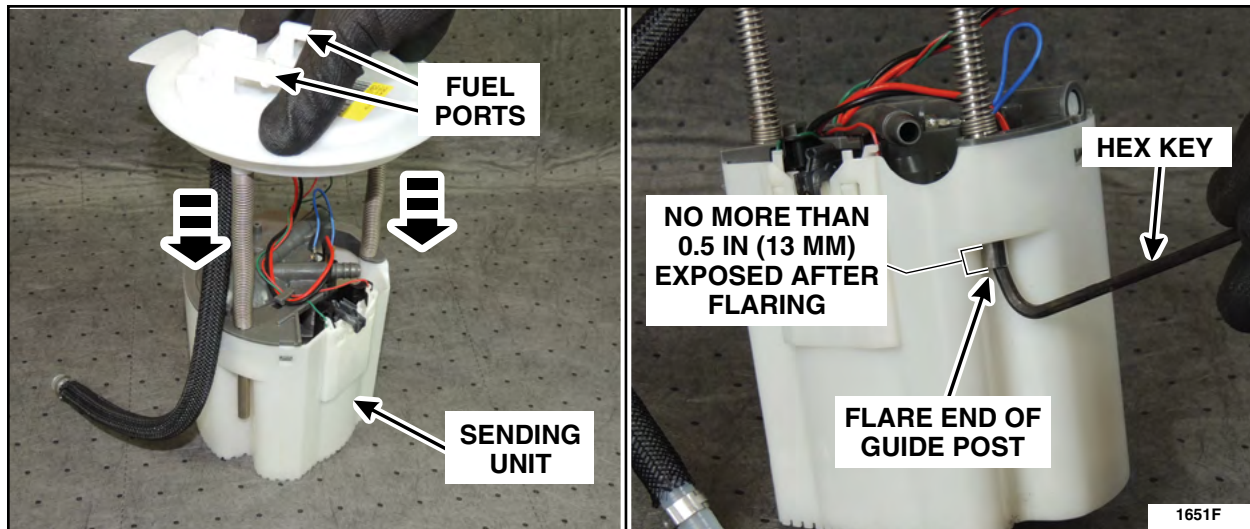
FIGURE 8

8. Install the *new* FDM flange, paying close attention to the proper orientation of the FDM flange to FDM. See Figure 8.

- Using a suitable tool, such as a hex key, flare the end of each guide post to secure the flange to the lower module.

**NOTE:** When installing the *new* FDM flange, the flange must be aligned properly so the ports are pointing towards the sending unit side of the FDM.

**NOTICE:** When flaring the end of each guide post, only apply enough pressure to prevent the guide post from pulling through the lower module. Using excessive pressure when flaring may cause bending of the guide post, which can limit the necessary travel of the flange. The flared guide post should look similar to Figure 5, and no more than 1/2 in (12.7 mm) of the guide post should be exposed on the bottom side of the FDM after flaring.

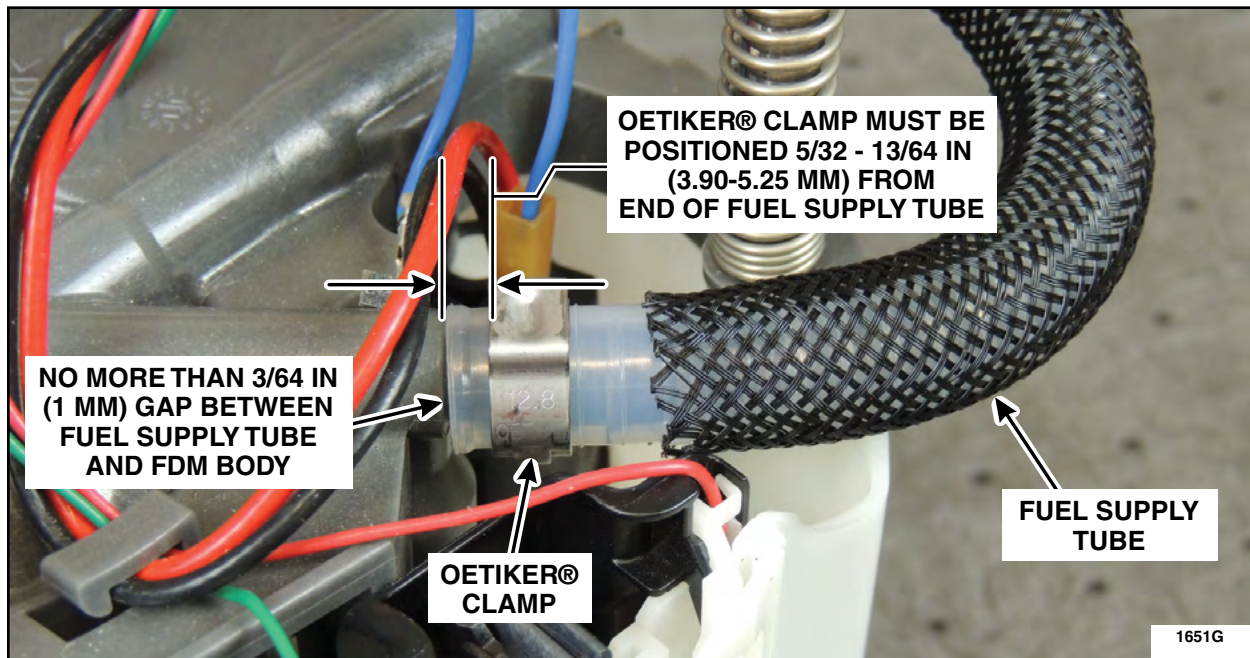
**FIGURE 9**

9. Connect the *new* fuel supply tube to the supply port and tighten the Oetiker® clamp using Oetiker® clamp pliers. See Figure 9.

**NOTE:** The Oetiker® clamp must be positioned properly and tightened using Oetiker® clamp pliers only. Do not use side-cutter pliers to tighten the Oetiker® clamp. If the fuel supply tube or clamp are not positioned properly or the clamp is tightened using anything other than Oetiker® clamp pliers, this may result in a long crank or hard start concern due to fuel pressure bleed down.

**NOTE:** *In the event an Oetiker® clamp is damaged or improperly clamped during installation, the Oetiker® clamp is available to order separate from the Fuel Delivery Module Flange Kit. Refer to the dealer bulletin for parts ordering information.*
