Product Safety Recall

36110 Passenger Presence Sensor and Instrument Cluster Malfunction

Reference Number: N16203611
GWM Number: 2036110
Revision Description: This bulletin has been revised to include a copy of the customer notification letter. Please discard all copies of bulletin 36110.

Release Date: July 2016
Revision: 01

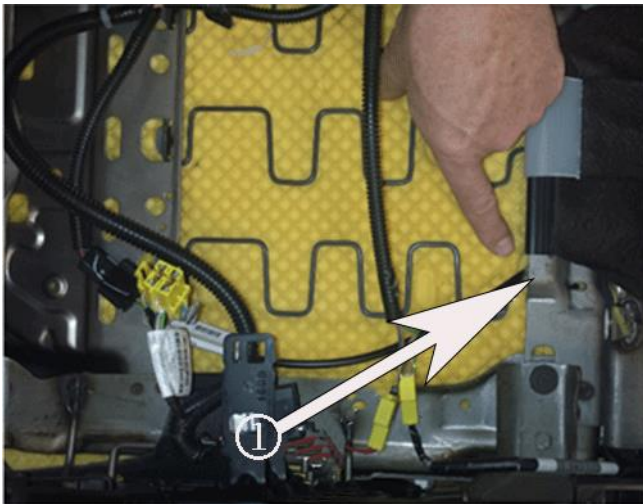
4551298

2. The picture above shows the bottom of the seat with the front of the seat facing to the left. The location shown (1) is where the PPS harness may come in contact with the seat pan.

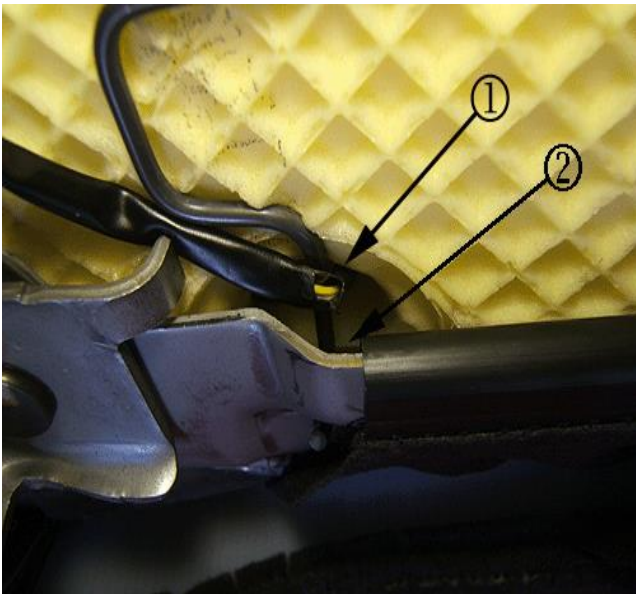
2462639

3. The picture above illustrates an example of the chafing (1) that may be identified on the PPS harness where it contacts the metal seat pan (2).

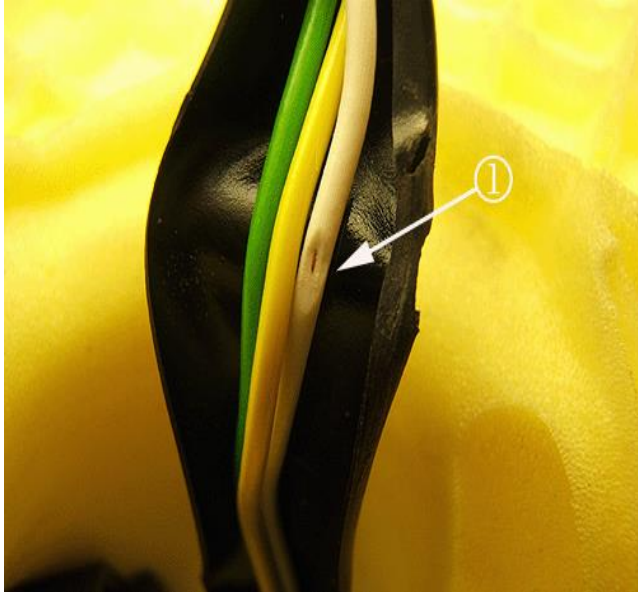
2462646

4. If the PPS harness shows signs of chafing, examine the wires in the harness carefully. If any wire is broken, shows signs of fraying or damage from an electrical short, repair using SI procedures. Refer to *Splicing Copper Wire Using Splice Sleeves* in SI. If the yellow wire is one of the damaged wires, please verify proper size airbag fuse is installed within the fuse box. If airbag fuse is open, please replace the airbag fuse. After performing any wiring repairs, proceed to Step 5. If the wire is not broken, frayed or showing damage from an electrical short, but the wire is exposed from the insulation (1) as shown above, proceed to Step 5.
