## CERTAIN 2017 MODEL YEAR F-SUPER DUTY VEHICLES EQUIPPED WITH A 6.7L DIESEL ENGINE — TRANSMISSION FLUID COOLER TUBES REPAIR

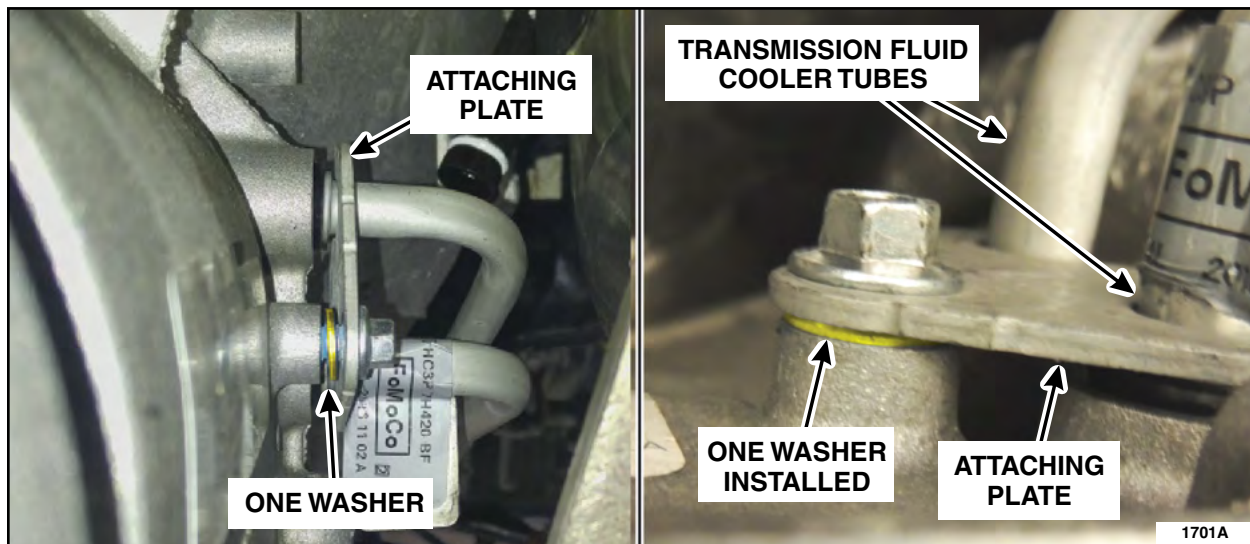
FIGURE 1

In some of the affected vehicles, a slow transmission fluid leak may occur due to the Transmission Fluid Cooler (TFC) tubes not being manufactured to the intended bend angle. This could cause stress loading, and ultimately cause a crack to form on the TFC tubes at the transmission, resulting in a leak. Customers may notice a small amount of fluid leakage on the ground and/or a service engine soon indicator illuminated in the instrument panel. If the leak progresses, customers could experience reduced engine function and hard transmission gear shifting. Dealers are to inspect the TFC tubes at the transmission for the presence of a leak. If no fluid leak is present, dealers are to install a washer behind the TFC tubes attaching plate, per the Technical Information, which will reduce stress loading of the TFC tubes. If a fluid leak is present, dealers are to replace the TFC tubes and install the washer as described above.

1. Inspect for the presence of a transmission fluid leak from the TFC tubes at the transmission.
  - If a transmission fluid leak **is** detected, proceed to Step 2.
  - If a transmission fluid leak **is not** detected, proceed to Step 3.
2. Replace the TFC tubes. Please follow the Workshop Manual (WSM) procedures in Section 307-02.
  - During installation, install a *new* washer between the transmission case and the TFC tubes attaching plate. See Figure 1.
3. Install a *new* washer behind the TFC tubes attaching plate.
  - a. Remove and discard the TFC tubes-to-transmission bolt.
  - b. Install a *new* washer between the transmission case and the TFC tubes attaching plate. See Figure 1.
  - c. Install the *new* bolt and tighten to 18 lb.ft (25 Nm).
