CERTAIN 2017 MODEL YEAR F-450/F-550/F-650/F-750, E-SERIES AND F-53/F-59 VEHICLES EQUIPPED WITH A 6.8L ENGINE — LOOSE CRANKSHAFT PULLEY BOLT

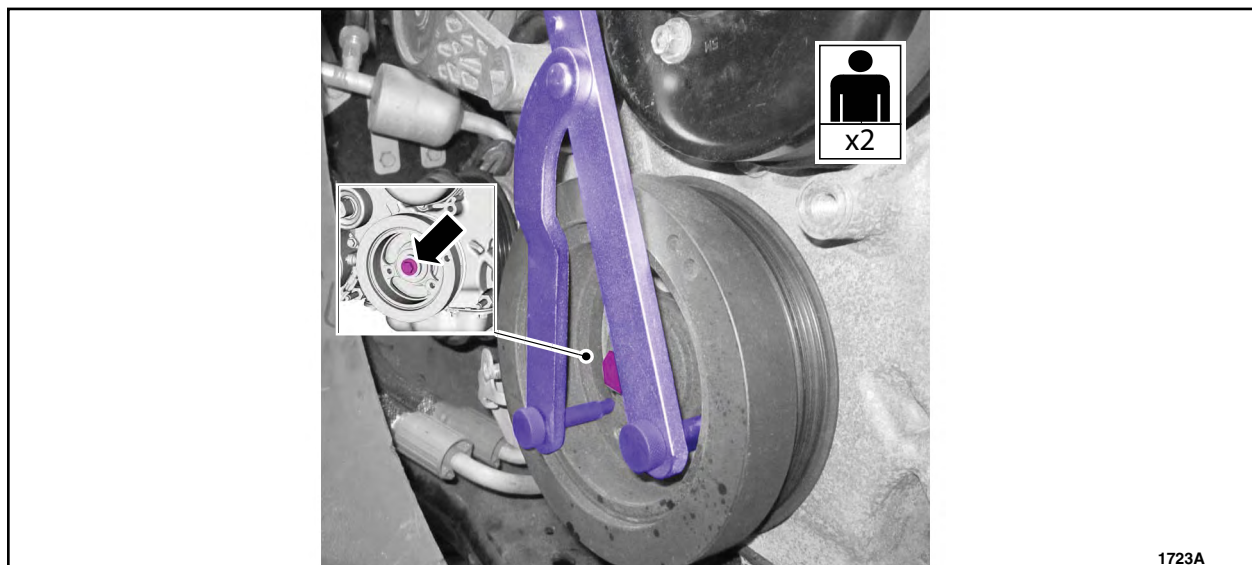
FIGURE 1

In the affected vehicles, the crankshaft pulley bolt may not have been torqued properly during engine assembly. Vehicles with a loose crankshaft pulley bolt may display a check engine light with engine misfire diagnostic codes without drivability symptoms present. If the vehicle is not serviced, engine damage may result.

2. Using a universal pulley holder (such as an OTC 4754, or equivalent), loosen the crankshaft pulley bolt 360° and then torque the crankshaft pulley bolt in 4 stages with the aid of an assistant.
See Figure 1.

Stage 1: Tighten to 90 Nm (66 lb.ft).
Stage 2: Loosen 360°.
Stage 3: Tighten to 50 Nm (37 lb.ft).
Stage 4: Tighten an additional 90°.
