CERTAIN 2017 MODEL YEAR MUSTANG VEHICLES — LEFT-HAND INTERIOR FRONT DOOR HANDLE SPRING INSPECTION

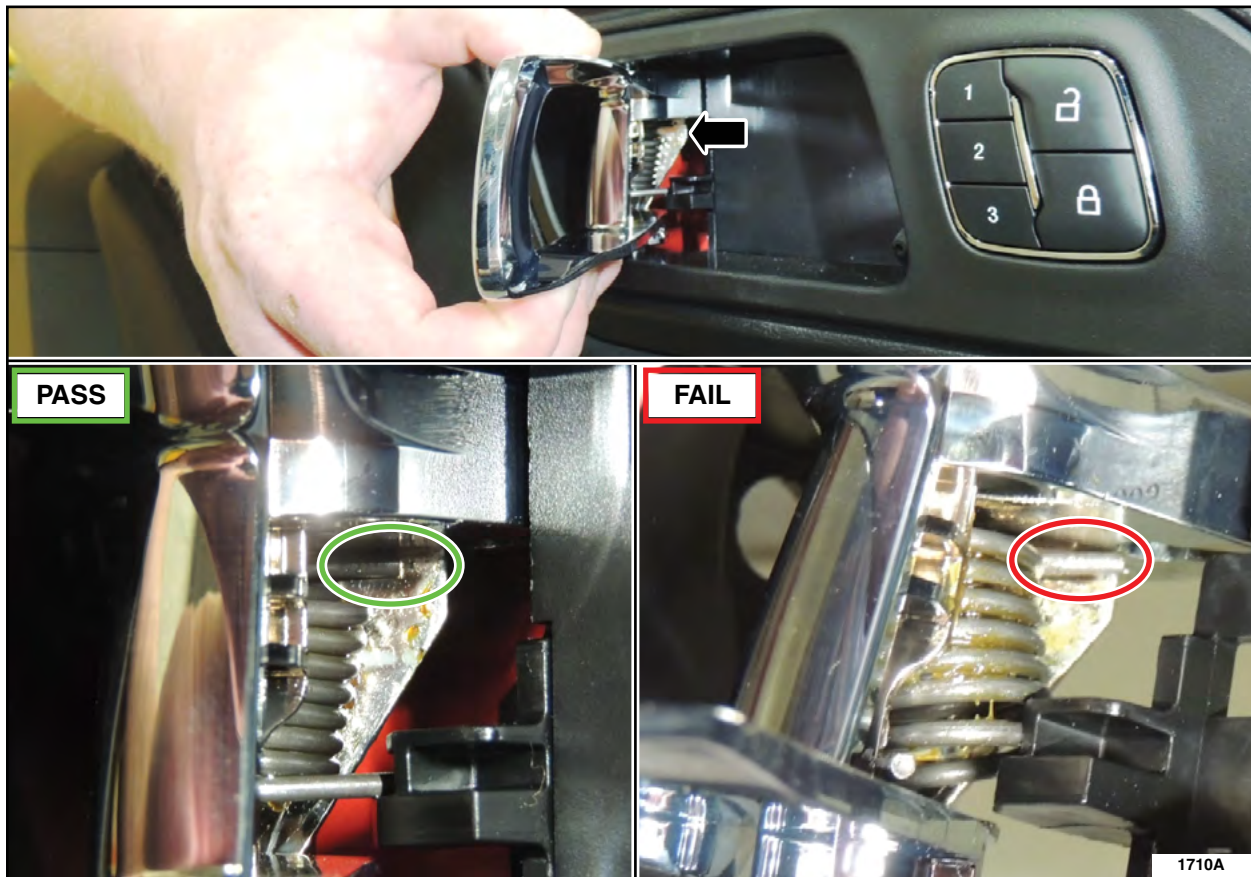
FIGURE 1

1. Inspect the position of the spring inside the left-hand (LH) interior front door handle. See Figure 1.

- If the spring is correctly installed, the spring tail will be approximately 3 mm (0.1 in) from the edge of the door handle spring wall. No service is required.
- If the spring tail is flush or above the edge of the door handle spring wall OR the spring is missing, proceed to Step 2.

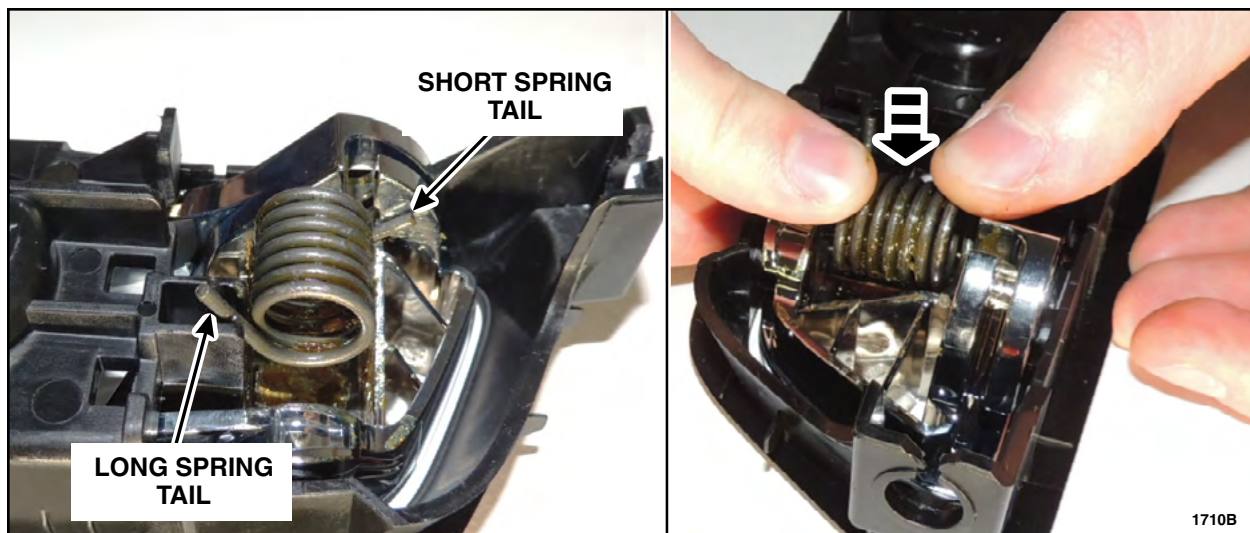
FIGURE 2

- When installed correctly the longer spring tail should face forward, toward the front of the vehicle when the handle is reinstalled.

4. Reinstall the spring into the LH interior front door handle in the correct orientation. Press downward until the spring is fully seated. See Figure 2.
