## CERTAIN 2017 MODEL YEAR FOCUS VEHICLES — REAR 60% SEAT BACK FRAME PIVOT WELD

### OVERVIEW

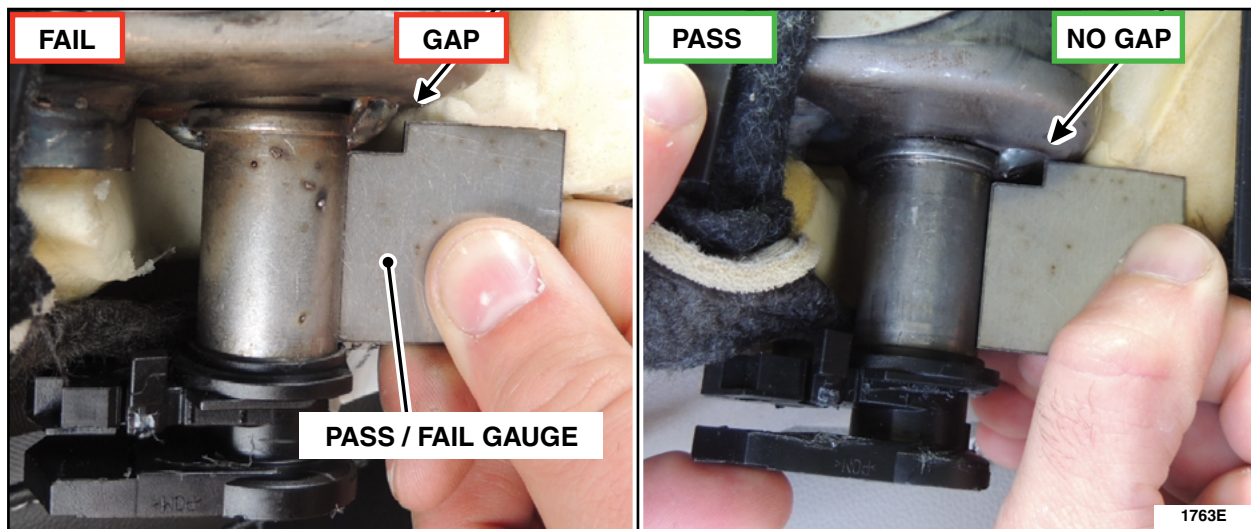
FIGURE 5

6. Place the Pass/Fail Gauge over the weld area. Ensure the Gauge is flush against the bracket and pivot shaft, zero gap is allowed on the bracket or pivot shaft. Utilize the Pass/Fail Gauge to measure the entire circumference of the weld area, the pivot weld must be contained within the notched measurement area of the Pass/Fail gauge. See Figure 5.

- If the Pass/Fail Gauge makes contact with both the pivot shaft and base of the seat back frame, the seat back frame passes inspection. The vehicle can be reassembled by reversing the removal procedure.
- If the Pass/Fail Gauge does not make contact to the base of the seat back frame due to an incorrect weld, the seat back must be replaced. Replace the rear 60% seat back frame following the Workshop Manual (WSM) procedure in Section 501-10B. When replacing the 60% seat back frame, it is not necessary to remove the hog rings or to separate the cushion cover from the cushion for seat back frame replacement.
