## CERTAIN 2018 MODEL YEAR EXPEDITION VEHICLES — COMFORT LOCK INSPECTION AND MARRIAGE BOLT TORQUE

### OVERVIEW

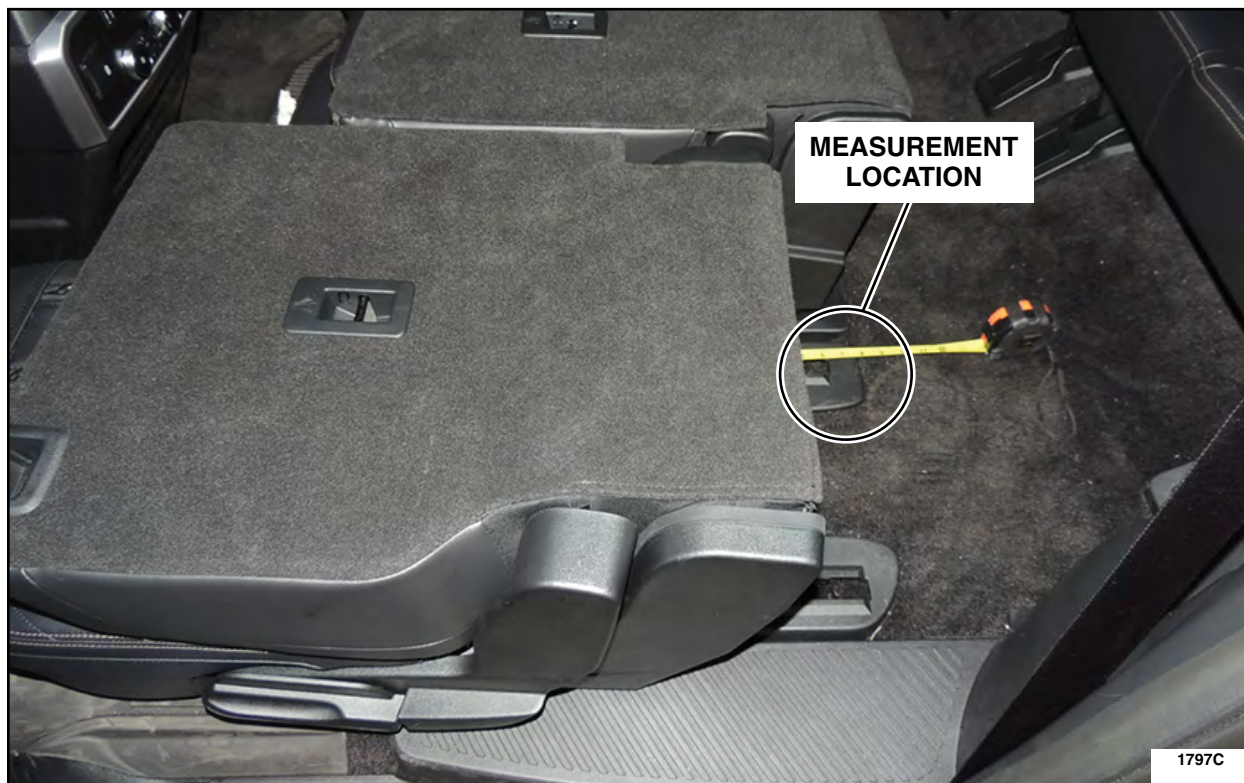
**FIGURE 1**

1. With the seats in their most forward position (Comfort Lock Forward Position), measure the position of both the RH and LH 2nd row 40% seats. See Figures 1 and 2.

**NOTE:** Seatback folded down in Figure 1 for photographic purposes only.

No – Replace the affected 2nd row 40% seat frame assembly. Transfer components from the original seat frame to the *new* assembly as required. Please follow the Workshop Manual (WSM) procedures in Section 501-10B. Repair is complete for that seat assembly.

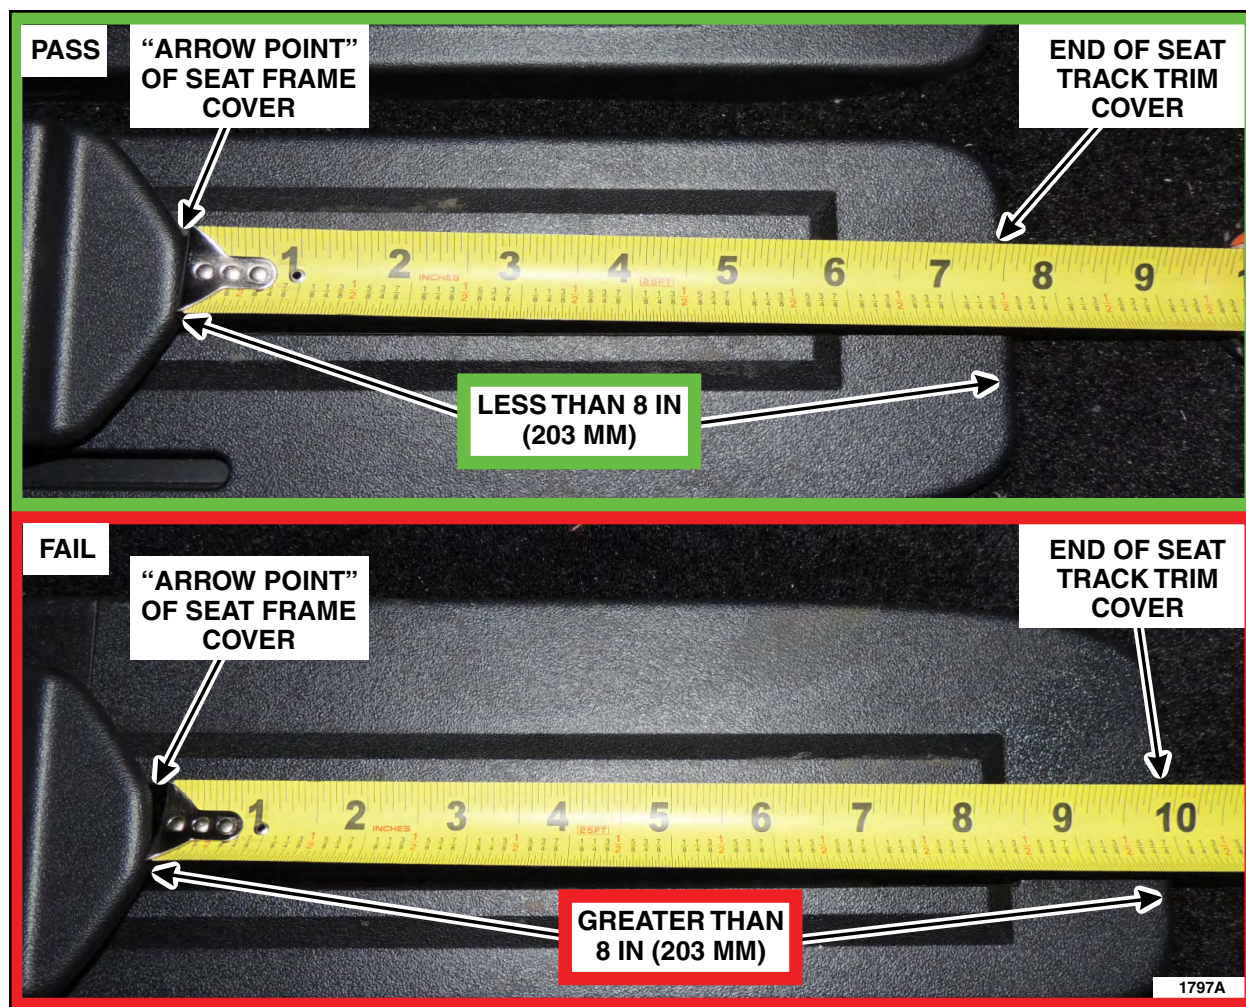
**FIGURE 2**

2. Was the measurement equal to or less than 8.0 in (203 mm)?

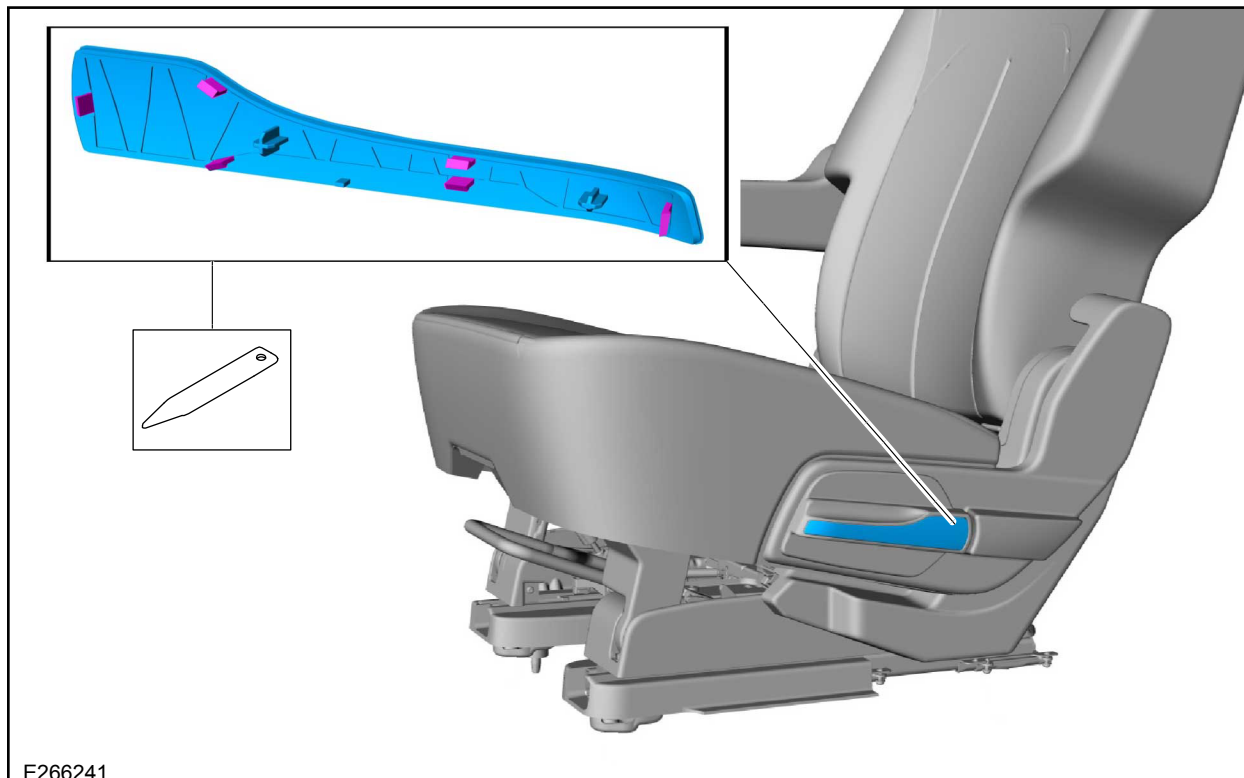
**FIGURE 3**

2. Release the retainers and remove the recline handle cover. See Figure 3.

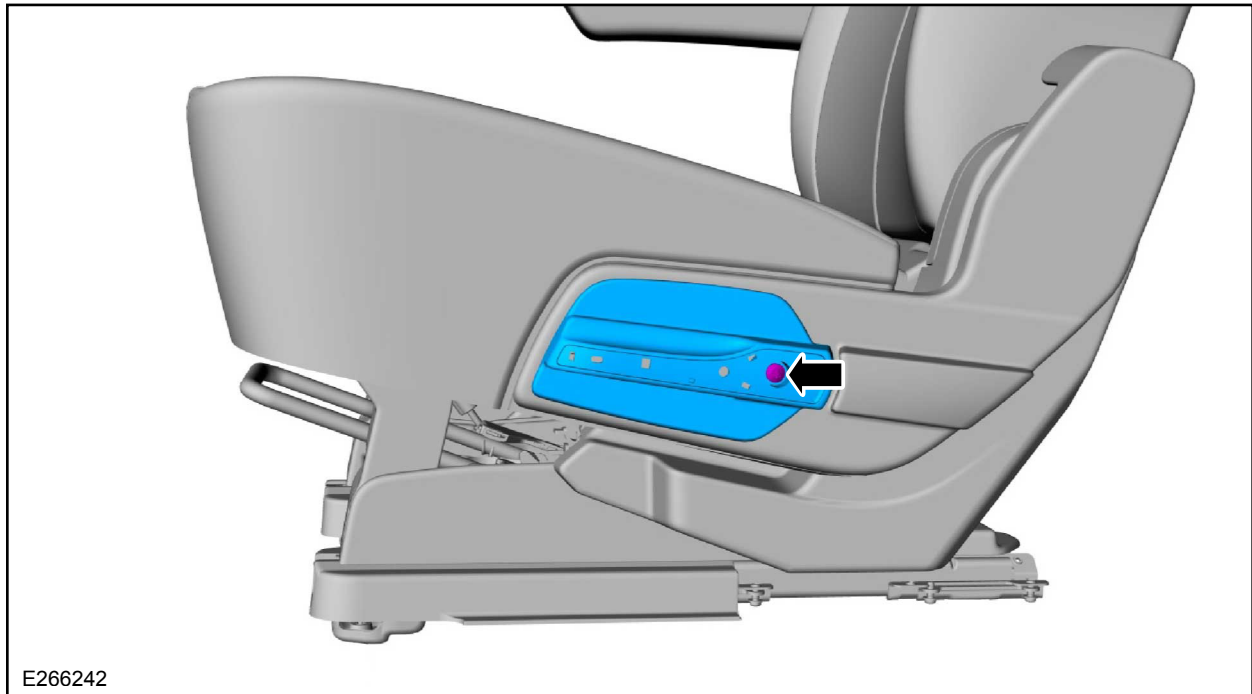
**FIGURE 4**

3. Remove screw and the recline handle. See Figure 4.

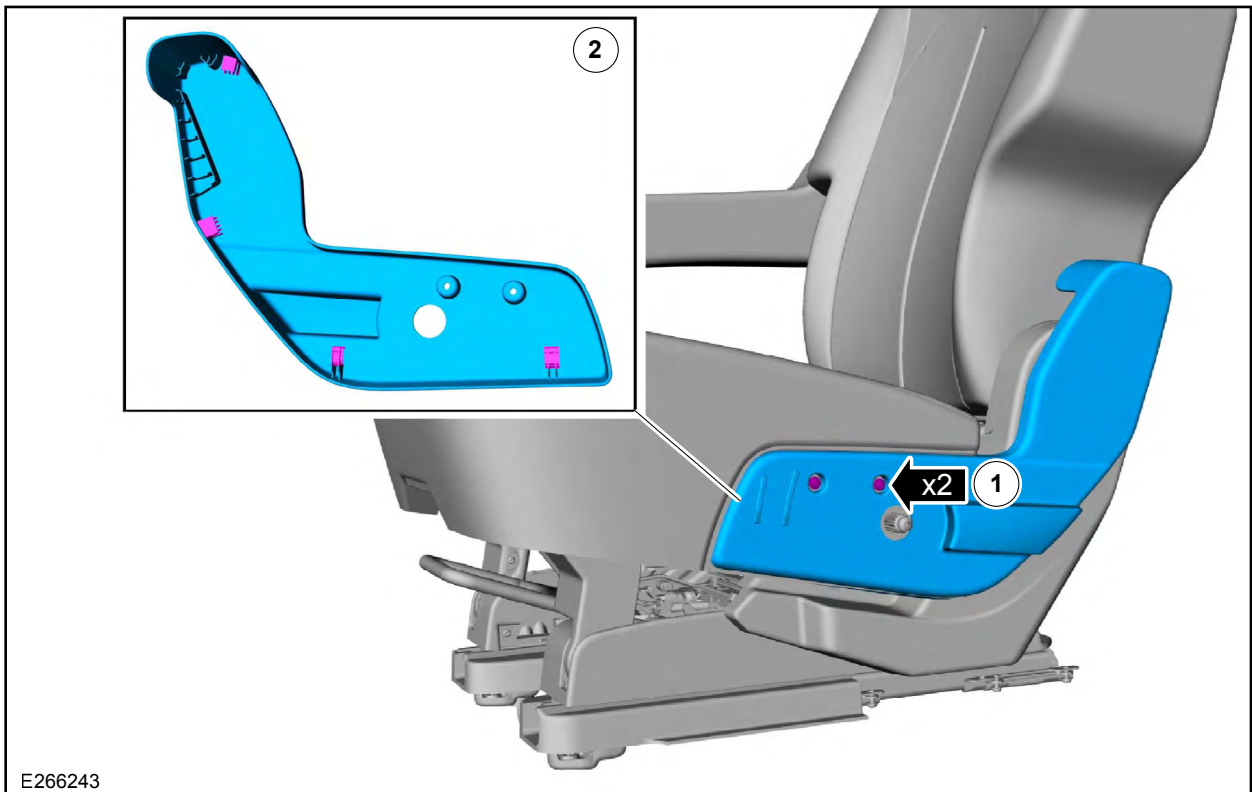
**FIGURE 5**

4. Remove the screws, release the retainers and remove the second row seat side shield. See Figure 5.

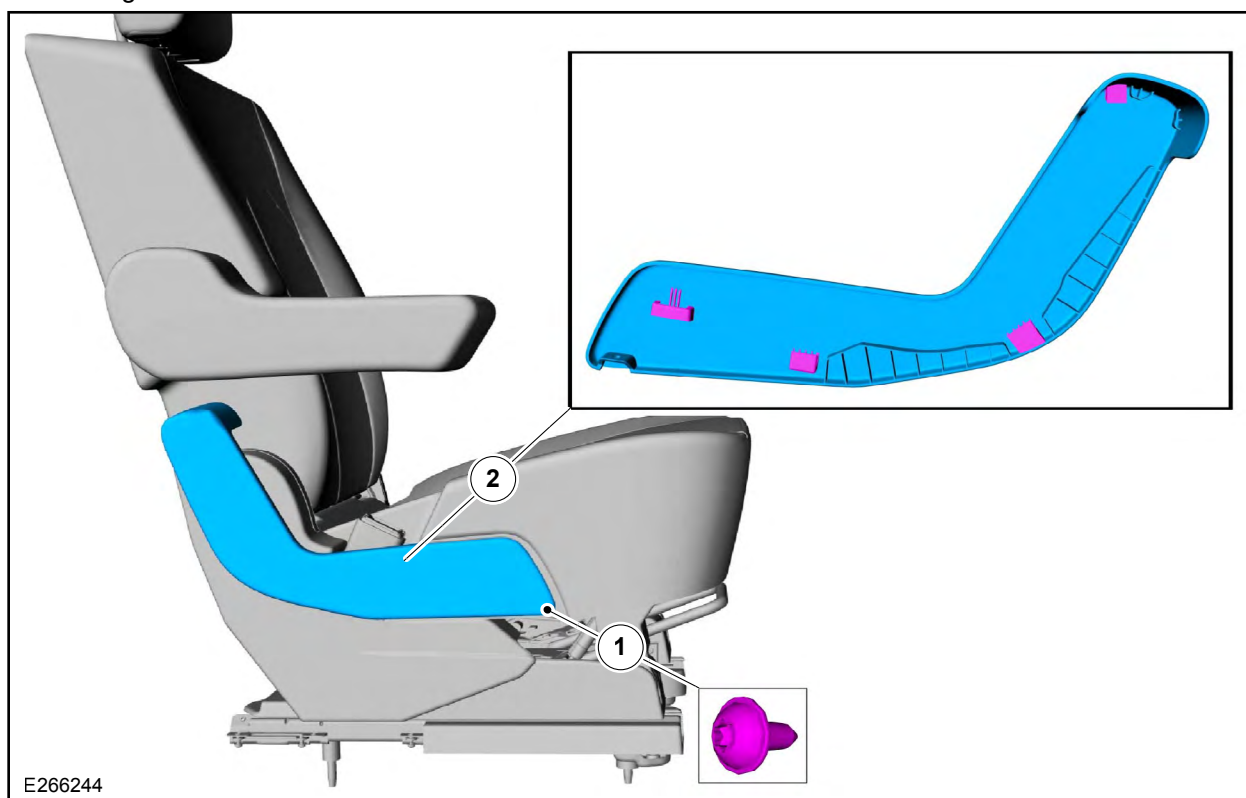
FIGURE 6

5. Remove the screws, release the retainers and remove the second row seat cushion pivot arm cover.  
See Figure 6.

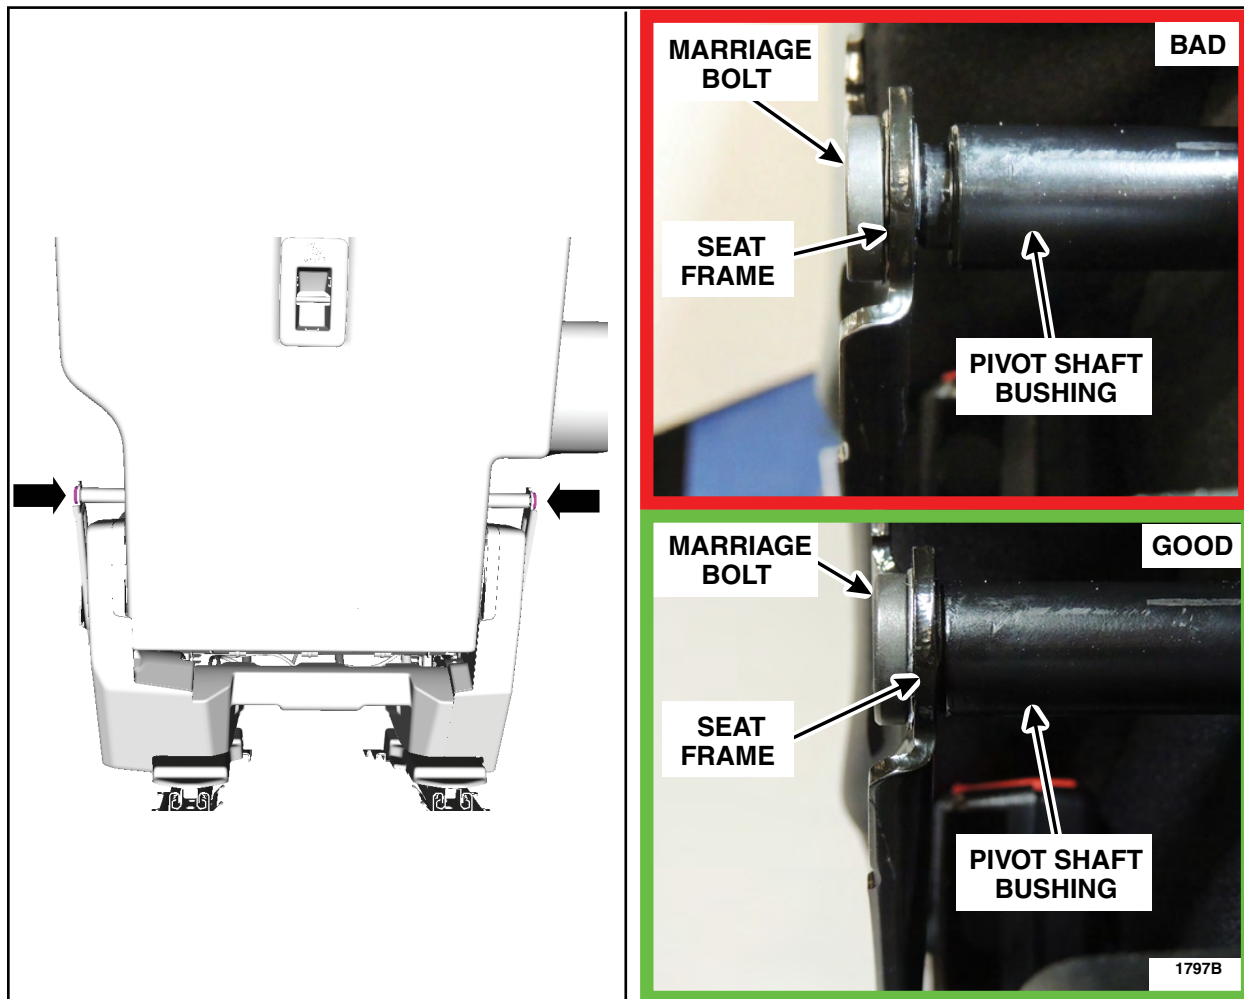
**FIGURE 7**

6. Verify the marriage bolts (2 per seat, four total), pivot shaft bushings and seat frames are properly aligned. See Figure 7.

- Tighten bolts to 15 Nm (11 lb-ft).
