**SUBJECT: NEW VEHICLE DEMONSTRATION / DELIVERY HOLD**  
**Safety Recall 17S34 – Supplement #1**  
 Certain 2015-2017 Transit Vehicles Equipped with a Trailer Module  
 Trailer Module Fuse and Footwell Drainage Hole

## CERTAIN 2015-2017 TRANSIT VEHICLES EQUIPPED WITH A TRAILER MODULE — TRAILER MODULE FUSE AND FOOTWELL DRAINAGE HOLE

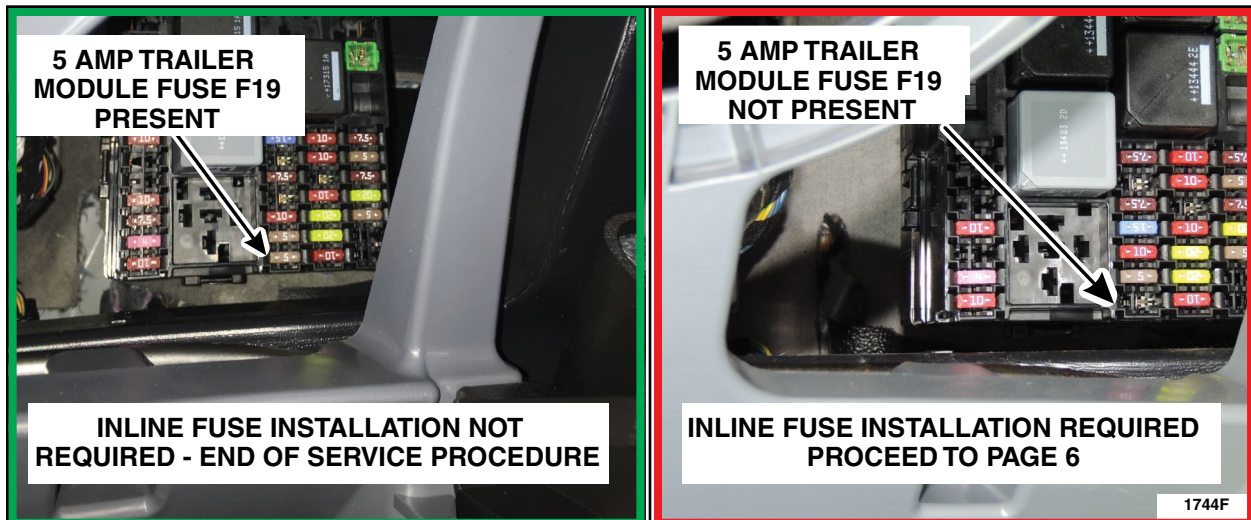
FIGURE 7

**NOTE:** Some installers may have used fuse position F19 for their aftermarket components. If F19 is anything other than a 5 amp fuse or has aftermarket wiring, then inline fuse installation is required.

2. Inspect for the presence of a 5 amp fuse in the auxiliary junction box at the specified location. Is a **5 amp** fuse present in position F19? See Figure 7.

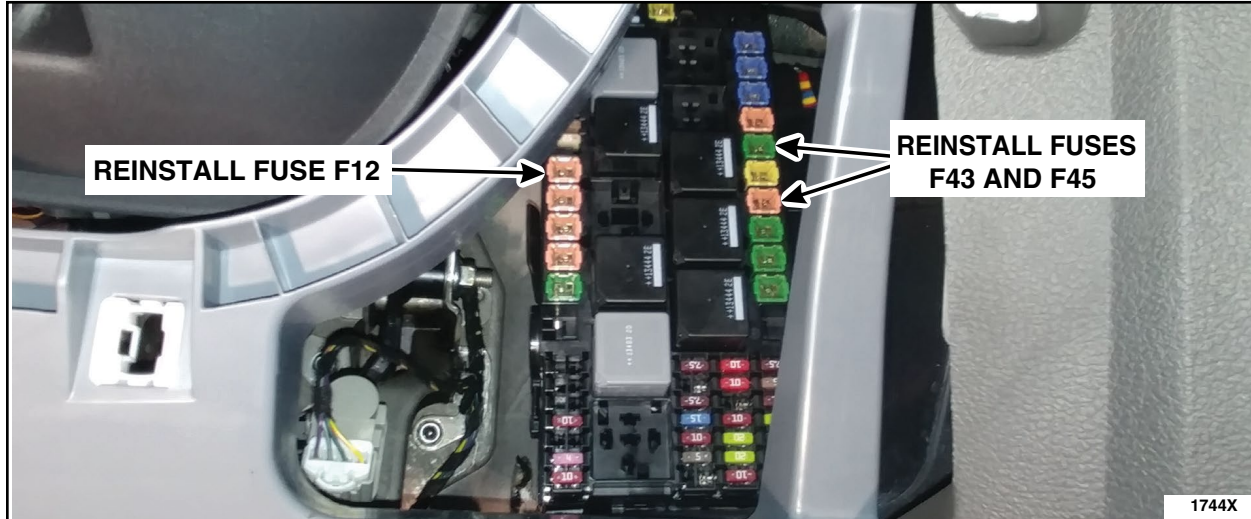
**FIGURE 30**

NOTE: These fuses may have been removed during an interim repair.

8. Inspect for fuses F12, F43 (pink 30 amp) and F45 (green 40 amp), and reinstall as required. See Figure 30.
