PRODUCT CAMPAIGN BULLETIN

<p>APPLICABILITY: 2003-2006 model year Baja 2003-2004 model year Legacy 2003-2004 model year Outback 2009-2011 model year Legacy 2009-2011 model year Outback 2009-2011 model year Forester 2006-2011 model year Tribeca 2006-2011 model year Impreza (including WRX and STI)</p>	<p>NUMBERS: TKA-16R TKB-16R TKC-16R</p> <p>DATE: 07/13/16</p> <p style="background-color: #f1c40f;">REVISED: 10/05/17</p> <p>NHTSA ID: 16V-358 16V-359 16V-361</p>
---	--

SUBJECT: Takata Front Passenger Airbag Inflator Replacement

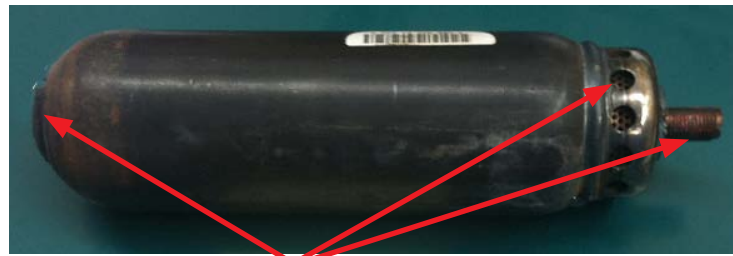
The shape, holes, and copper-colored stud indicate this not a Genuine Subaru inflator.

- Document the presence of the aftermarket or counterfeit device on the repair order and with photos. Report this information immediately on a Quality Monitoring Report (QMR). **IMPORTANT:** When entering a related QMR, use failure code ULF and **NOT** the campaign fail code.

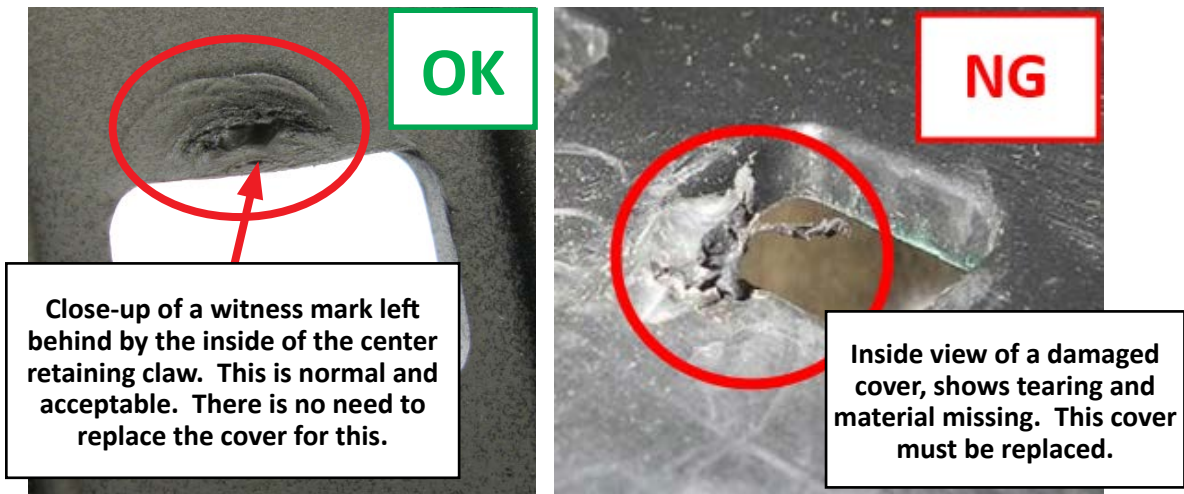
- Inspect the claw openings on the outside and inside of the cover for damage. If any found to look like the NG example photo below, the cover must be replaced.
