**PRODUCT CAMPAIGN BULLETIN**

**APPLICABILITY:** 2017MY Impreza

**NUMBER:** WTN-74R

**SUBJECT:** Reprogramming File Availability to Optimize Rear View Camera Operation on Harman Gen 3 Audio and Navigation Head Units

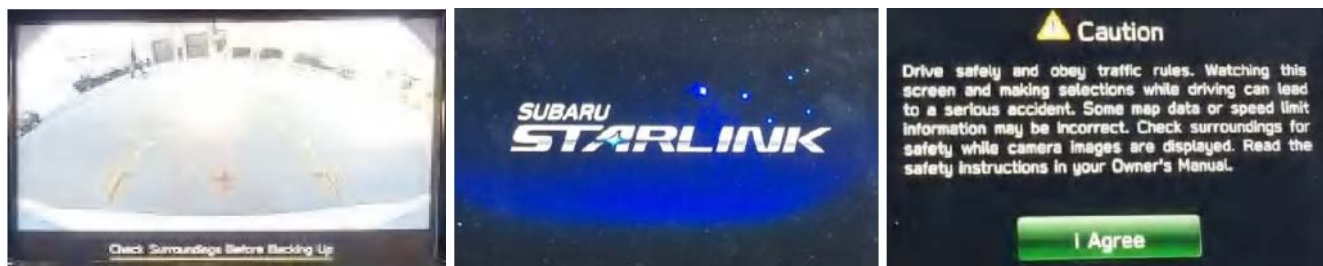
The main purpose of this campaign is to address display screen freeze-up during rear view camera display (when the shifter is in “R”). In addition, the screen may also freeze when either the Subaru STARLINK or Disclaimer Caution / I Agree is displayed.

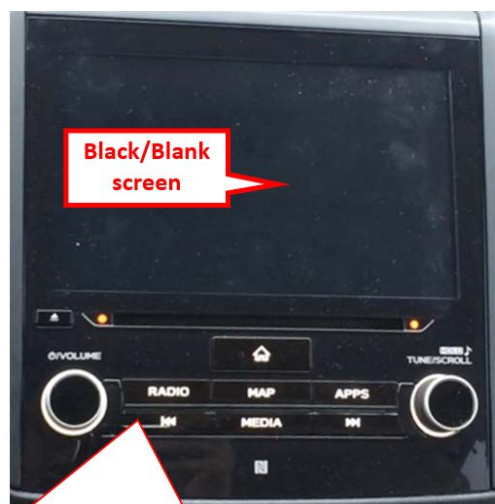
- 1) After switching the vehicle (ACC or IGN) on, the display screen goes black with no audio output and the hard key buttons are illuminated (on solid, or flashing / blinking).

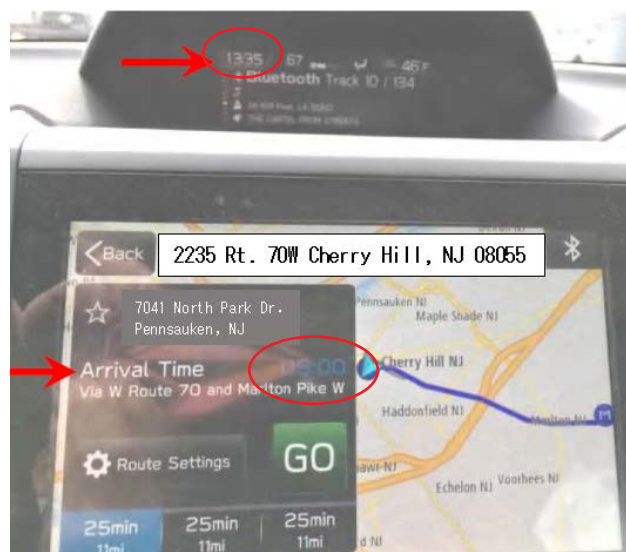
- 2) Time of day displayed in the MFD (Multi-Function Display) is incorrect and the arrival time displayed in Navigation units is also incorrect.

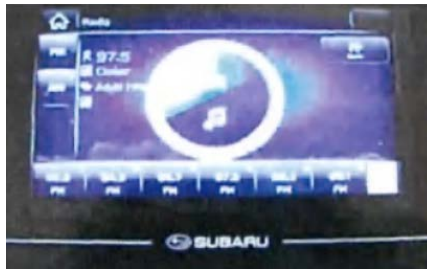
- 3) The time in the MFD automatically reverts back to a “default” setting, even after setting the time using “Manual” mode.
- 4) Audio volume goes to maximum automatically after one click of the volume up button on the steering wheel. In some cases, this condition may also occur without input from the operator. Maximum volume is also displayed on the screen.
