SAFETY RECALL ACTION

Reference number:	RA-07-0023	Issued: 6 July, 2017
Subject:	Connector failure on V8 Vantage 6-Speed SportShift Transmission	
Model(s):	V8 Vantage with 6-Speed SportShift Transmission	
VIN range:	Refer to the separately published list of VINs	
Applicable to:	All USA Dealers	
Distribute to:	After Sales Manager Executive Manager Service Manager Sales Manager	Warranty Staff Technician(s) Parts Staff

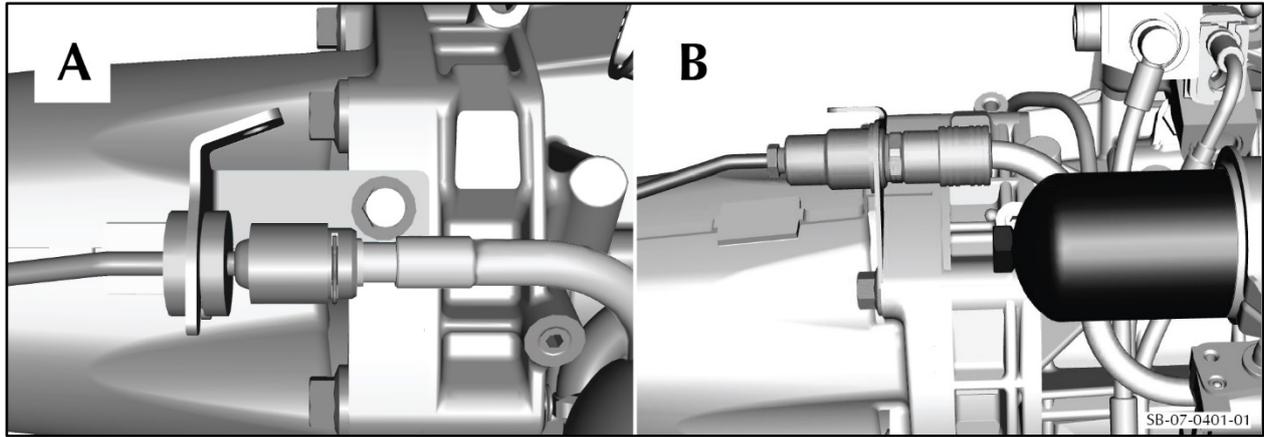
Figure 3

From VIN C15849, the 6-speed ASM transmission installed on V8 Vantage, has a different design of connector between the pipe for the clutch fluid and the ASM (Auto-Shift Manual) system. It is possible that this connector can fail and cause loss of the clutch fluid.

- Raise the vehicle and make it safe.
- Use an endoscope to examine the connector between the clutch fluid tube and the transmission.
- If the connector is the same as type "A" shown in Figure 3, continue from Part B.

- If the connector is the same as type "B" shown in Figure 3, you do not need to do more work.

Faulty Connector

New Connector

- If necessary, install a new connector and support bracket.

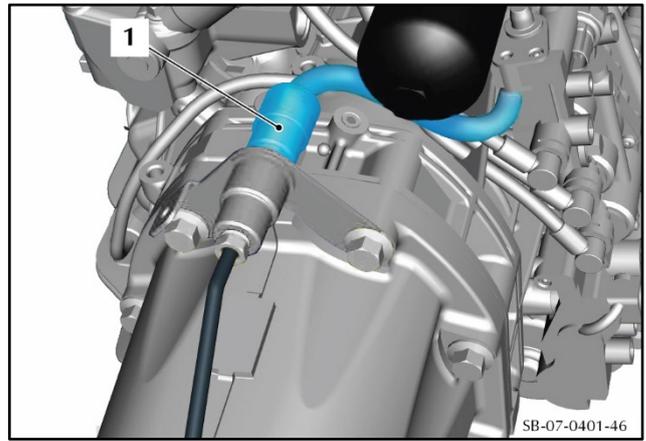
Figure 48

94. Connect the dry-break connector to the tube assembly for the clutch slave cylinder (refer to Figure 48). Make sure that the locking collar for the connector is in the correct position shown in view A of Figure 49. View B shows a connector that is not correctly connected.
