SAFETY RECALL ACTION

Reference number:	RA-07-0024	Issued: 6 July, 2017
Subject:	Connector failure on V8 Vantage 7-Speed SportShift II Transmission	
Model(s):	V8 Vantage and V8 Vantage S with 7-Speed SportShift II Transmission	
VIN range:	Refer to the separately published list of VINs	
Applicable to:	All USA Dealers	
Distribute to:	After Sales Manager Executive Manager Service Manager Sales Manager	Warranty Staff Technician(s) Parts Staff

Reason for this Recall Action (NHTSA Ref. 17V391)

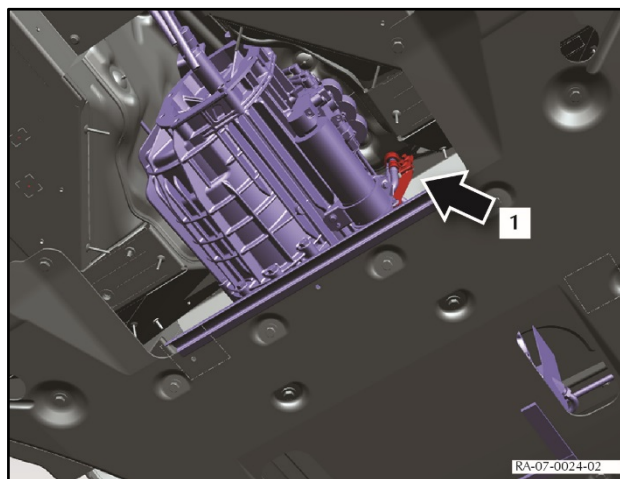
2. Examine the connector on the clutch supply line. If the bracket (1) shown in Figure 3 is installed, you do not need to do more work. Do Step 4.

If the bracket is not installed, continue from Part B.
