Product Safety Recall

17276 Loss of Steering Assist

Reference Number: N172085440

Release Date: August 2018
Revision: 02

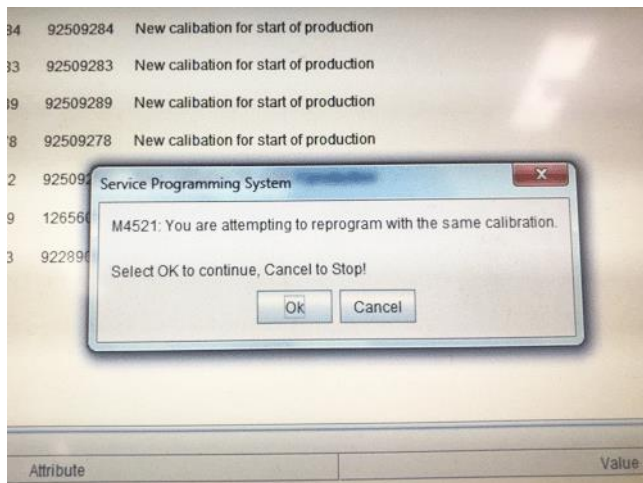
5045242

Note: If the Same Calibration/Software Warning is noted on the SPS controller screen, select “Ok” and continue programming.

1. Reprogram the power steering control module. Refer to *Power Steering Control Module Programming and Setup* in SI.
2. Record SPS Warranty Claim Code on job card for warranty transaction submission.
3. CALIFORNIA VEHICLES ONLY: Complete a “Proof of Correction” certificate and provide to the vehicle owner upon recall completion.
