# Product Safety Recall

## 17276 Loss of Steering Assist

**Reference Number:** N172085440

**Release Date:** May 2018  
**Revision:** 01

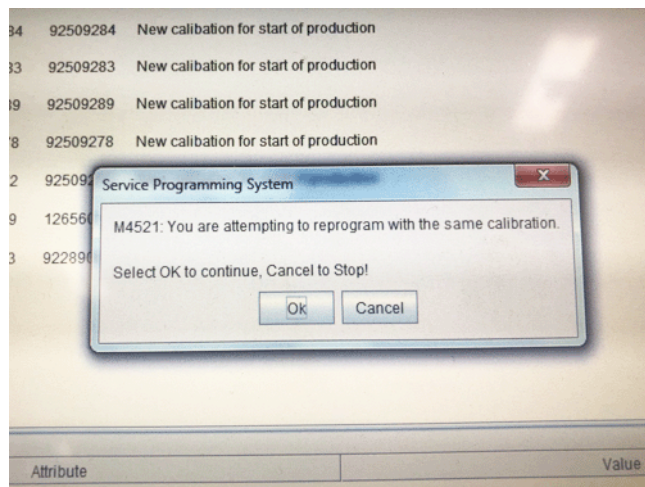
5045242

- Ensure the programming tool is equipped with the latest software and is securely connected to the data link connector. If there is an interruption during programming, programming failure or control module damage may occur.

- Stable battery voltage is critical during programming. Any fluctuation, spiking, over voltage or loss of voltage will interrupt programming. When required install the *EL-49642* SPS Programming Support Tool to maintain system voltage. If not available, connect a fully charged 12 V jumper or booster pack disconnected from the AC voltage supply. **DO NOT** connect a battery charger.

- Turn OFF or disable systems that may put a load on the vehicles battery such as; interior lights, exterior lights (including daytime running lights), HVAC, radio, etc.

- Clear DTCs after programming is complete. Clearing powertrain DTCs will set the Inspection/Maintenance (I/M) system status indicators to NO.

**Note:** If the Same Calibration/Software Warning is noted on the SPS controller screen, select “Ok” and continue programming.

1. Reprogram the power steering control module. Refer to *Power Steering Control Module Programming and Setup* in SI.
2. Record SPS Warranty Claim Code on job card for warranty transaction submission.
3. CALIFORNIA VEHICLES ONLY: Complete a “Proof of Correction” certificate and provide to the vehicle owner upon recall completion.
