Thor Motor Coach Recall Repair Instructions

Recall #	17V-692 2017-544		
Description/Title:	7-Pin Wire Harness		
Affected Product Line(s):	Certain 2018 Ace, Axis, Hurricane, Vegas & Windsport motorhomes		
Service Campaign # :	RC000148	Released Date:	11/20/2017
Failure Code:	TMCRC80470V	Document Date:	11/20/2017
Time Allowed:	0.4	Document Revision:	A

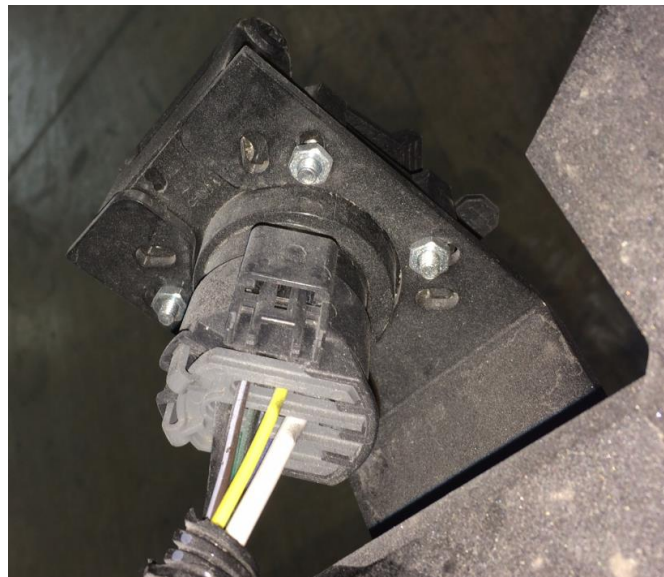
(Figure 1)

It has been discovered that on certain 2018 Ace, Axis, Hurricane, Vegas & Windsport motorhomes, the 7-Pin wires were not properly installed in the connector.

1. At the back of the 7-way tow connector (located on the hitch), unplug the taillight harness (See Figure 1).
