SI B62 16 17
Instruments

DELIVERY STOP & RECALL 17V-719: INSTRUMENT PANEL DISPLAY

RE: Delivery Stop & Recall 17V-719: Instrument Panel Display B62 16 17

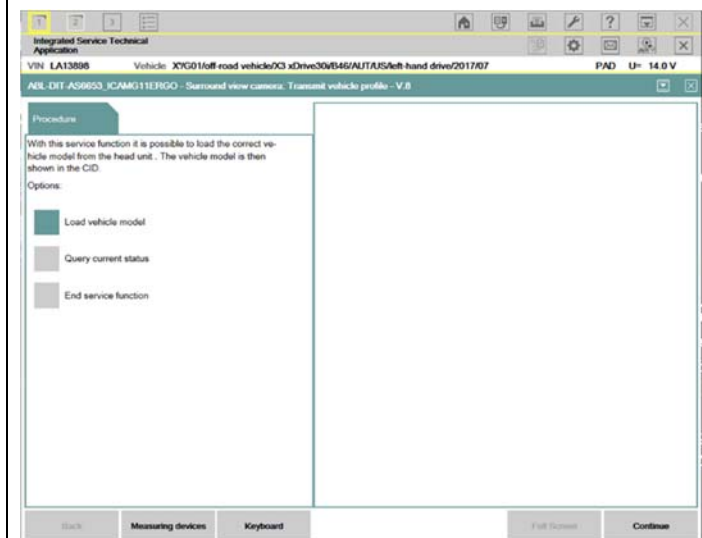
8. Check the fault memory after for FC 800B8A “TRSV: vehicle type not updated.
9. Calculate the test plan.

10. Select “Load vehicle model” and finish the test plan.
11. Turn the ignition off and let the vehicle sleep (for at least 2 minutes).
12. Make sure that all faults are corrected and that the correct model is displayed I the iDrive.
