SI B62 16 17  
Instruments

## DELIVERY STOP & RECALL 17V-XXX: INSTRUMENT PANEL DISPLAY

RE: Delivery Stop & Recall 17V-XXX: Instrument Panel Display B62 16 17

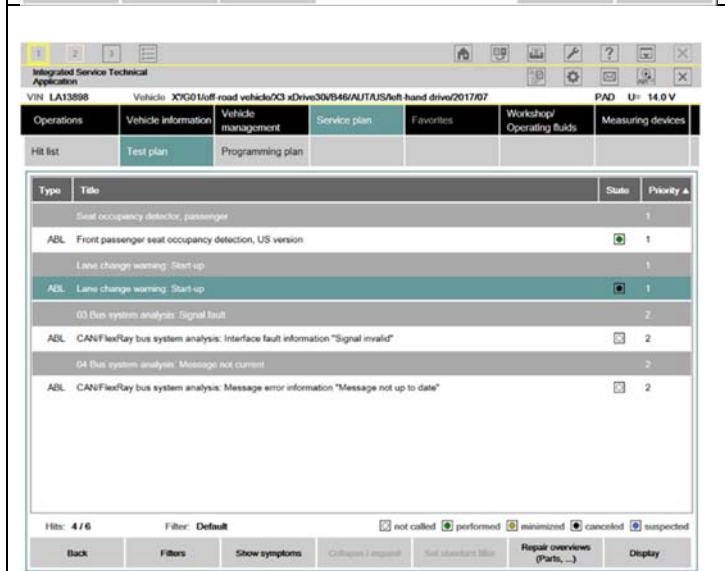
5. Select “Enable after re-coding” and continue and finish the test plan to enable the seat mat.

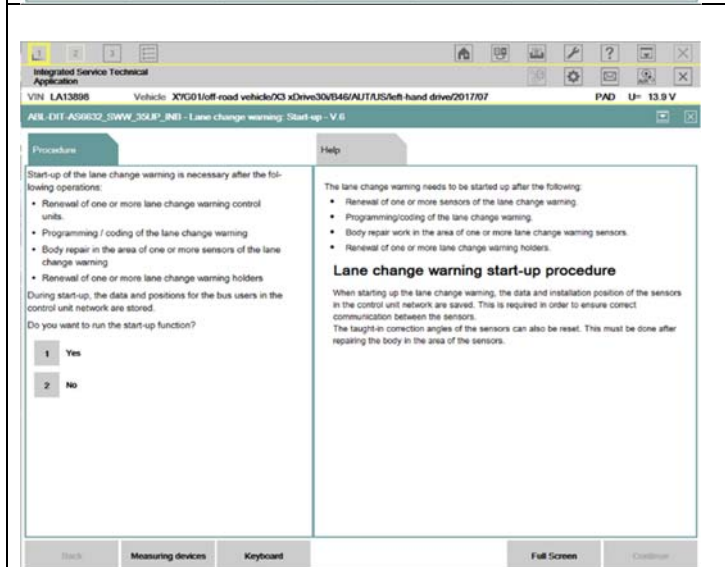
6. Select the test plan for the lane change warning and display.

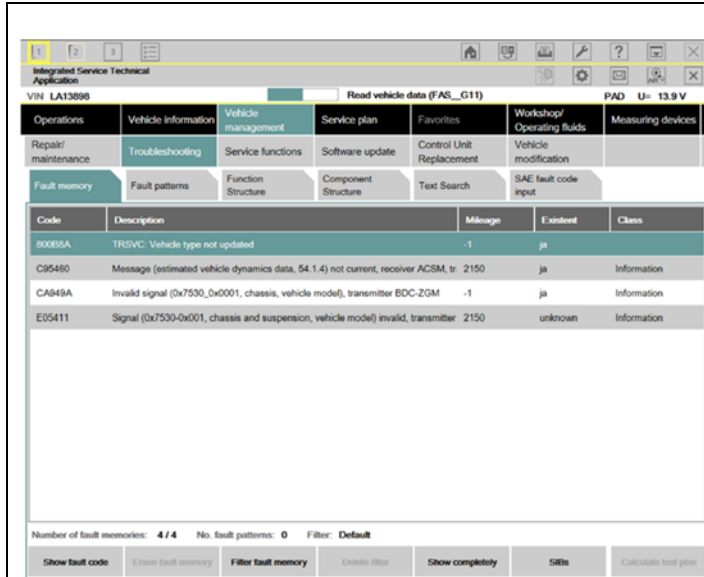
7. Select “Yes” to run and complete the start-up function.

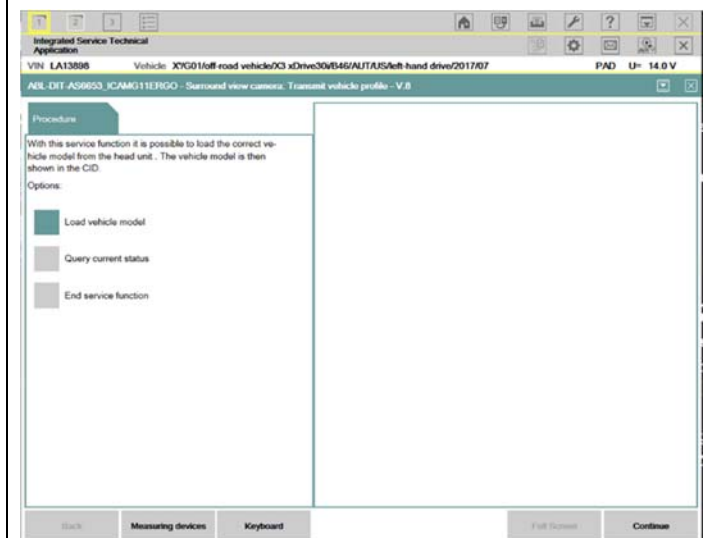
8. Check the fault memory after for FC 800B8A “TRSVc: vehicle type not updated.
9. Calculate the test plan.

10. Select “Load vehicle model” and finish the test plan.
11. Turn the ignition off and let the vehicle sleep (for at least 2 minutes).
12. Make sure that all faults are corrected and that the correct model is displayed I the iDrive.
