RECALL BULLETIN:
171213REV

Inspection /
Correction of
12-Volt Harness
Connectors and
Routing

ISSUE DATE:
February 2018

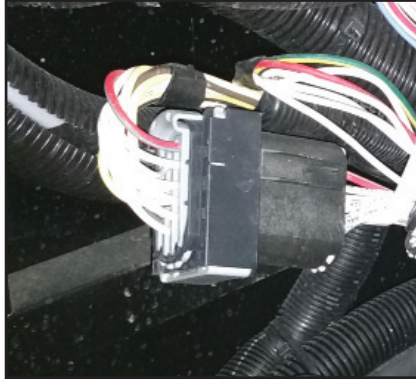
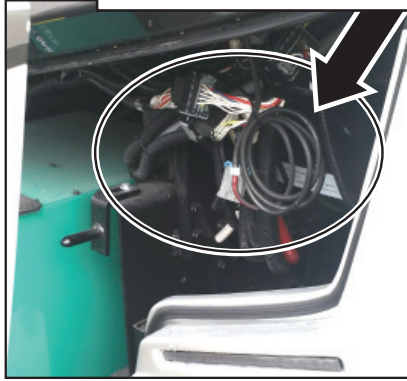
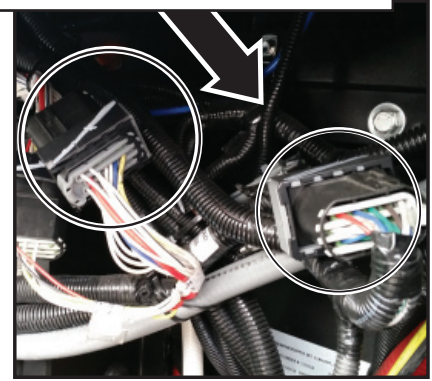
Location of large 12-Volt harness pin connectors in the front cap, on each side or slightly above, the generator

3. Working from the inside of the front cap, locate the large 12-Volt harness pin connectors (located on each side or slightly above the generator). See Figures A-3, A-4, and A-5.

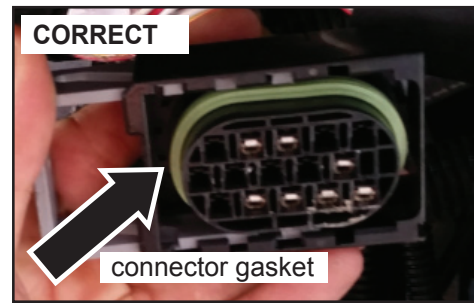
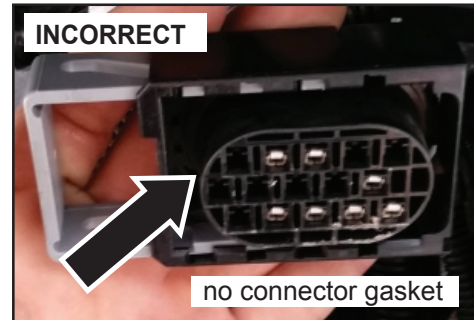
- Referring to Figures A-8 and A-9, inspect the female half of the pin connector. A green connector gasket should be installed; if the gasket is missing, install a new gasket from the recall Kit (see Parts list on Page 9).

- Inspect the connection for any loose pins. **Add dielectric grease inside the connector.** If any damage to the connector or its pin terminals is found (e.g., bent pins, corrosion, etc.) contact REV Dealer Technical Support.
- Carefully seat and press the 2 halves of the connectors together to ensure no damage is caused to the terminals.
- Once the connector is snapped together, push in the gray lock on the connector to re-engage the connector lock See Figure A-10.
- Reinstall any wire tie(s) that were previously removed to access wire harness and connectors.

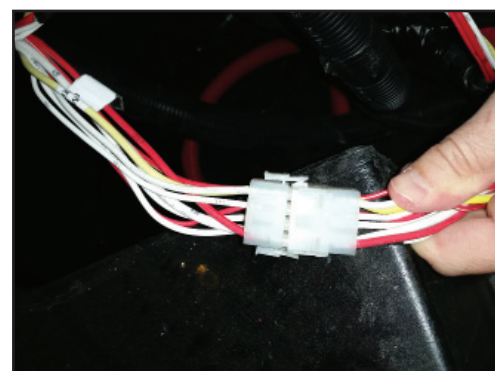
Figure B-2

Look for the white 12-Volt molded 6-pin or 12-pin connector(s) inside the compartment. See Figure B-2. The connector(s) may not be immediately visible without slightly shifting the wire bundle; use care to ensure the connector(s) are located without damaging any wiring.

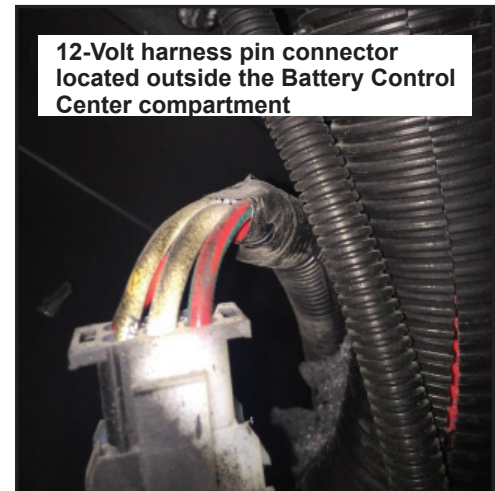
Figure B-3

- Unbundle the harness and auto loom to inspect for the white, 12-Volt molded pin connector(s) terminating on the outside of the compartment. See Figure B-3.
- From inside the Battery Control Center compartment, locate the large amount of spray foam sealer that was used to seal the opening in the compartment through which the wire harnesses are routed. This will be in the upper right-hand corner above the Battery Control Center. See Figure B-4.
- Carefully dig out the spray foam sealer to find the opening where the wire harnesses are routed through to the inside of the compartment. See Figure B-5.
