BULLETIN

Subject: Truck Bodies

No: B18001

Re: Truck Body Vertical Leg Support Inspection/Repair **Type:** Safety

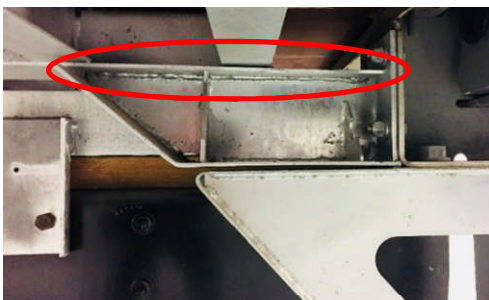
On certain dry truck body rear frames manufactured in 2017, a weld may not have been completed during final assembly. The weld is present on R.I.G. equipped units only, and does not affect other product types such as lift gate or special equipment products. MSCT, MSC, or non-sub frame mount R.I.G. (chassis frame connection) units are not included.

Figure 1 is an example of a completed weld. This weld may be on either side of the center flange.

On affected units the horizontal full length weld at the joint of the center flange and top plate will not be present.

Before weld application, remove the galvanizing or paint coating in the area that is to be welded. Weld the joint according to the welds in Figure 2. After the weld is complete a re-application of a "cold" galvanizing paint or protective coating must be applied to the area.
