## CERTAIN 2018 MODEL YEAR F-53 MOTORHOME CHASSIS - FRONT WHEEL STUDS

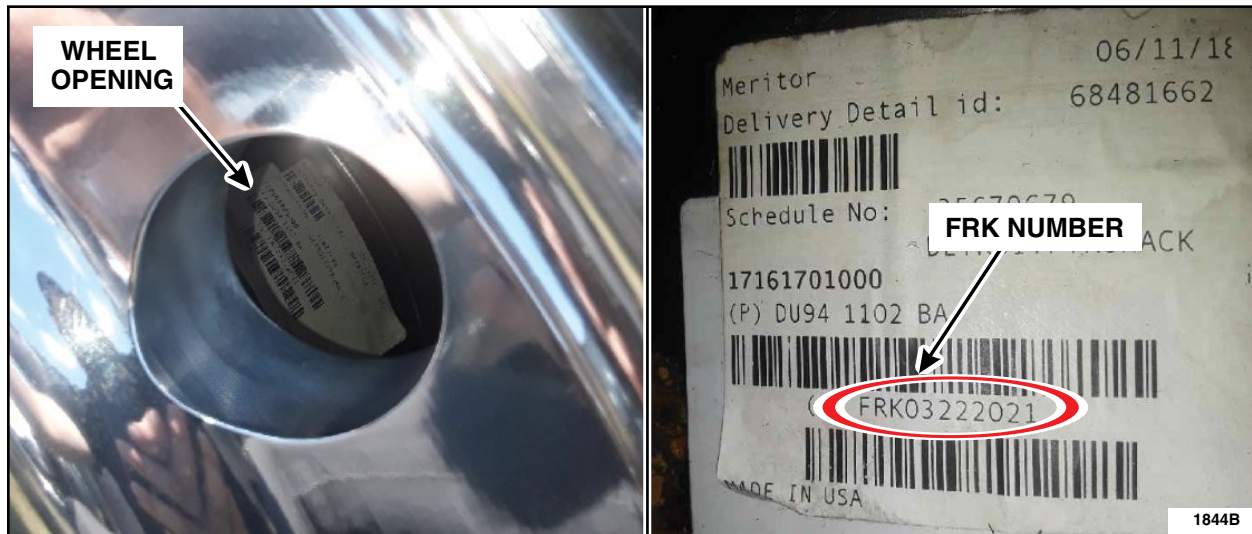
FIGURE 1

1. Locate the printed label on each front wheel hub and rotor assembly by viewing it through the wheel openings. See Figure 1.
2. Record the serial numbers printed on the labels starting with the letters "FRK". See Figure 1.
  - If left hand or right hand wheel hub assembly serial numbers fall between the ranges in the table below, the wheel studs are suspect and need to be individually inspected, proceed to Step 3.

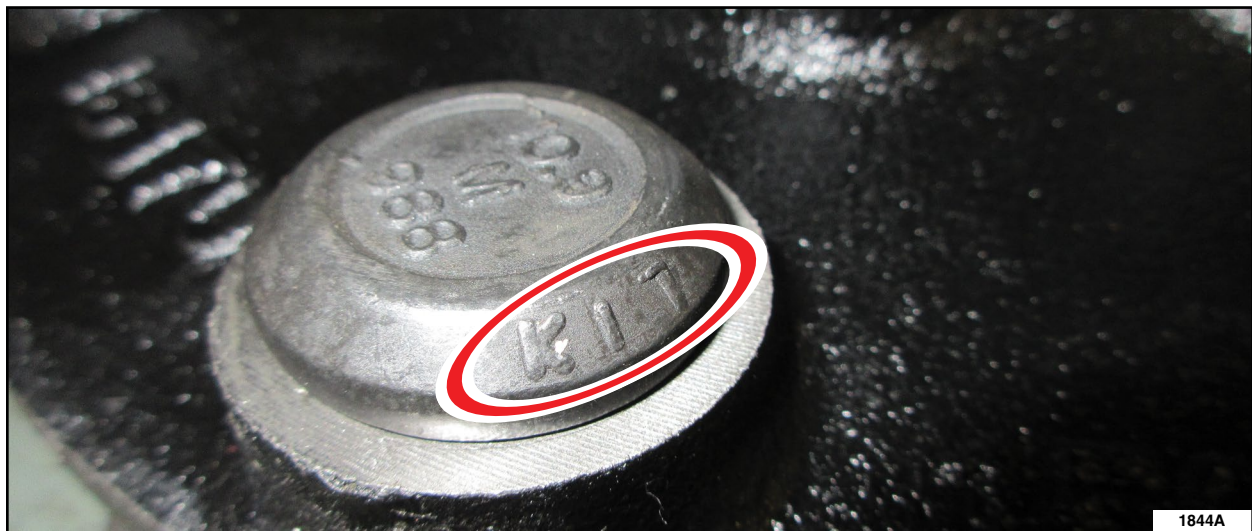
FIGURE 2

- If the hub assembly label is missing or illegible, the wheel studs are suspect and need to be individually inspected, proceed to Step 3.
  - If neither hub assembly serial number falls within the range listed, the inspection is complete.
3. Remove the wheel from the affected hub assembly (or assemblies).
  4. Inspect the head of each wheel stud. Studs marked with K17 must be replaced. See Figure 2. Proceed to the proper repair based on the vehicle's GVW as listed below.
    - If no wheel studs are marked with K17 then the inspection is complete.

5. Remove the wheel hub. Please refer to Workshop Manual (WSM) procedures in section 204-01.
6. Remove the brake disc. Please refer to WSM procedures in section 206-03.
7. Replace the affected wheel studs. Please refer to WSM procedures in section 204-01.

8. Replace the affected wheel studs. Please refer to WSM procedures in section 204-01.
