## IMPORTANT SAFETY RECALL

NHTSA Safety Recall  
No. 18V-006

## Slewing Ring Bolt Check

## **TECHNICAL BULLETIN N° 30/2017**

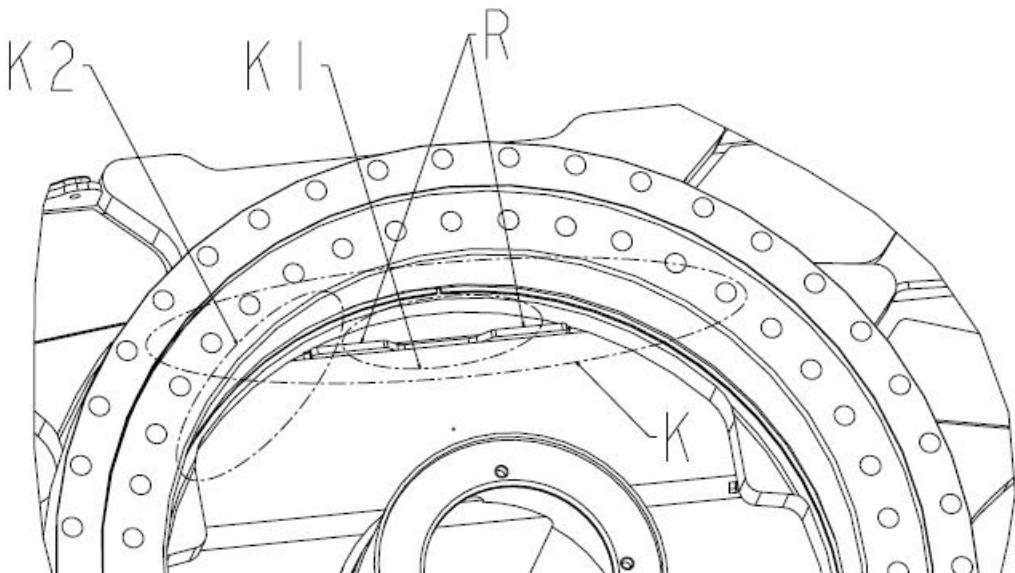
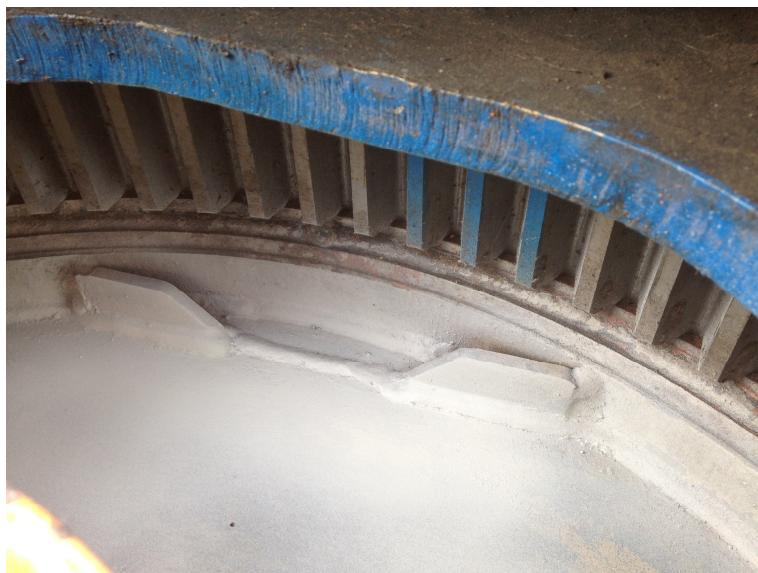
Rotate the crane with the booms towards the stabilizers of the crane in order to have visual access to the internal welding of the basement. Clean carefully the area and check with penetrant liquids the welding and adjacent areas in the whole area K (in particular in the area K1 and between the two ribs R and in the circular welds K2).

In case there are cracks in the above-mentioned welding, it is necessary to take the column off, proceed with the welding of a reinforcement kit and replace the inner and outer bolts of the slewing ring as per the following procedure.

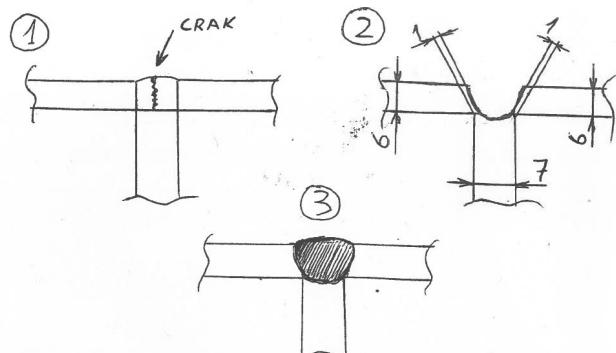
- a. Case of crack present in the center of the weld or removal and renew of the welding

According to the figure, remove material with emery according to the dimensions given and re-weld

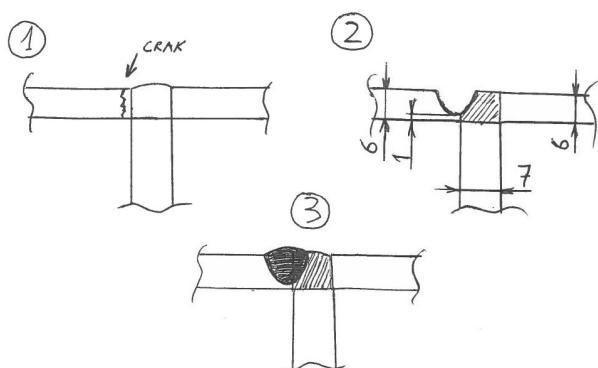
- b. Case of crack present in the edge of the weld

According to the figure, remove material with emery according to the dimensions given and re-weld

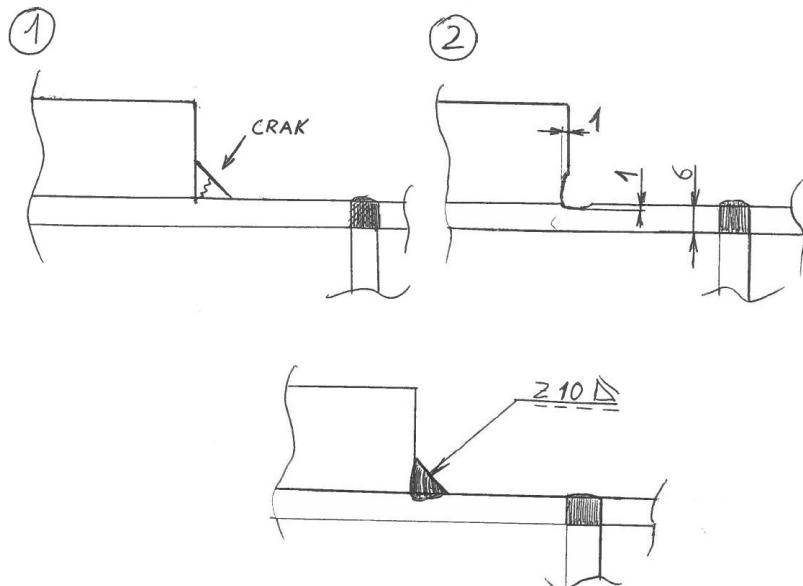
4. ZONE K2

- a. Case of crack in the traits of annular welding in the K area  
Remove with emery according to the dimensions given and re-weld.
