## **IMPORTANT SAFETY RECALL 18V-008 (SN663)**

## Safety Notice

SN-663

SUBJECT: Single Stick Control Adjustment

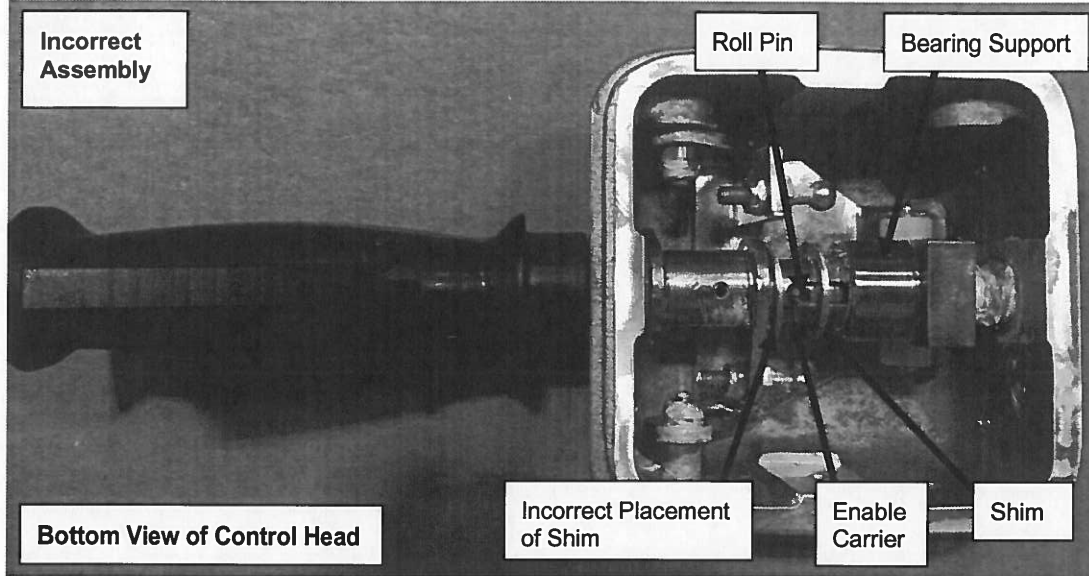
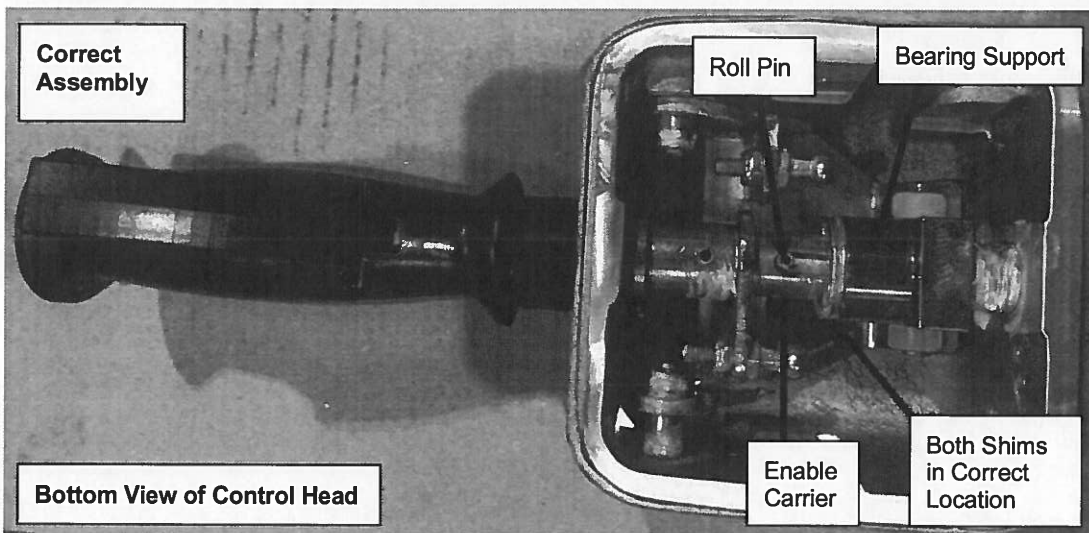
- a. Remove the plastic cap and lower the boot over the single stick mechanism.
  - b. Inspect the position of the two shims on the enable carrier.
  - c. If only one shim is between the roll pin and bearing support, the single stick is assembled incorrectly. Contact your local TEREX dealer to arrange repair. The control head must be assembled properly to provide allowance for wear to attain rated boom speeds.

- d. If both shims are between the roll pin and bearing support, the single stick is assembled properly. No further action is required for this bulletin. Continue to perform regular inspections and maintenance as stated in the manuals.
