PRODUCT CAMPAIGN BULLETIN

APPLICABILITY:	2009-2013 model year Legacy 2009-2013 model year Outback 2009-2013 model year Forester 2009-2013 model year Tribeca 2009-2011 model year Impreza 2009-2013 model year WRX and STI	NUMBERS: TKA-18 TKB-18 TKC-18
		DATE: 02/09/18
		NHTSA ID: 18V-012 18V-013 18V-014
SUBJECT:	Takata Front Passenger Airbag Inflator Replacement (2018 Calendar year expansion)

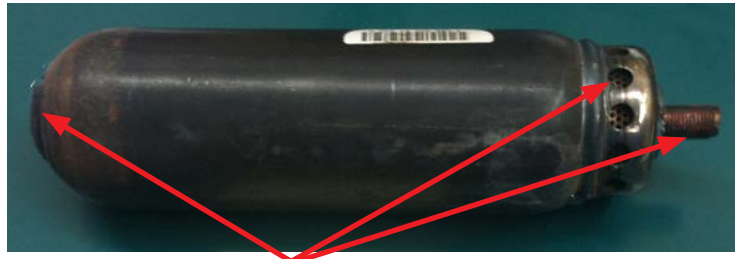
The shape, holes, and copper-colored stud indicate this not a Genuine Subaru inflator.

- **Do not proceed with this repair if your inspection reveals a non-Genuine Subaru airbag module has been installed in the vehicle.** Follow the instructions described in the “Counterfeit Airbag Information” Dealer Advisory Bulletin.
