PRODUCT CAMPAIGN BULLETIN

<p>APPLICABILITY: 2009-2013 model year Legacy 2009-2013 model year Outback 2009-2013 model year Forester 2009-2013 model year Tribeca 2009-2011 model year Impreza 2009-2013 model year WRX and STI</p> <p>SUBJECT: Takata Front Passenger Airbag Inflator Replacement (2018 Calendar year expansion)</p>	<p>NUMBERS: TKA-18R TKB-18R TKC-18R</p> <p>DATE: 02/09/18 REVISED: 03/06/18</p> <p>NHTSA ID: 18V-012 18V-013 18V-014</p>
---	---

DESCRIPTION OF THE SAFETY DEFECT AND SAFETY HAZARD

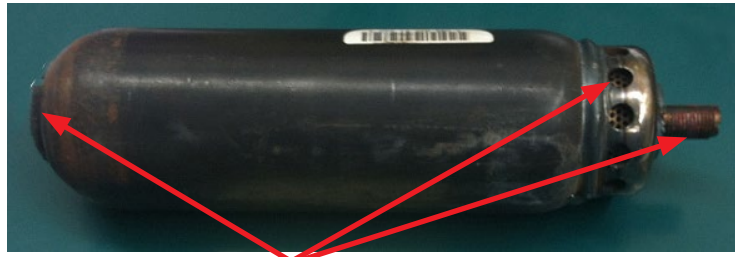
The shape, holes, and copper-colored stud indicate this not a Genuine Subaru inflator.

- **Do not proceed with this repair if your inspection reveals a non-Genuine Subaru airbag module has been installed in the vehicle.** Follow the instructions described in the “Counterfeit Airbag Information” Dealer Advisory Bulletin.
