PRODUCT CAMPAIGN BULLETIN

<p>APPLICABILITY: 2009-2013 model year Legacy 2009-2013 model year Outback 2009-2013 model year Forester 2009-2013 model year Tribeca 2009-2011 model year Impreza 2009-2013 model year WRX and STI</p> <p>SUBJECT: Takata Front Passenger Airbag Inflator Replacement (2018 Calendar year expansion)</p>	<p>NUMBERS: TKA-18R TKB-18R TKC-18R</p> <p>DATE: 02/09/18 REVISED: 07/20/18</p> <p>NHTSA ID: 18V-012 18V-013 18V-014</p>
---	---

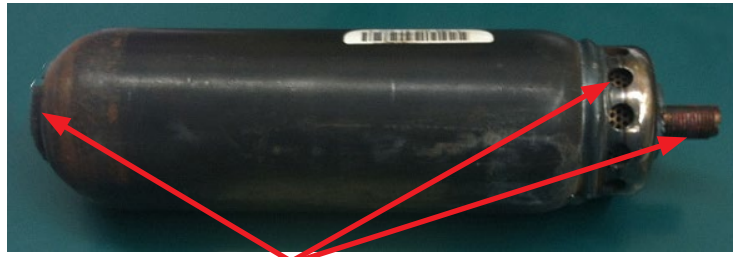
The shape, holes, and copper-colored stud indicate this not a Genuine Subaru inflator.

- **Do not proceed with this repair if your inspection reveals a non-Genuine Subaru airbag module has been installed in the vehicle.** Follow the instructions described in the “Counterfeit Airbag Information” Dealer Advisory Bulletin.

- Document the presence of the aftermarket or counterfeit device on the repair order and with photos. Report this information immediately on a Quality Monitoring Report (QMR). **IMPORTANT:** When entering a related QMR, use failure code **ULF** and **NOT** the campaign fail code.
