PRODUCT CAMPAIGN BULLETIN

<p>APPLICABILITY: 2009-2013 model year Legacy 2009-2013 model year Outback 2009-2013 model year Forester 2009-2013 model year Tribeca 2009-2011 model year Impreza 2009-2013 model year WRX and STI</p> <p>SUBJECT: Takata Front Passenger Airbag Inflator Replacement (2018 Calendar year expansion)</p>	<p>NUMBERS: TKA-18 TKB-18 TKC-18</p> <p>DATE: 02/07/18</p> <p>NHTSA ID: 18V-012 18V-013 18V-014</p>
---	--

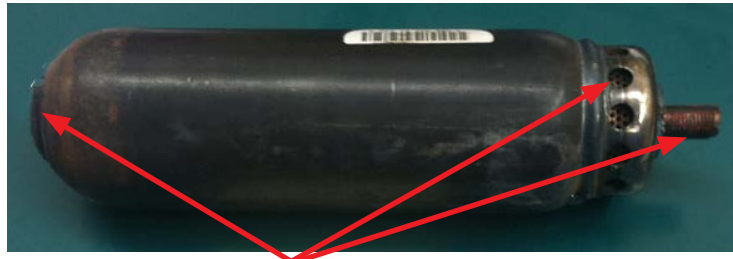
The shape, holes, and copper-colored stud indicate this not a Genuine Subaru inflator.

- **Do not proceed with this repair if your inspection reveals a non-Genuine Subaru airbag module has been installed in the vehicle.** Follow the instructions described in the “Counterfeit Airbag Information” Dealer Advisory Bulletin.

- Document the presence of the aftermarket or counterfeit device on the repair order and with photos. Report this information immediately on a Quality Monitoring Report (QMR). **IMPORTANT:** When entering a related QMR, use failure code **ULF** and **NOT** the campaign fail code.
