Product Safety Recall

17476 Front Passenger Air Bag Inflator

Reference Number: N161644423

Release Date: March 2018

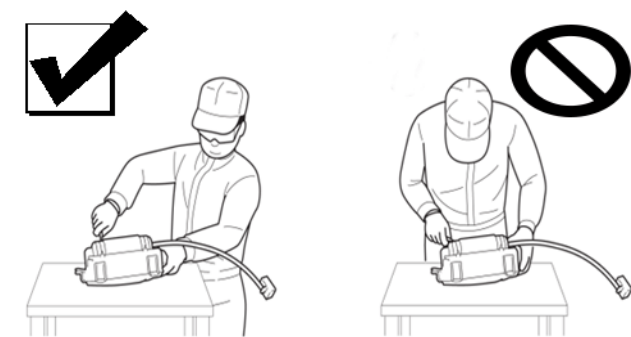
4751076

Warning: Confirm the stopper plate to inflator fitment is correct. *DO NOT* pinch the harness between the inflator and the stopper plate.

Warning: When working with the airbag module, avoid standing directly in front of the parts

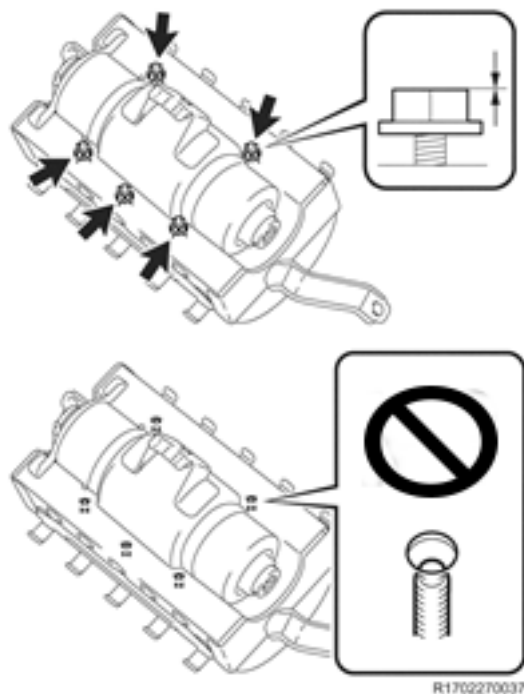
4751077

Note: Put a mark on each of the 5 loosened self-locking nuts to prevent accidental reuse.

1. Loosen the 5 self-locking nuts until each face becomes flush with the edge of the stud bolt.

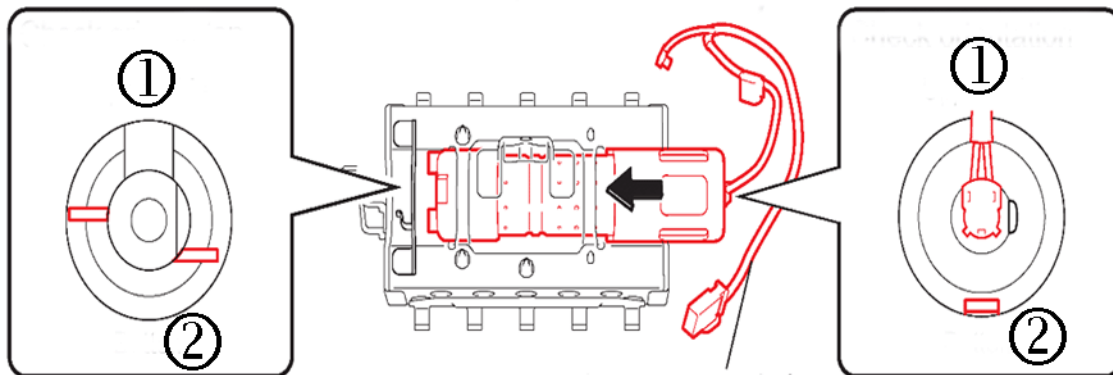
4751078

Important: DO NOT insert the inflator fully.

4. Insert a NEW inflator to the center of the airbag case with the correct orientation as shown (1) Upper side (2) Bottom.
 - If the passenger airbag inflator is upside down, it will not be able to be fully inserted.
 - Make sure that the passenger airbag inflator is oriented correctly as shown, not upside down.

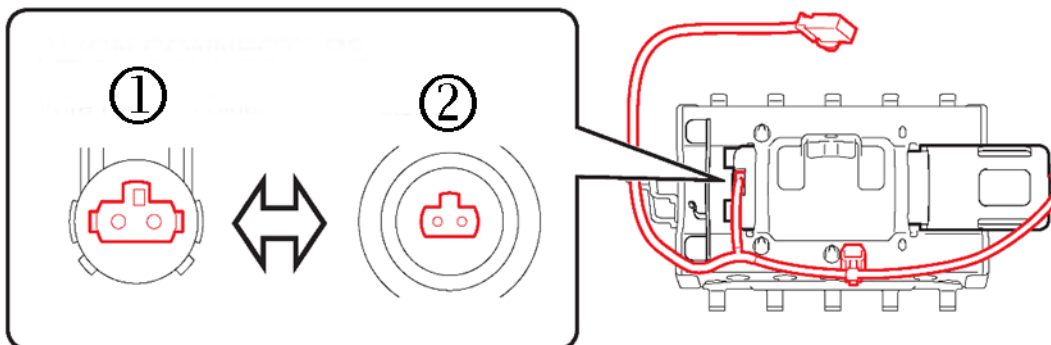
4751079

Important: Make sure that the inflator is oriented correctly as shown in the illustration, not upside down. If the passenger airbag inflator is upside down, it will not be able to be fully inserted.

5. Connect the connector and push in each airbag connector lock as shown (1). Wire harness side (2) Inflator side.

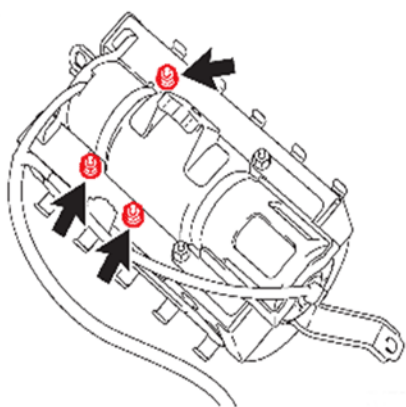
4751083

Important: If any gap exists, the aligned flats may move apart, resulting in failure in normal deployment of the airbag.

8. Remove the 3 remaining old self-locking nuts and install temporarily 3 **NEW** self-locking nuts by hand. Store the removed self-locking nuts in a replacement part box or the like.
9. Push the inflator and plate towards the position determining plate to eliminate any gap.

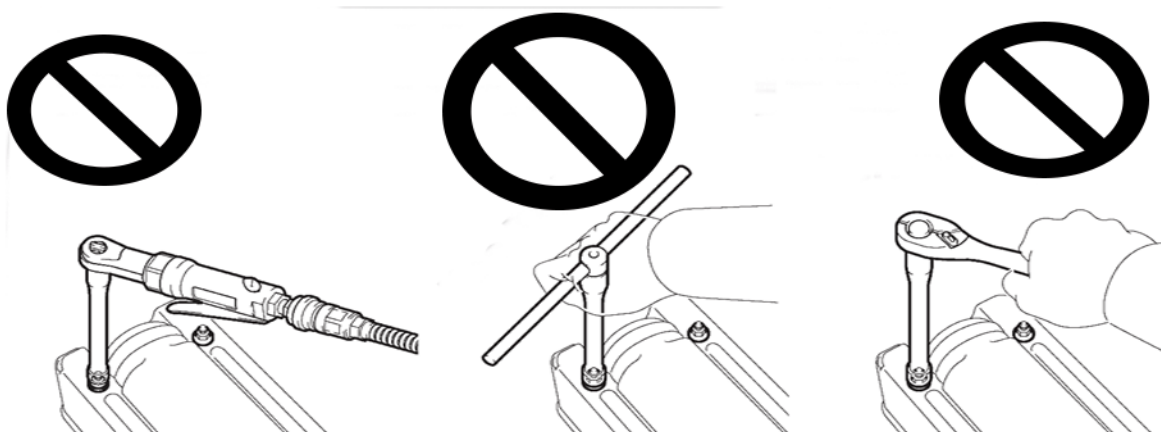
4751084

Important: The tightening torque is low (3.9 N·m). Use of an air ratchet wrench or tightening strongly with a T-handle wrench or a ratchet handle may cause deformation of the stud bolt.
