TO: Mercedes-Benz Dealer Principals, General Managers, Sales Managers, Service Managers, Parts Managers	FROM: Gregory Gunther, Department Manager, Vehicle Compliance and Analysis, Engineering Services
RE: <b>Recall Campaign Launch Notification – 2019050008 Takata PG4 and PG5 DRIVER and PASSENGER AIRBAGs</b> Certain MY08-09 C63 AMG C-Class (W204)	DATE: May 24, 2019

Recall Campaign Launch Notification			May 24, 2019
Campaign No. :	NHTSA ID: 16V081 16V363/17V017 18V043	Campaign Desc. :	Takata Recall - PG 4 & 5 Driver and Passenger Airbag
2019050008		19P9194003	
<p>This is to notify you of the <b>Recall Campaign</b> to replace the front driver-side and passenger-side airbags on approximately <b>2,691</b> Model Year ("MY") 2008-2009 C63 AMG (204) vehicles. The recall campaign will be visible on the <a href="http://www.safercar.gov">www.safercar.gov</a> website and may generate questions from customers. Affected VINs will be flagged in VMI as "OPEN" on May 24, 2019.</p>			
<b>Background</b>			
<b>Issue</b>	<p>Based on the defect decision of TK Holdings, Inc. ("Takata"), in certain frontal airbags produced by Takata used in certain Model Year 2008-2009 Mercedes-Benz vehicles, under speci

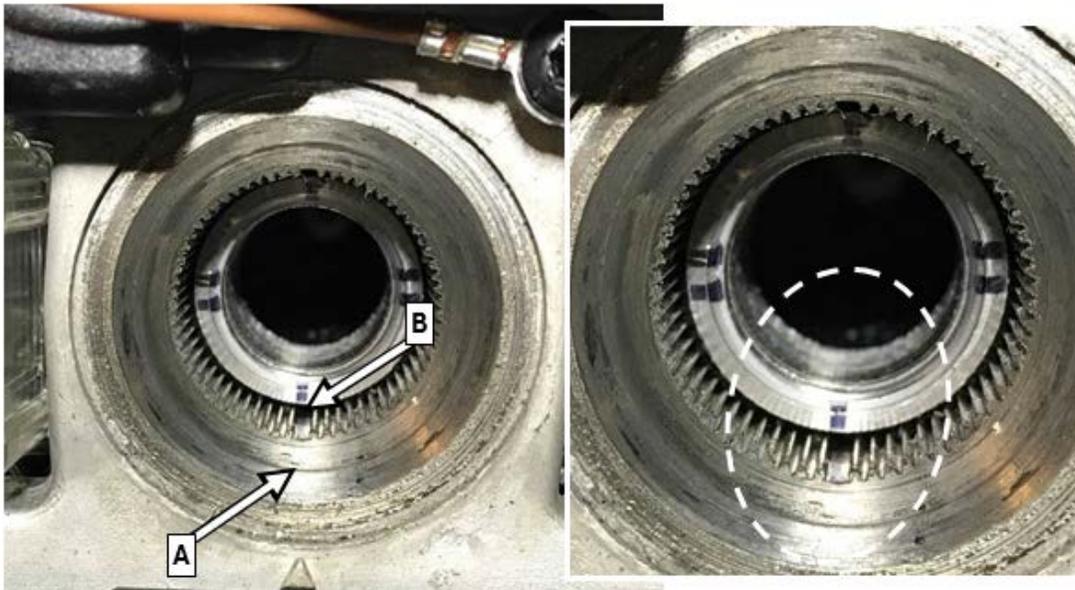
Figure 2

**i** The serrations (A, Figure 2) on the steering wheel must be aligned with the marking (B, Figure 2) on the steering shaft.

**i** Check the position carefully before removal and position identically during installation.
