David J. Johnson
Director
Service Engineering Operations
Ford Customer Service Division

September 24, 2018

SUBJECT: **Safety Recall 18S01 – Supplement #6**
Certain 2009-2010 and 2013 Mustang, 2009-2010 Ranger, 2009-2010 Fusion and Milan, 2009-2010 MKZ, and 2009-2010 Edge and MKX Vehicles
Passenger Airbag Inflator Replacement

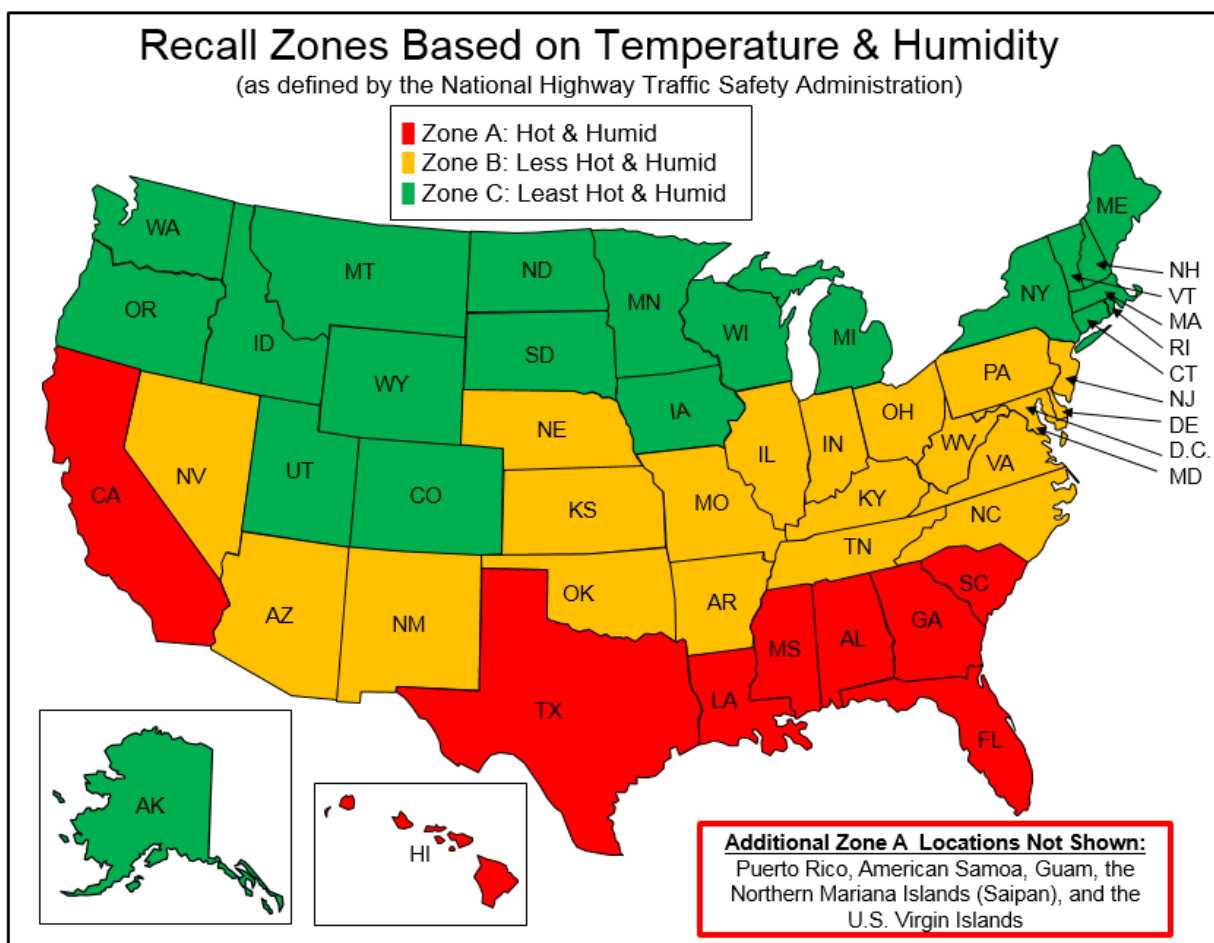
FIGURE 1

The Takata airbag recall zones have been defined by the NHTSA, based on temperature and humidity.
