Revised April 2018

Dealer Service Instructions for:

Safety Recall U11 / NHTSA 18V-100 Brake Transmission Shift Interlock

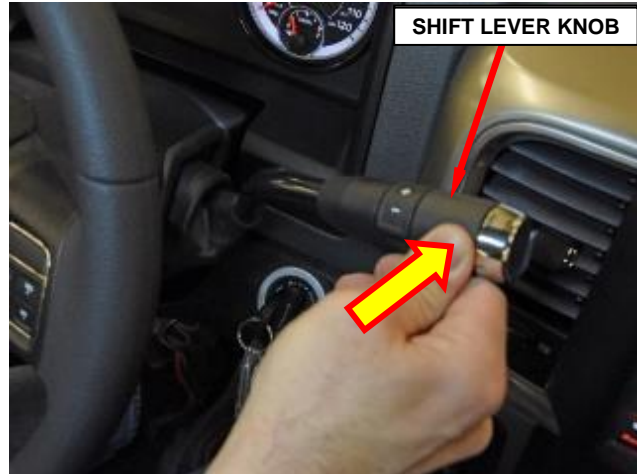
Figure 1 – Push Lightly On Shift Lever Knob Toward Instrument Panel To Feel BTSI Solenoid Pin Movement

5. Place your hand on the shift lever knob and push lightly on the shift lever toward the instrument panel. This will allow you to feel a click sensation from BTSI solenoid pin movement when the brake pedal is applied and released (Figure 1).

9. After five seconds of holding the brake pedal down, release the brake pedal while both listening and feeling for the click of the BTSI pin movement. The sound and feel of the BTSI pin movement should occur immediately within 0-2 seconds upon release of the brake pedal.

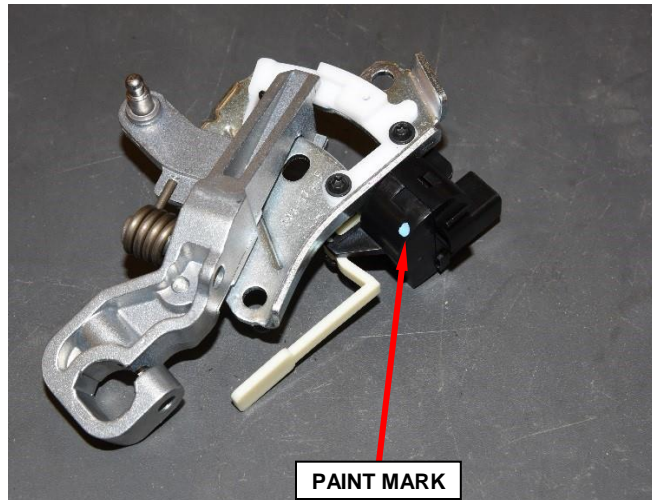
Figure 14 – Gearshift Bracket / BTSI Assembly Paint Mark Verification

24. Discard the old gearshift bracket / BTSI assembly.
25. Verify the **new** gearshift bracket / BTSI assembly to be used has a paint mark on the BTSI solenoid (Figure 14).
26. Install the gearshift lever to the **new** gearshift bracket / BTSI assembly and ensure the gearshift lever is fully inserted into the gearshift bracket (Figure 15).
