Revised March 2018

Dealer Service Instructions for:

## **Safety Recall U11 / NHTSA 18V-100 Brake Transmission Shift Interlock**

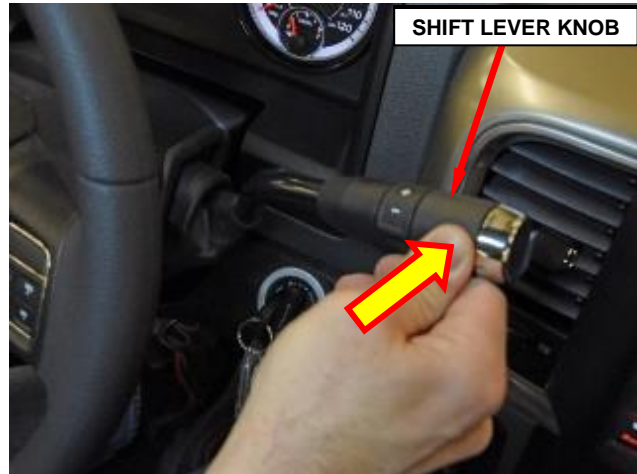
5. Place your hand on the shift lever knob and push lightly on the shift lever toward the instrument panel. This will allow you to feel a click sensation from BTSI solenoid pin movement when the brake pedal is applied and released (Figure 1).

**Figure 1 – Push Lightly On Shift Lever Knob Toward Instrument Panel To Feel BTSI Solenoid Pin Movement**

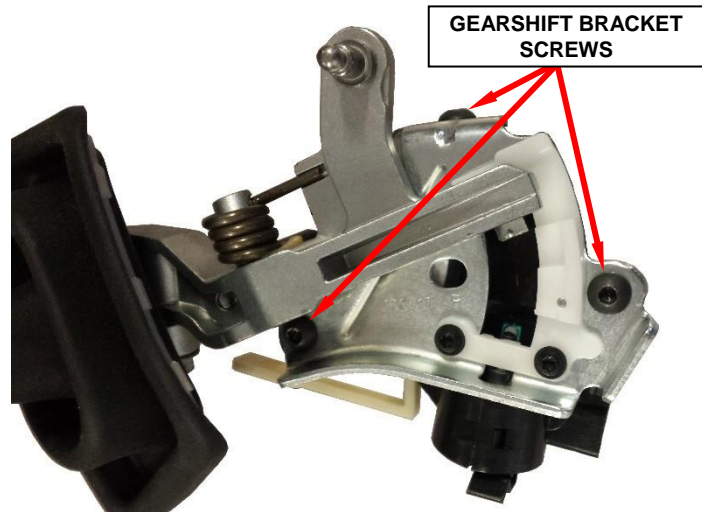
18. Remove and save the three T27 star-head screws securing the gearshift bracket / BTSI assembly to the steering column (Figure 12).

**Figure 12 – Gearshift Bracket / BTSI Assembly Screws**

31. Install the three T27 star-head screws securing the gearshift bracket / BTSI assembly to the steering column. Tighten the screws to 10 N·m (89 in. lbs.) (Figure 12).

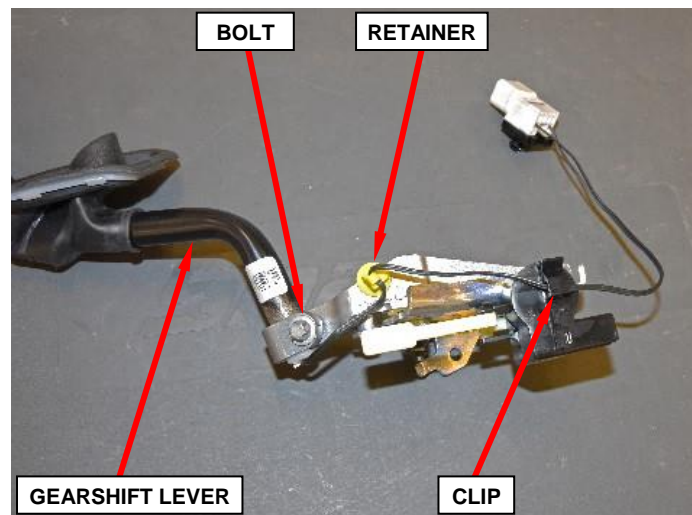
19. Remove the gearshift bracket / BTSI assembly with shift lever from the steering column then transfer to bench (Figure 13).

**Figure 13 – Gearshift Lever**

27. Install the E10 star-head pinch bolt securing the shift lever to the gearshift bracket / BTSI assembly. Tighten the pinch bolt to 11 N·m (97 in. lbs.) (Figure 13). Ensure shift lever is properly seated and not loose after tightening.
28. Attach the upshift/downshift electrical harness retainer to the gearshift bracket / BTSI assembly (Figure 13).

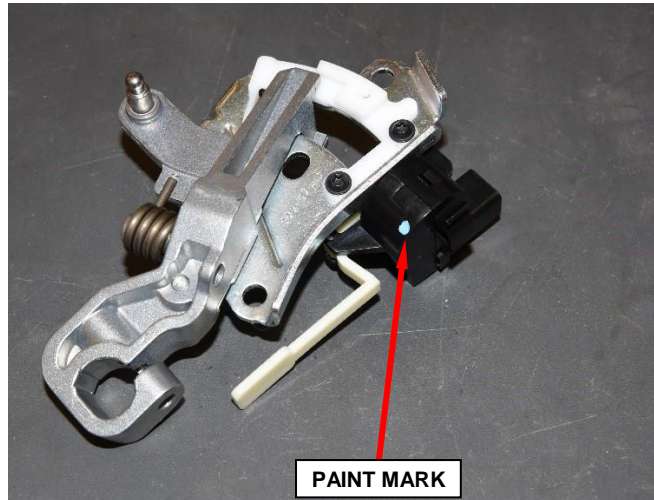
24. Discard the old gearshift bracket / BTSI assembly.
25. Verify the **new** gearshift bracket / BTSI assembly to be used has a paint mark on the BTSI solenoid (Figure 14).
26. Install the gearshift lever to the **new** gearshift bracket / BTSI assembly and ensure the gearshift lever is fully inserted into the gearshift bracket (Figure 15).

**Figure 14 – Gearshift Bracket / BTSI Assembly Paint Mark Verification**

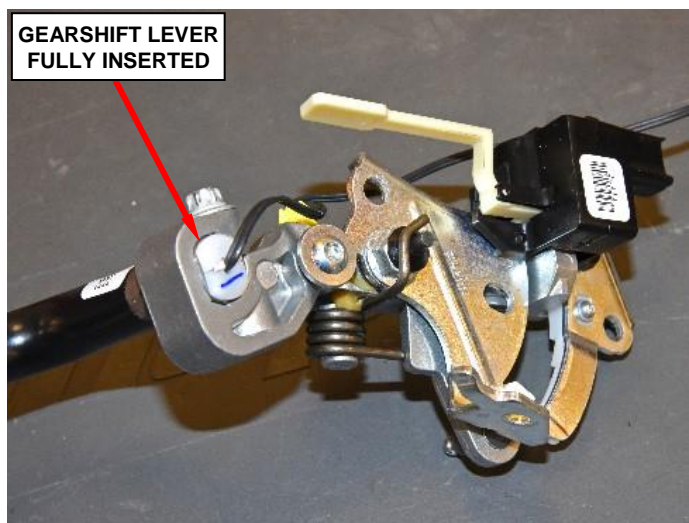
**Figure 15 – Gearshift Lever Insertion**
