Revised February 2018

Dealer Service Instructions for:

Safety Recall U11 / NHTSA 18V-100 Brake Transmission Shift Interlock

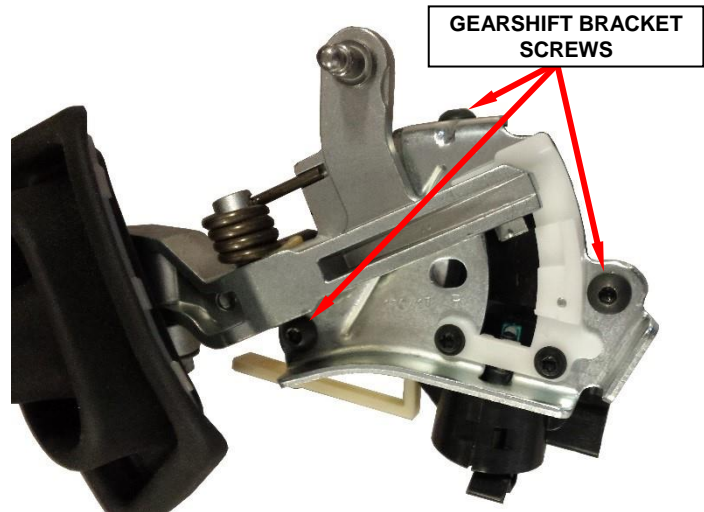
Figure 12 – Gearshift Bracket / BTSI Assembly Screws

31. Install the three T27 star-head screws securing the gearshift bracket / BTSI assembly to the steering column. Tighten the screws to 10 N·m (89 in. lbs.) (Figure 12).

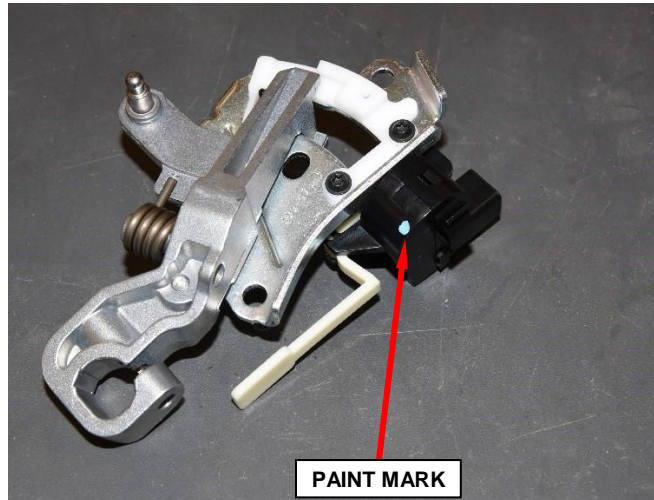
Figure 14 – Gearshift Bracket / BTSI Assembly Paint Mark Verification

- 24. Discard the old gearshift bracket / BTSI assembly.
- 25. Verify the **new** gearshift bracket / BTSI assembly to be used has a paint mark on the BTSI solenoid (Figure 14).
- 26. Install the gearshift lever to the **new** gearshift bracket / BTSI assembly and ensure the gearshift lever is fully inserted into the gearshift bracket (Figure 15).
