## H074NAS1 TECHNICAL BULLETIN 21 MAR 2018

MODEL:	MODEL YEAR:	VIN:	ASSEMBLY PLANT:
E-PACE (X540) 2018		Z01546-Z06323	Graz (Austria)

#### H074NAS1 - SAFETY RECALL: Brake Hose Bracket | TOPIx

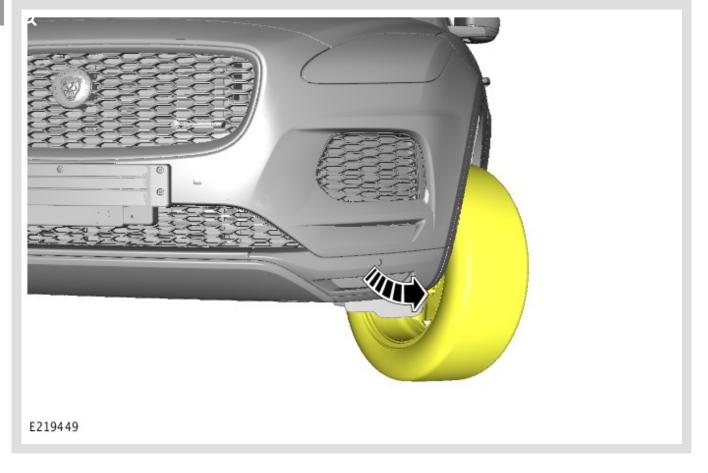
Turn the wheel and tire assembly as shown.

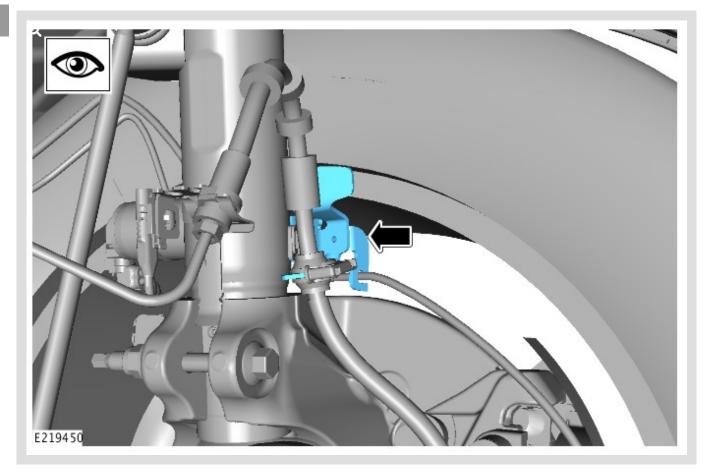
Locate the front left brake hose support bracket.

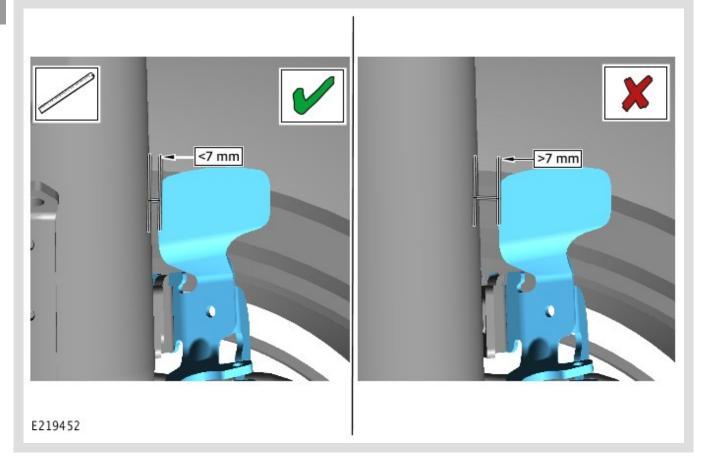
Measure and record the gap between the brake hose support bracket and the shock absorber.

- If the gap between the brake hose support bracket and the shock absorber is 7 mm
   or less (√) on both sides of the vehicle, no repair is necessary. go to Step 10.
- If the gap between the brake hose support bracket and the shock absorber is more than 7 mm (X) on either side of the vehicle, go to Step 6.
- Remove the wheel and tire assembly (see TOPIx Workshop Manual section 204-04: Removal and Installation - Wheels and Tires - Wheel and Tire).

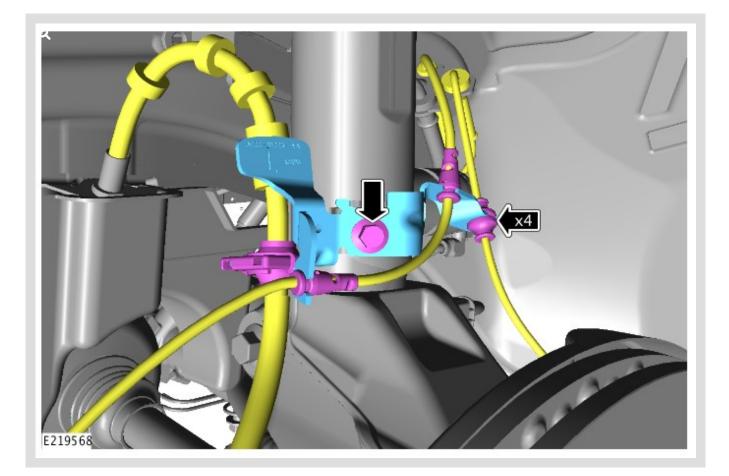
Make sure the gap between the brake hose support bracket and the shock absorber is correct after installing the new brake hose support bracket.

Replace the brake hose support bracket.

- Torque: 28 Nm
- Install the wheel and tire assembly (see TOPIx Workshop Manual section 204-04: Removal and Installation - Wheels and Tires - Wheel and Tire).
- Repeat Steps 6-8 on the other side of the vehicle if required.

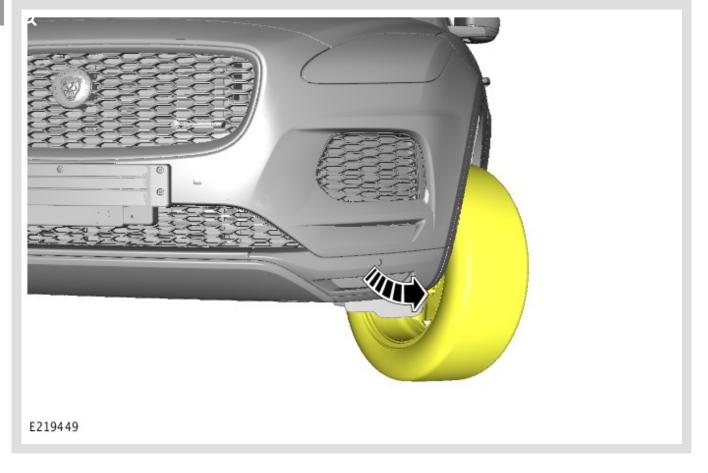
Turn the wheel and tire assembly as shown.

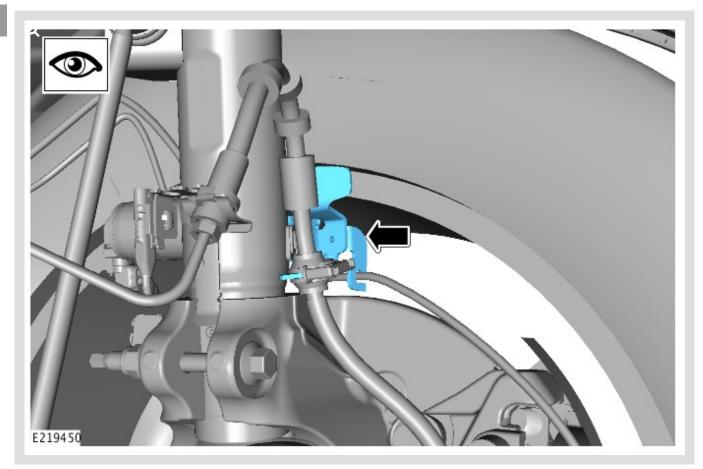
Locate the front left brake hose support bracket.

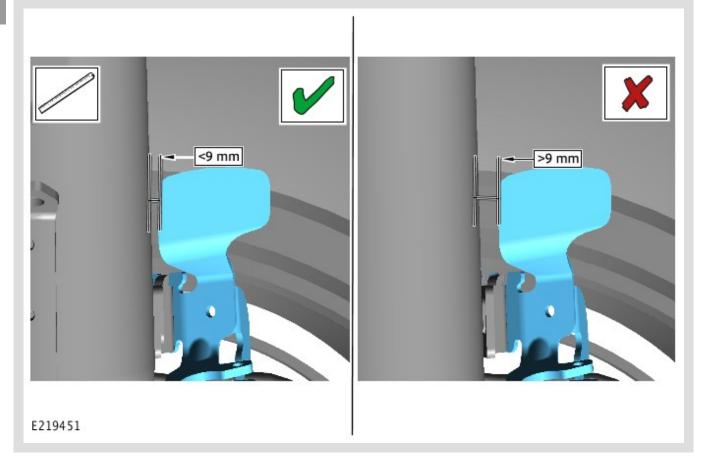
Measure and record the gap between the brake hose support bracket and the shock absorber.

- If the gap between the brake hose support bracket and the shock absorber is 9 mm
   or less (√) on both sides of the vehicle, go to Step 10.
- If the gap between the brake hose support bracket and the shock absorber is more than 9 mm (X) on either side of the vehicle, go to Step 6.

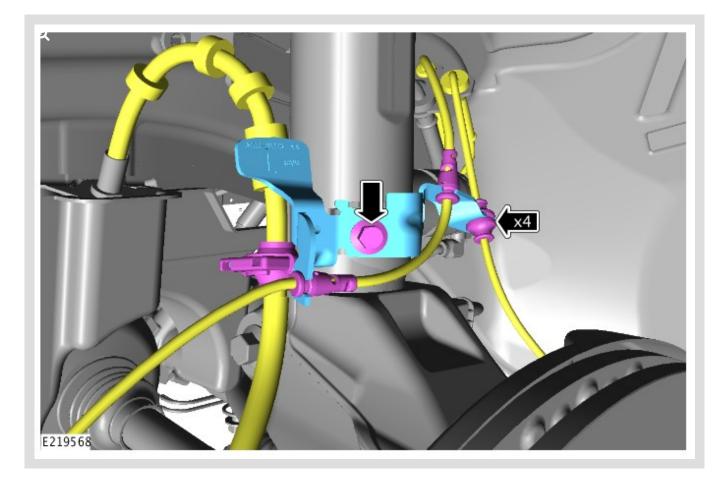
Make sure the gap between the brake hose support bracket and the shock absorber is correct after installing the new brake hose support bracket.

Replace the brake hose support bracket.

- Torque: 28 Nm
- Install the wheel and tire assembly (see TOPIx Workshop Manual section 204-04: Removal and Installation - Wheels and Tires - Wheel and Tire).
- Repeat Steps 6-8 on the other side of the vehicle if required.
