April 2018

Dealer Service Instructions for:

## Safety Recall U24 / NHTSA 18V-147 Windshield Wiper System

**2018 (GU) Alfa Romeo Stelvio**

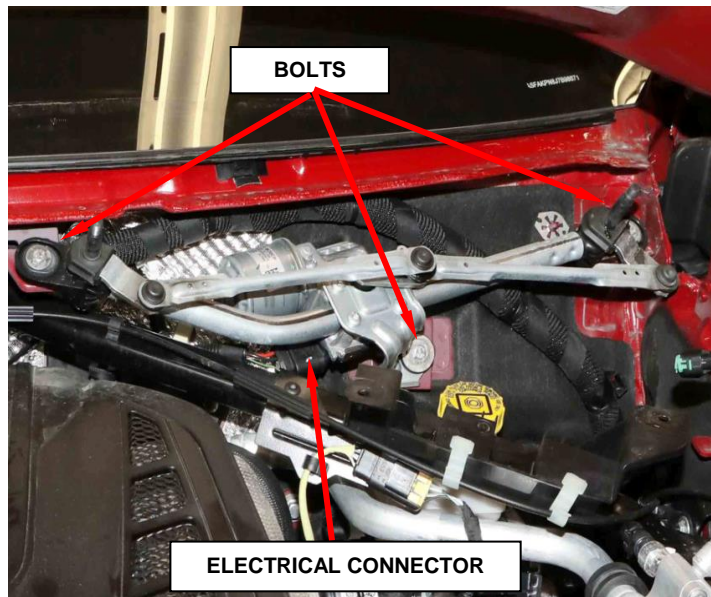
**Figure 9 – Wiper Linkage Assembly**

The windshield wiper system on about 1,500 of the above vehicles may have been built with wiper motor software that may erroneously calculate that the wiper motor is overheating and limit the function of the motor to low speed. Under certain conditions, the windshield wiping system may be limited to low speed operation only which may reduce the driver's visibility. This reduced driver visibility may, in certain cases, result in a crash without prior warning.

9. Remove and save the three bolts that secure the linkage assembly (Figure 9).
10. Move the linkage assembly slightly and disconnect the wire harness electrical connector from the linkage motor.
11. Remove and **discard** the wiper linkage assembly.
12. Connect the wire harness electrical connector to the **new** linkage assembly motor.

13. Position the **new** wiper linkage assembly to the body.
14. Install the three bolts that secure the linkage assembly and tighten to 8 N·m (71 in. lbs.)
15. Use the following steps to install the cowl trim cover.
  - a. Position the cowl trim in position and engage the retaining profile along the entire cowl.
