TO: Mercedes-Benz Dealer Principals, General Managers, Sales Managers, Service Managers, Parts Managers	FROM: Gregory Gunther, Department Manager, Vehicle Compliance and Analysis, Engineering Services
RE: <b>Recall Campaign Launch Notification</b> <b>AMG Performance Seatback Rail</b> <b>MY18 205, 213 (C-Class, E-Class)</b>	DATE: June 29, 2018

Campaign No. 2018060001, June 2018

SUBJECT: **Models 205 & 213 Model Year 2018**  
**Replace both seatback members on left and right front seat**

Daimler AG ("DAG"), the manufacturer of Mercedes-Benz vehicles, has determined that on certain C-Class and E-Class vehicles (205 and 213 platform) equipped with AMG Performance Seats, the laser welding between the driver or passenger-side seatback rail and metal fitting may not meet production specifications. As a result, the seat may not support the required level of stress, increasing the risk of injury in the event of a crash. An authorized Mercedes-Benz dealer will replace the seatback rails for the affected vehicles.

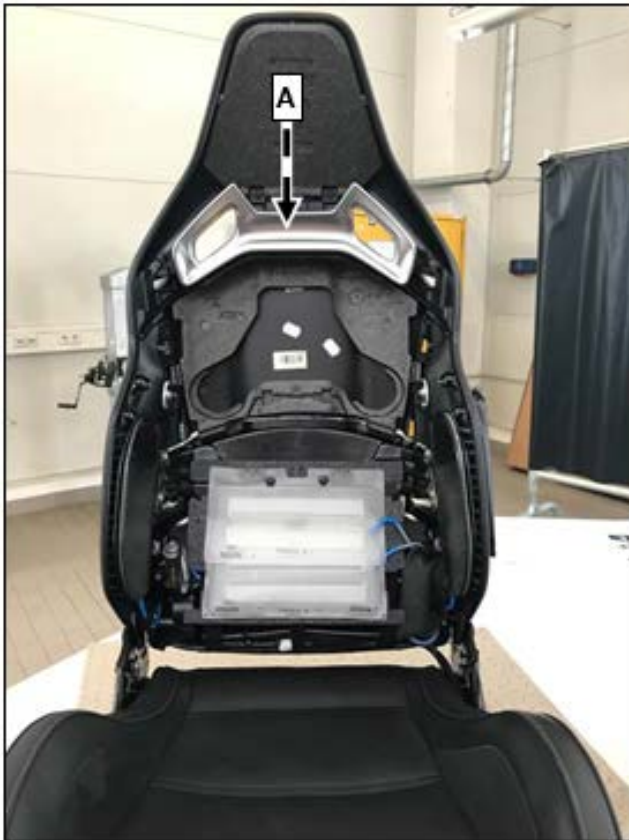
Figure 1

**i** Do ***not*** remove cover **(A)** (figure 1).

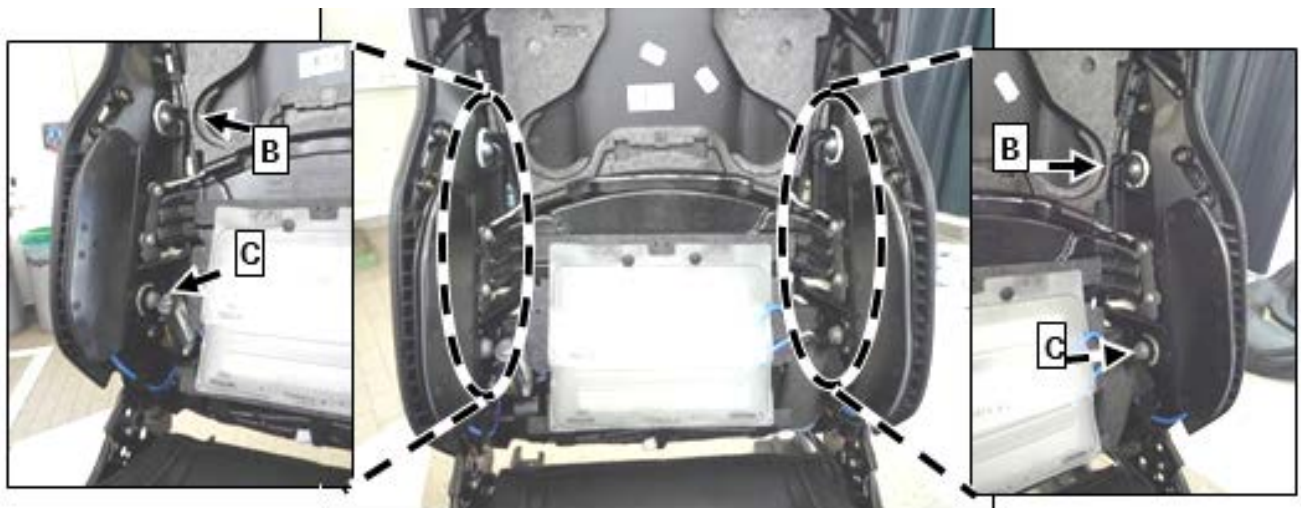
Figure 7

- i** Cover the seat shell!
- i** A Torx screw **(B)**(**figure 7**) is on the top.
- i** A hexagon head bolt **(C)** (**figure 7**) is on the bottom.

9. Remove the threaded connection of the seatback member (**figure 7**).

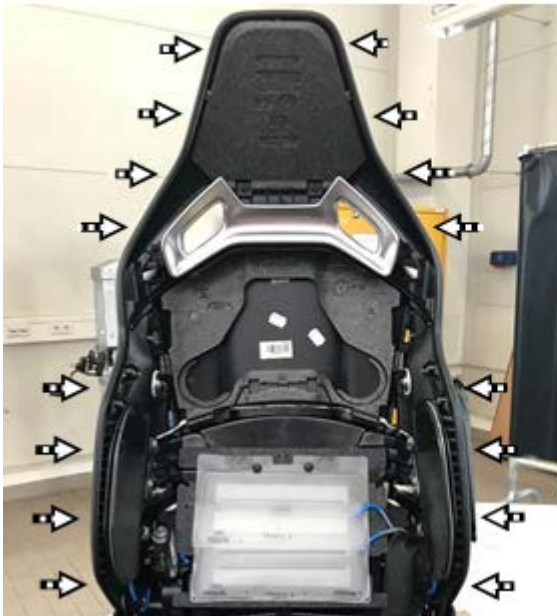
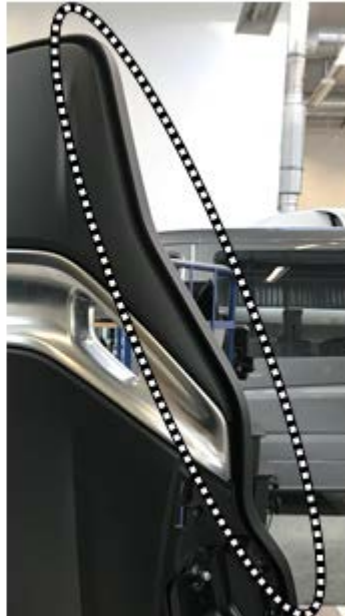
**Figure 27**

- i* Position of the expanding clips in the groove shown in (**figure 27**).
- i* The section with the groove of the seatback shell is shown in (**figure 28**).

- i* Replace the expanding clips as required.
- 19.1. Position the expanding clips in the groove of the seatback shell (**figures 27 and 28**).
- i* With aids (putty knife/flat tool).
