SAFETY RECALL

Mack Trucks Inc.
Greensboro, NC USA

Date	Number	Page
3/18	SC0409	1 (19)

Light Control Module, Inspection and Replacement

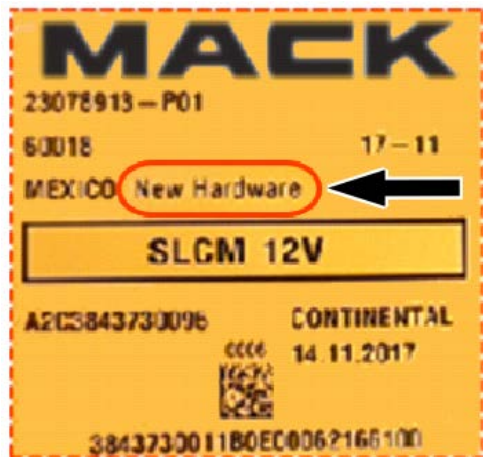
- Inspect the part number label on the LCM. Use the table below to determine the action needed to repair the vehicle.

Label Contents	Action
"New Hardware" (as shown below)	Do not replace LCM –Skip to step 16
No "New Hardware" designation shown	Replace LCM starting at step 10
