Safety Recall

Code: 10F7

Subject	Engine Support Bolts – USA ONLY
Release Date	03/15/2018
Affected Vehicles	<p>U.S.A.: Certain 2018 MY Volkswagen Tiguan LWB</p> <p>The four (4) vehicles affected by this recall are: 3VV3B7AX1JM000844 3VV3B7AX7JM000847 3VV3B7AX9JM000848 3VV3B7AXXJM000843</p> <p><i>Check Campaigns/Actions screen in Elsa on the day of repair to verify that a VIN qualifies for repair under this action. Elsa is the <u>only</u> valid campaign inquiry & verification source.</i></p> <ul style="list-style-type: none">✓ Campaign status must show “open.”✓ If Elsa shows other open action(s), inform your customer so that the work can also be completed at the same time the vehicle is in the workshop for this campaign.
Problem Description	Affected vehicles may have engine support bolts that were not properly torqued at the engine factory. Improperly torqued engine support bolts can result in an unexpected engine breakdown, sudden loss of engine power and a crash without warning.

**Subject: Safety Recall 10F7 – Engine Support Bolts
Certain 2018 Model Year Volkswagen Tiguan LWB Vehicles**

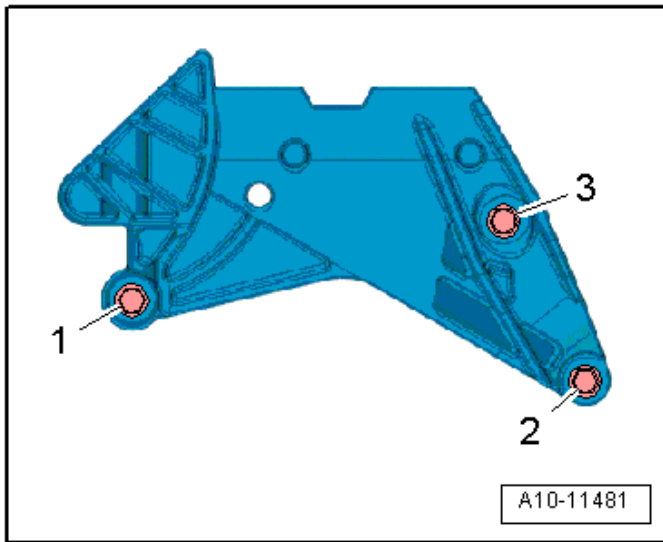
- What is the issue?** Affected vehicles may have engine support bolts that were not properly torqued at the engine factory. Improperly torqued engine support bolts can result in an unexpected engine breakdown, sudden loss of engine power and a crash without warning.

- Slightly lower the engine. Remove the bolts <1 and 2> with the -T10099- from below.
- Lift the engine again and remove the bolt <3> from the top.
- Install the new engine support with new bolts and torque the bolts in the following sequence:
 1. <1 to 3> 7 Nm
 2. <1 to 3> 40 Nm
 3. <1 to 3> 90°

Qty.	Part Number	Part Description
1	06K199207A	Engine Support
3	N 10701501	Bolt - M10x65
