October 2018
FL766A
NHTSA #18V-191
Transport Canada #18-190

Subject: Western Star Power Cable Studs

Models Affected: Specific Western Star 4700, 4900, 5700, and 6900 model vehicles manufactured September 12, 2016, through February 6, 2018.

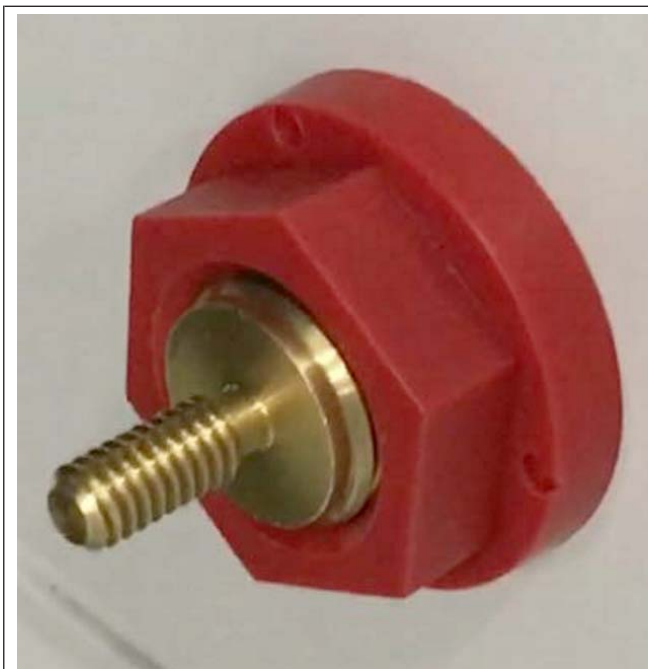
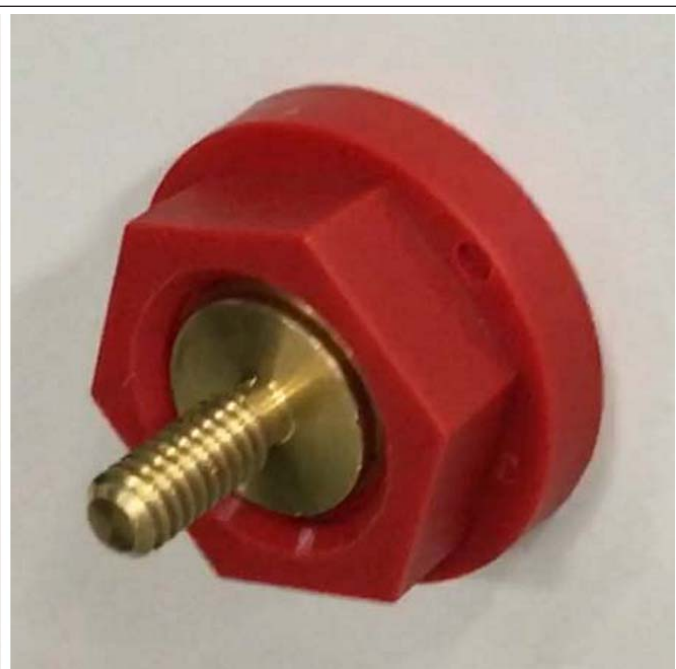
Fig. 3, Installation Inspection

4. Pull back the covers on the power cable stud connectors. See [Fig. 2](#). Inspect each cable stud to make sure at least one thread protrudes past the plastic nut. See [Fig. 3](#) and [Fig. 4](#).

If at least one thread does **NOT** protrude past the plastic nut, the installation is **INCORRECT**. Proceed to "Power Cable Stud Replacement."

If at least one thread protrudes past the plastic nut, the installation is **CORRECT** and the recall is complete. Continue with the next step.

05/14/2018
A. Correct Installation

B. Incorrect Installation
