Dealer Service Instructions for:

Safety Recall U34 / NHTSA 18V-203 Safety Recall U36 / NHTSA 18V-205 Water Intrusion

2018 (GU) Alfa Romeo Stelvio

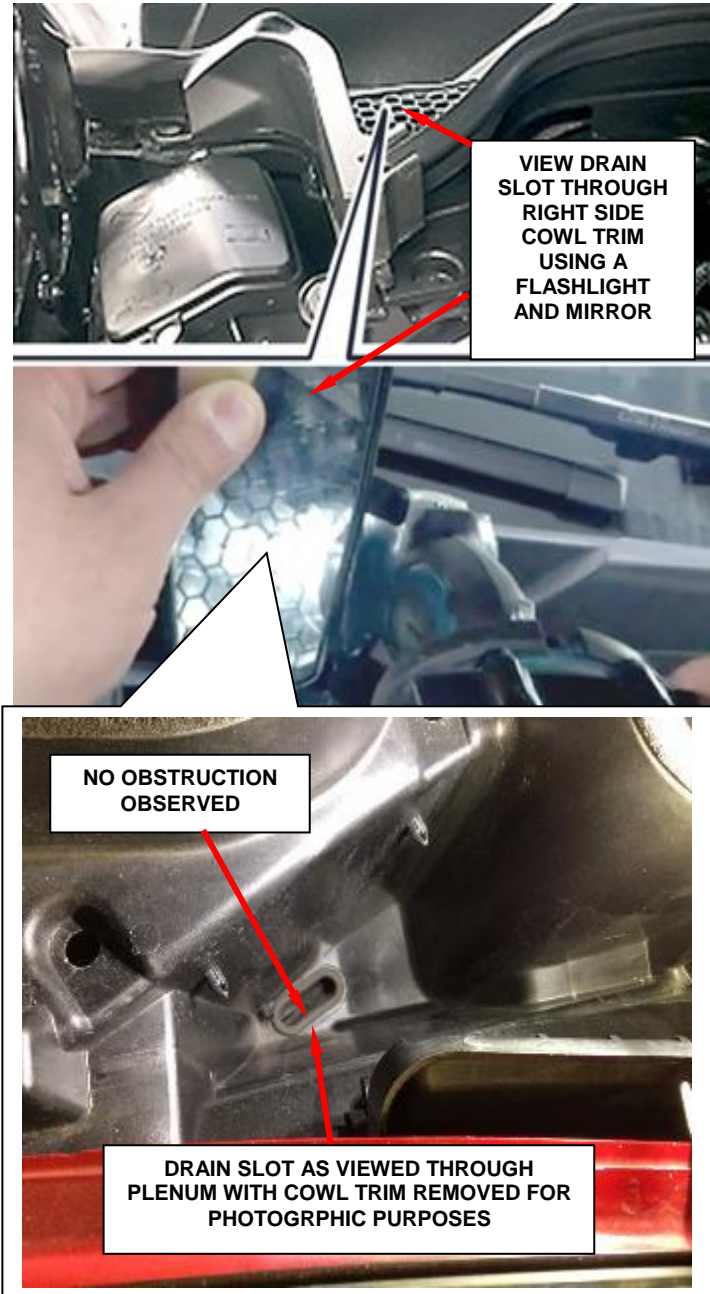
Figure 3 - Inspect Drain Slot for Obstruction (Cowl Trim Removed for Drain Slot Clarity)

- Check for correct opening of the water drain slot located in the bottom of the plenum on the right side of the engine compartment.

1. Using a mirror and a light, position them as shown and check whether the water drain slot is clear. **No objects (wiring harness, foreign material) should be protruding up into/down through a portion of the drain slot grommet,** thus blocking the passage of water (Figure 3).
2. If no obstruction is observed, **continue with Operation 2.**
3. If the slot (only the one on the right-hand side) is obstructed by an engine compartment wiring, **use the following steps to remove the cowl trim cover and plenum then adjust the engine wire routing.**

NOTE: If water is present in the right drain slot of the service compartment, after the execution of operation described above, the water can be cleared out with the use of compressed air.

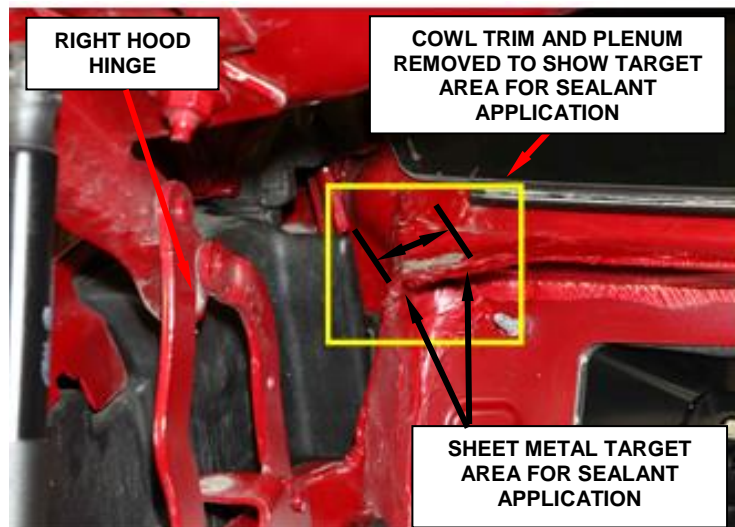
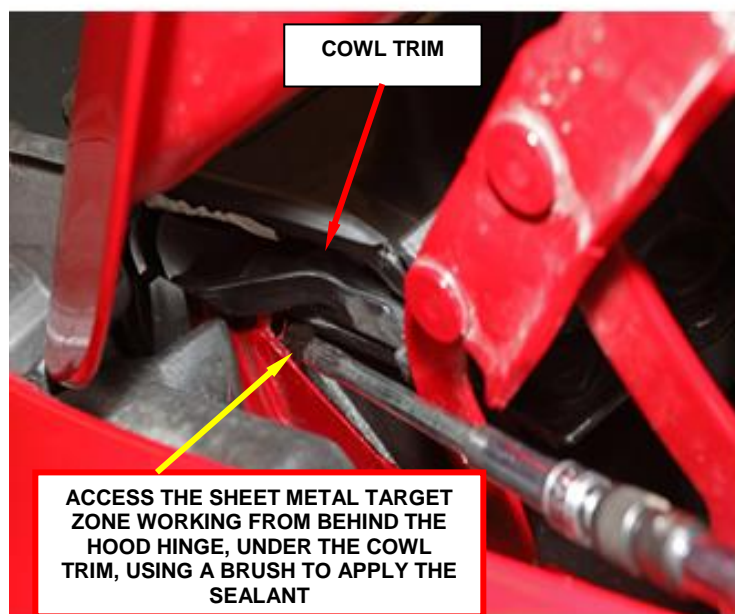
Figure 15 – Sealant Application (Right Side Shown)

The following procedure describes the operation needed for sealing the sheet metal at the joint, on the right side of the shelf under the windshield, to prevent water dripping on the bulkhead. Application of closed-cell sponge pads on the right side of the service compartment.

1. Protect the zone around the indicated application area.
2. Using a brush of adequate size, apply MOPAR RTV sealant (approximately 0.3 oz./10 grams) on the metal sheet areas as shown. (Figure 15).

IMPORTANT: The sealant must be applied to the target area as shown (Figure 15).

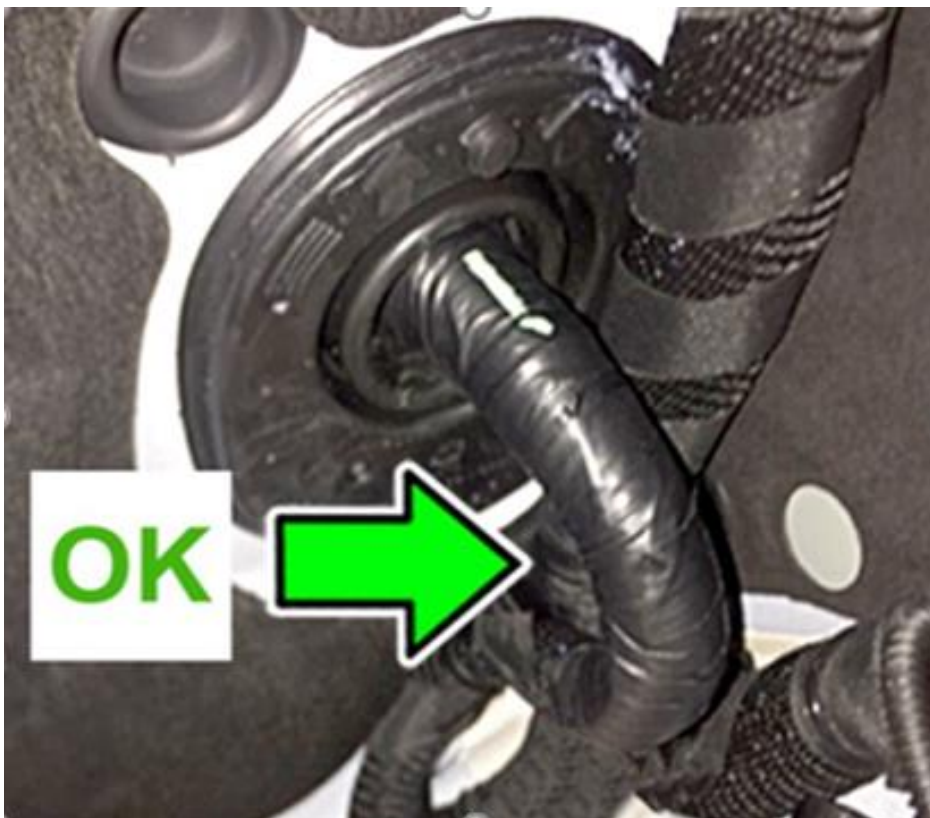
Figure 19 – Wiring Position OK

1. Check the wiring from the left-hand bulkhead to be sure it is positioned as shown in the figure, i.e. facing downwards without loops (Figure 19).
2. If the wiring is facing downwards, as shown (Figure 19), **the position is conforming: vehicle OK.**

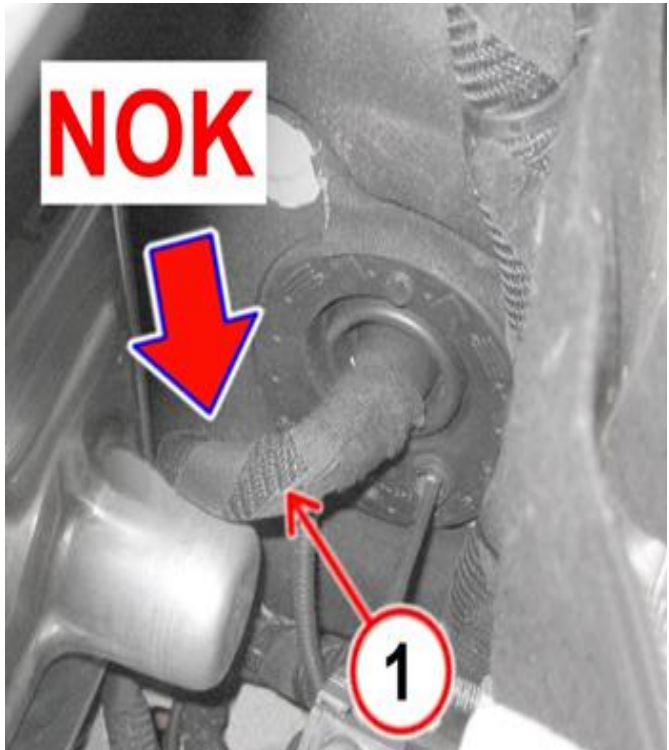
Figure 20 – Wiring Position NOT OK

3. If the wiring (1) from the bulkhead connector is not facing downwards, as shown (Figure 20), **the position is NOT conforming: vehicle NOK.**
