Safety Recall U34 / NHTSA 18V-203

Safety Recall U36 / NHTSA 18V-205

Water Intrusion

2018 (GU) Alfa Romeo Stelvio

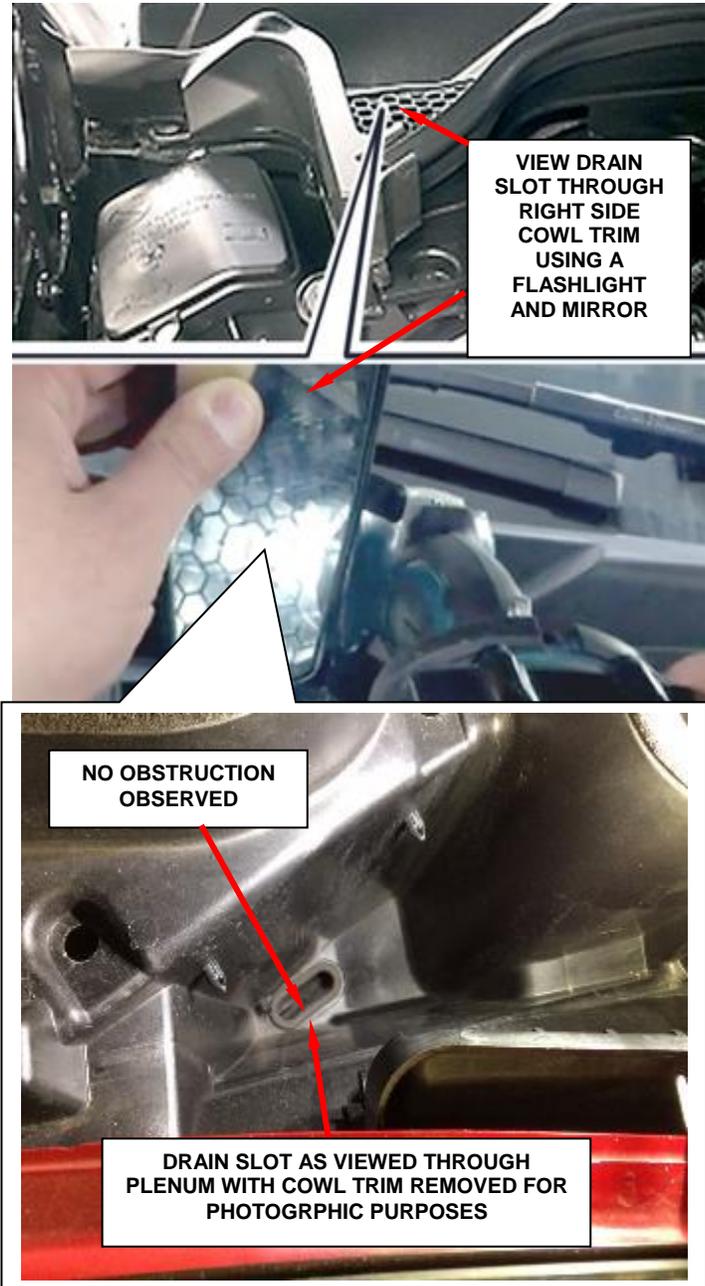
Figure 3 - Inspect Drain Slot for Obstruction (Cowl Trim Removed for Drain Slot Clarity)

1. Using a mirror and a light, position them as shown and check whether the water drain slot is clear. **No objects (wiring harness, foreign material) should be protruding up into/down through a portion of the drain slot grommet,** thus blocking the passage of water (Figure 3).
2. If no obstruction is observed, **continue with Operation 2.**
3. If the slot (only the one on the right-hand side) is obstructed by an engine compartment wiring, **use the following steps to remove the cowl trim cover and plenum then adjust the engine wire routing.**

NOTE: If water is present in the right drain slot of the service compartment, after the execution of operation described above, the water can be cleared out with the use of compressed air.

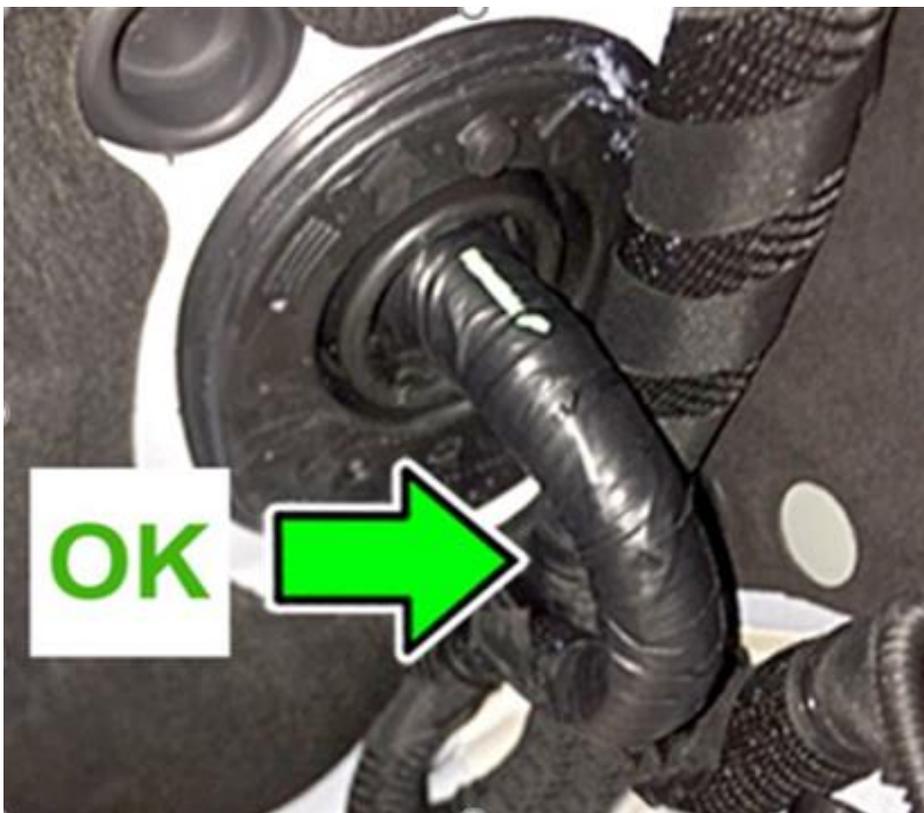
Figure 19 – Wiring Position OK

1. Check the wiring from the left-hand bulkhead to be sure it is positioned as shown in the figure, i.e. facing downwards without loops (Figure 19).
2. If the wiring is facing downwards, as shown (Figure 19), **the position is conforming: vehicle OK.**

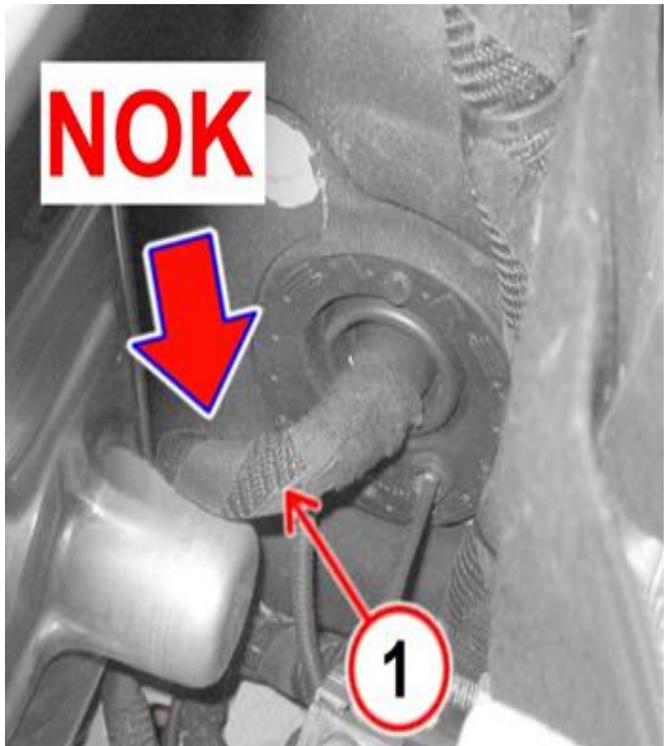
Figure 20 – Wiring Position NOT OK

3. If the wiring (1) from the bulkhead connector is not facing downwards, as shown (Figure 20), **the position is NOT conforming: vehicle NOK.**
