то: Mercedes-Benz Dealer Principals, General	FROM: Gregory Gunther, Department Manager,
Managers, Sales Managers, Service Managers, Parts	Vehicle Compliance and Analysis, Engineering
Managers	Services
RE: Recall Campaign 2018040007 - Phase 2	
Launch Notification	
Check Seatback Lock	DATE: June 1, 2018
MY17-18 205 238	
(C-Class, E-Class Coupe & Cabriolet)

Campaign No. 2018040007, June 2018

SUBJECT: Models 205 and 238 Model Years 2017 and 2018

Check Seat Back Lock

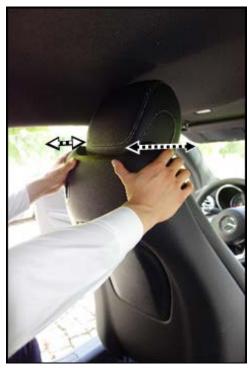
Figure 1 (left front seat)

- The play must be the **same** on both the right and left sides.
 - i If the play is not correct, the <u>right</u> side of the seat backrest has a <u>significantly larger amount of play</u> than the left (figures 1 and 2)!

- a. Play of the seat backrest frame not ok: Carry out work procedure.
- b. Play of the seat backrest frame is ok: End measure.
