MODEL:	TYPE:	SECTION/GROUP:	DATE:
J Series	Field Change Program	03- Body	08/ 23/ 2018

Ref. MCI NHTSA Recall No.: 18V-225

Ref. MCI Transport Canada Recall No.: 2018-171

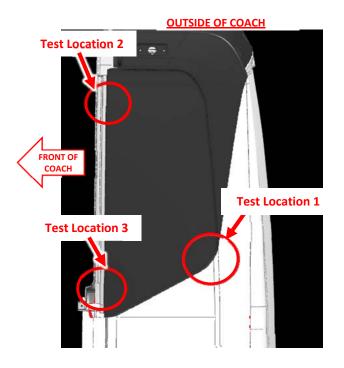
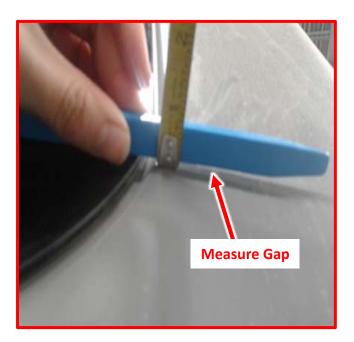
#### 1.1 Inspecting Window Fitment

Using a tape measure and a flat ruler, measure the distance that the transom window glass surface extends past the fiber glass surface at each of the three locations shown below:

If all gaps measurements are less than 1/8 inch, the window fitment is not compromised and indicates there is no de-bonding of the adhesive. The rest of this procedure is not required.

If any gap exceeds 1/8 inch, additional testing is required, as detailed in section 1.2.

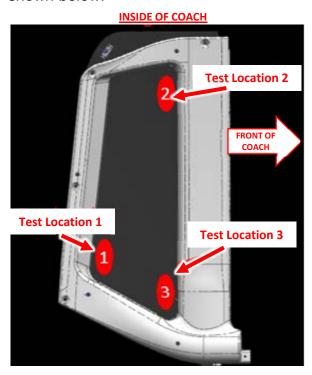
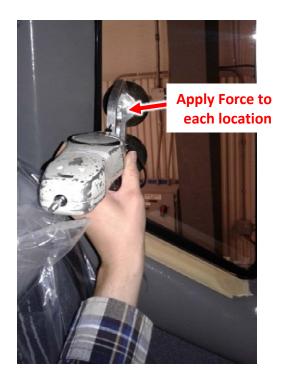
### 1.2 Inspecting Adhesive Integrity

Using a force gauge rated 10 to 50 LBs, apply force at all of the three locations shown below:

At each location, apply the force in the following increments: 20LB, 30LB, 40LB, and 50LB. When 50LB has been reached, back off slightly and reapply 50LB again. Observe the window for the amount of deflection.

If little or no window movement is observed, the adhesive is not compromised and the rest of this procedure is not required.

If substantial movement is observed, follow the instruction outlined in the remainder of the procedure.
