MODEL:	TYPE:	SECTION/GROUP:	DATE:
			March 12,
J Series	Field Change Program	03- Body	2019

Ref. MCI NHTSA Recall No.: 18V-225

Ref. MCI Transport Canada Recall No.: 2019-049

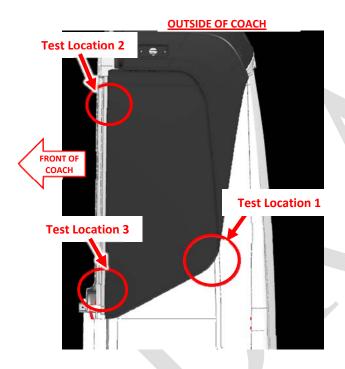
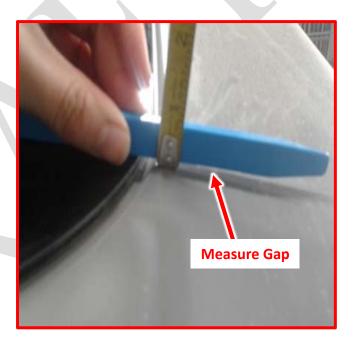
Using a tape measure and a flat ruler, measure the distance that the transom window glass surface extends past the fiber glass surface at each of the three locations shown below:

If any gap is 1/8 inch or more, additional testing is required, as detailed in section 1.2.

If all gap measurements are less than 1/8 inch, the window fitment is not compromised and indicates there is no de-bonding of the adhesive. In such case, follow instructions outlined in the section 3 of this procedure.

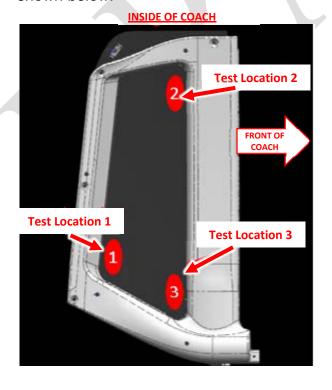
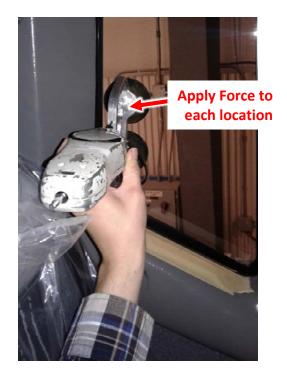
Using a force gauge rated 10 to 50 LBs, apply force at all of the three locations shown below:

At each location, apply the force in the following increments: 20LB, 30LB, 40LB, and 50LB. When 50LB has been reached, back off slightly and reapply 50LB again. Observe the window for the amount of deflection.

If substantial movement is observed during any of the force applications, follow the instructions outlined in section 2.

If little or no window movement is observed, the adhesive is not compromised, and in such case follow the instructions outlined in section 3.
