Dealer Service Instructions for:

Safety Recall U27 / NHTSA 18V-231

Under Body Ladder Rail

2018 (JK) Jeep® Wrangler

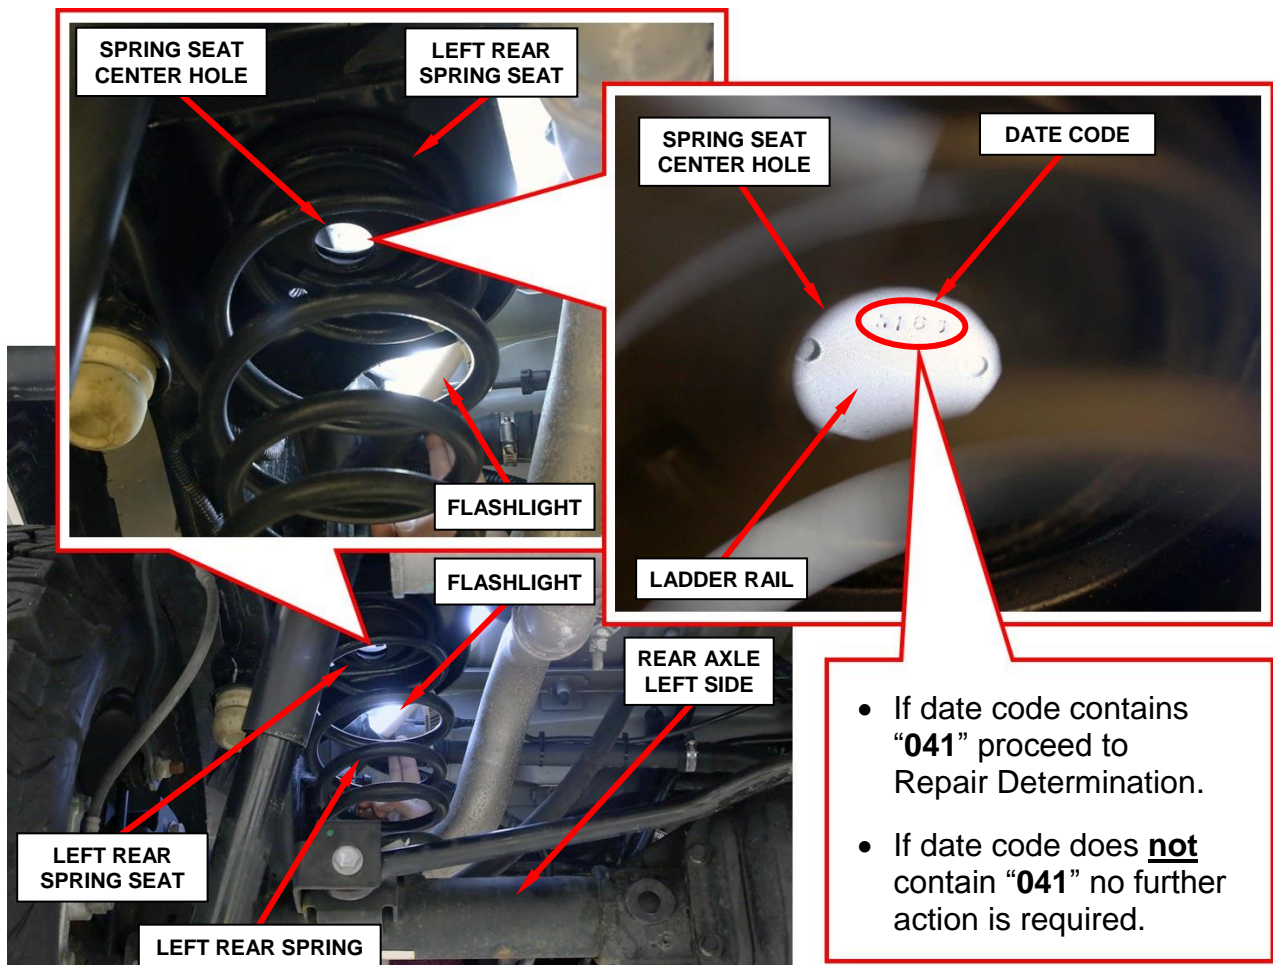
Figure 2 – Inspect Date Code - Left Side Rear Longitudinal Under Body Ladder Rail

1. Raise and support the vehicle.
2. While using a flashlight or bore scope, stand behind the rear axle to view the left side rear longitudinal under body ladder rail above the left rear spring seat. The date code can be viewed through the left rear spring seat center hole (Figure 2). Locate the date code stamped on the ladder rail and record date code numbers only. **Ignore any preceding letters, read the numbers only.**
 - If the date code **is** 041, proceed to **Step 3**.
 - If date code is **not** 041, lower the vehicle and return to the customer. Claim LOP 23-U2-71-81 for inspection.
 - If the date code cannot be read, contact your area Technical Advisor.

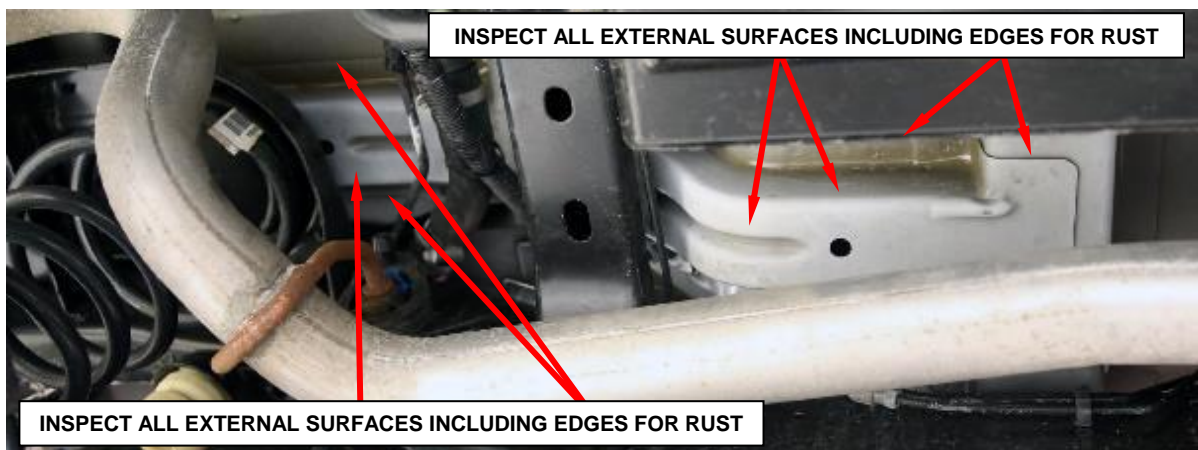
Figure 4 – Inspect Ladder Rail External Surfaces and Edges for Rust

2. Inspect the left side rear longitudinal under body ladder rail for any visible red rust. Visually inspect the external surfaces and edges for rust (Figure 4). Use a lighted borescope inserted through the existing holes in the ladder rail to inspect the internal cavity surfaces and edges for rust (Figure 5).
 - If red rust is visible, the vehicle is not repairable and must be repurchased. Claim LOP 23-U2-71-82 for Repair Determination.
 - If red rust is **not** visible, proceed to **Step 3**.
