RECALL 18V-314: ELECTRICAL POWER DISTRIBUTION: BATTERY CABLE

MODEL

E90 (335D)

Installing the repair cable for the positive battery cable of the power distribution box

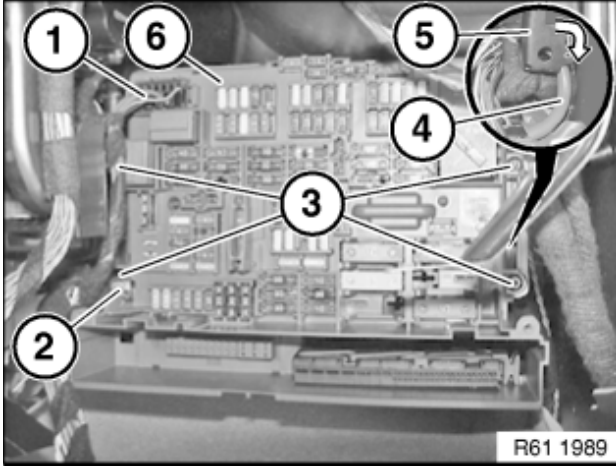
Disconnect plug connection (1).

Release the wiring harness mounting (2) from the power distribution box (6).

Loosen screws (3).

Fold the power distribution box (6) forward. Feed positive battery cable (4) out of holder (5) in the direction of the arrow.

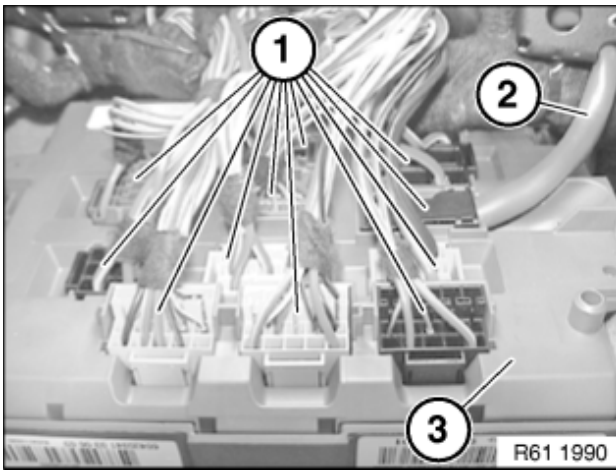
Disconnect the positive battery cable (2).

Extra plug connections (1) on the back of the power distribution box (3) must not be detached.

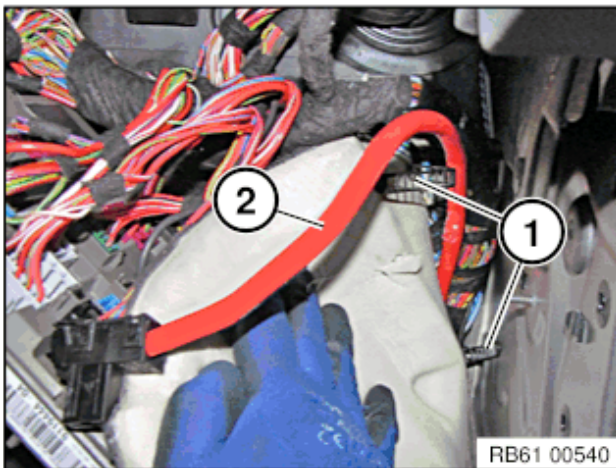
Open retaining straps (1). Pull out positive battery cable (2) as far as possible.

Predrill both bridges (2) of the power distribution box (1) at the area marked with an arrow with a 2 mm drill. Then drill through with a 5 mm drill.

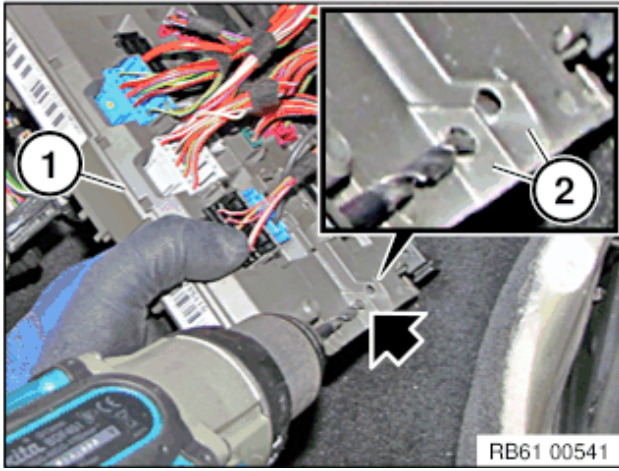
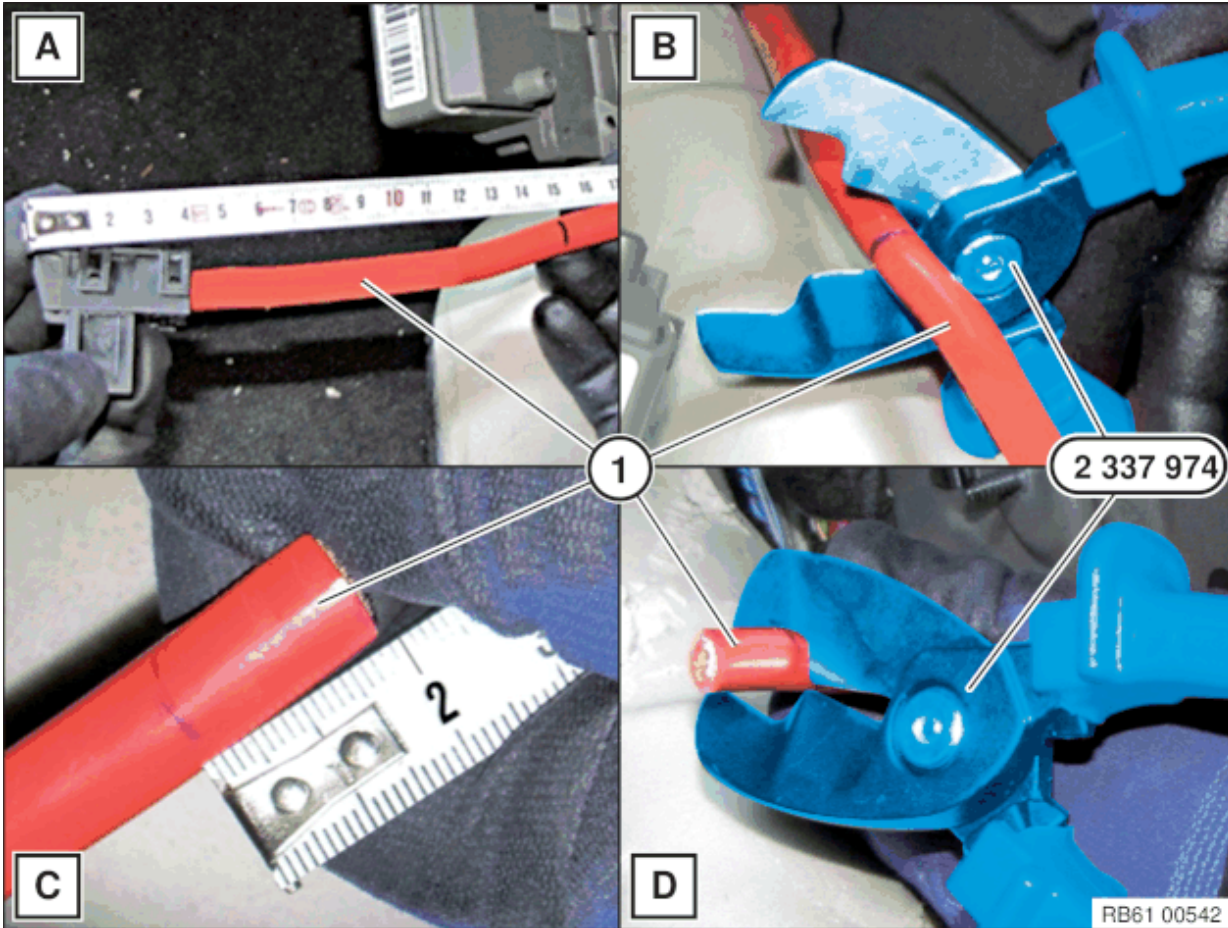
- A. Measure a 15 cm length as shown and mark on the positive battery cable (1).
- B. Cut off the positive battery cable (1) at the marked location with special tool 2 337 974.
- C. At the cut-off end of the positive battery cable (1), measure and mark 2 cm.
- D. Carefully strip insulation off of the positive battery cable (1) at the marked location with special tool 2 337 974.

Do not damage the strands during stripping!

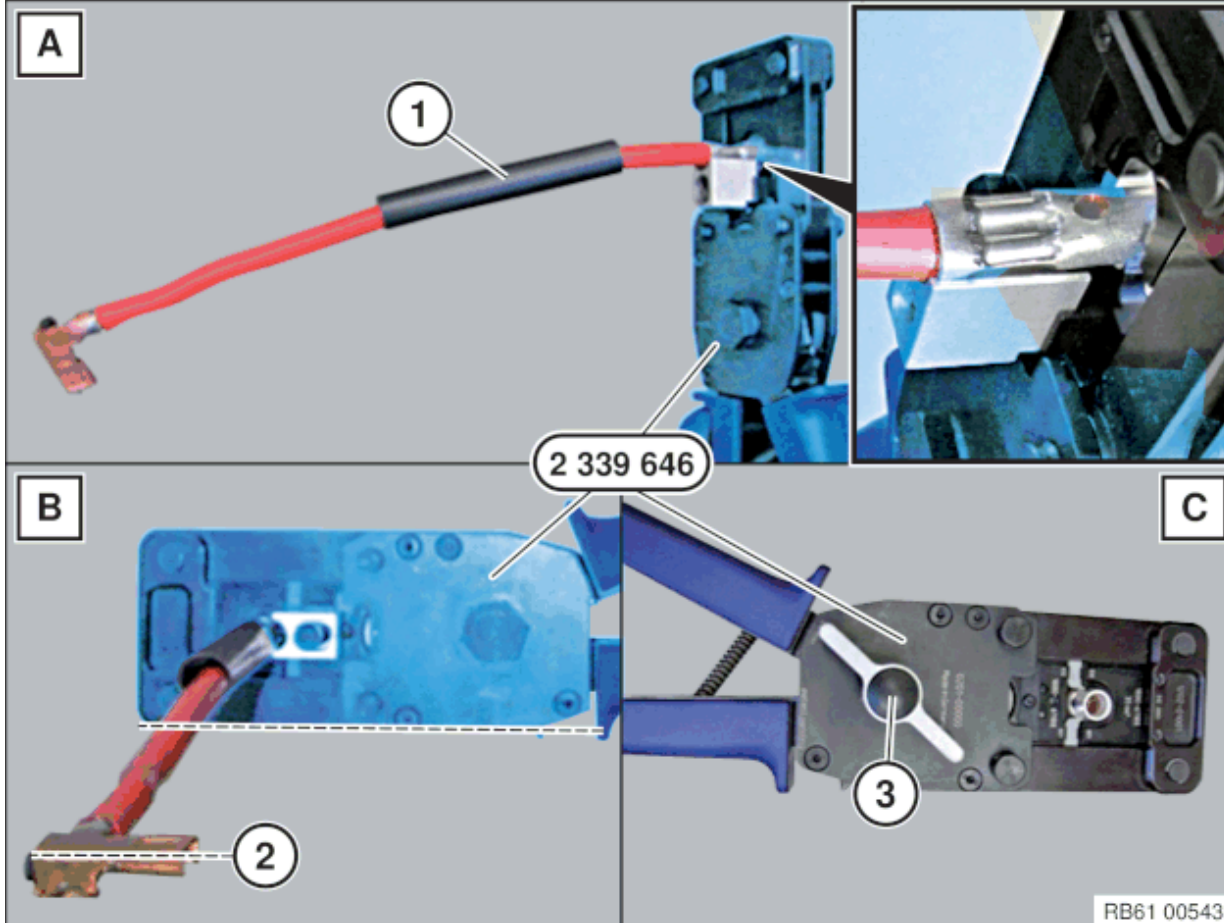
A. Attach heat-shrink tubing (1) to positive battery cable. Insert the positive battery cable in special tool 2 339 646 as shown.

(Pliers 2 339 646, die plate 2 339 647)

B. Position the contact (2) as shown.

C. Close the special tool. Turn the screw plug (3) counter-clockwise and move it to the position shown.

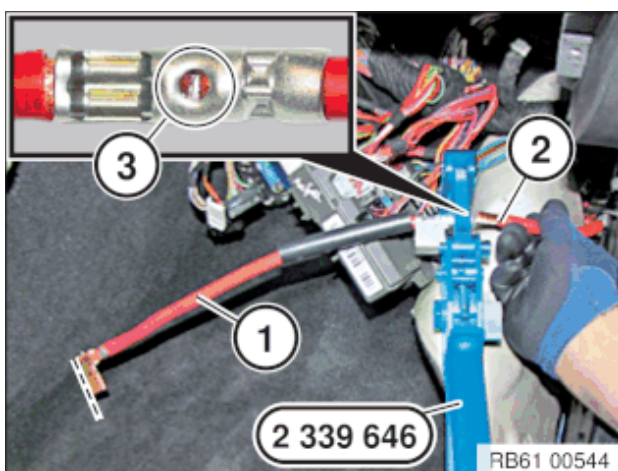
Crimp the vehicle-side positive battery cable (2) and the repair positive battery cable (1) using the special tool 2 339 646.

After crimping, copper wires of the vehicle-side positive battery cable (2) must be visible in the opening (3).

Pliers 2 339 646 must be operated approx. 20 times during the crimping process.

Crimping process is complete when pliers 2 339 646 automatically open.

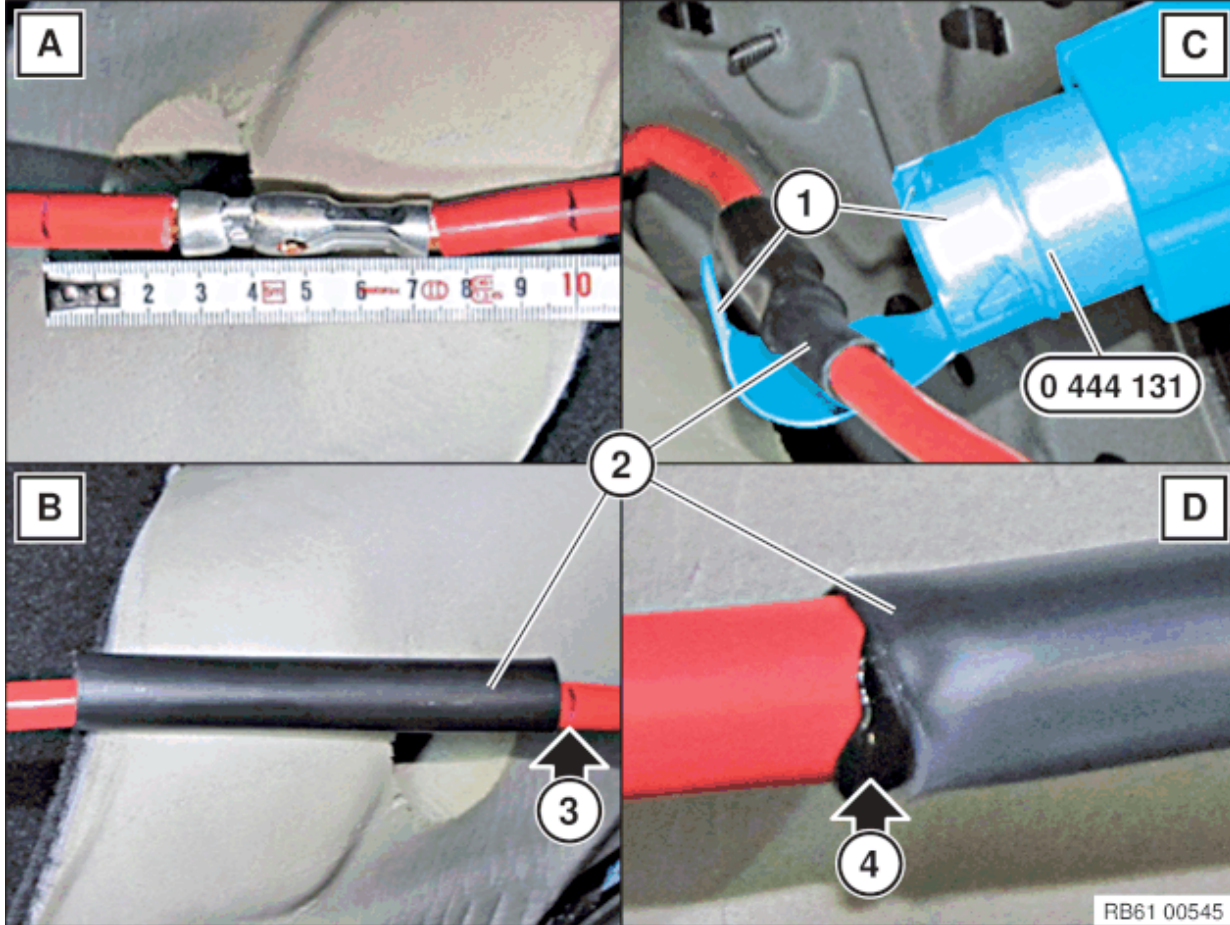
- A. Centrally measure and mark distance = 10 cm as shown.
- B. Position the heat-shrink tubing (2) over the crimping location so that mark (3) is must barely visible.
- C. Shrink the heat-shrink tubing (2) with hot air blower 0 444 131.
(Heat shrink temperature 400 °C)
- D. After shrinking, adhesive (4) must emerge from both sides of the heat-shrink tubing (2).

It is imperative that you use a heat-shrink tubing reflector (1).

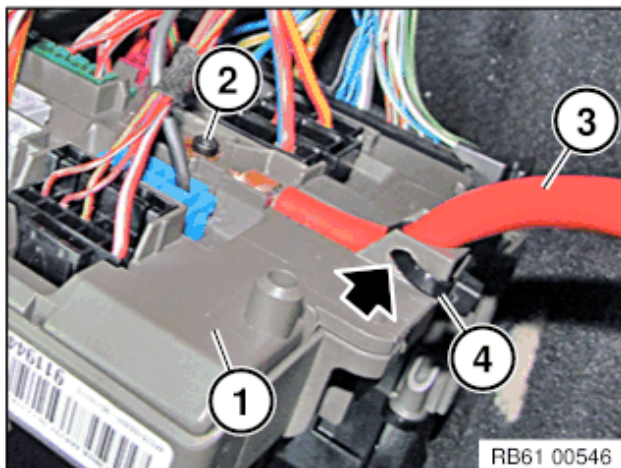
Connect the connector contact of repair positive battery cable (3) to power distribution box (1) by **pressing bolt (2)** all the way to the limit position.

Tighten screw (2). Tightening torque: 1,0 Nm

While tightening bolt (2), continue pushing down the connector contact.

After tightening, bolt (2) must be flush with the connector contact.

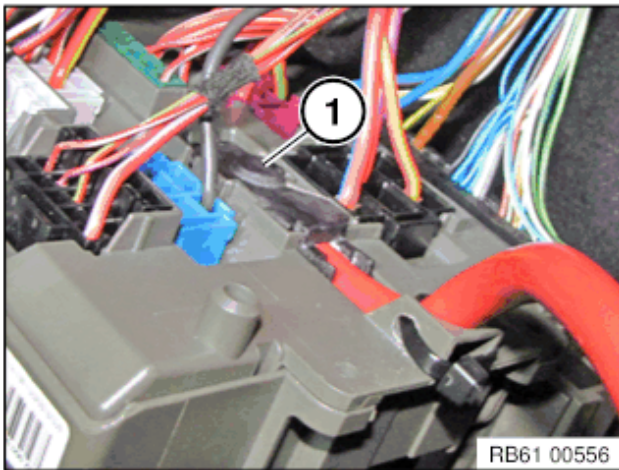
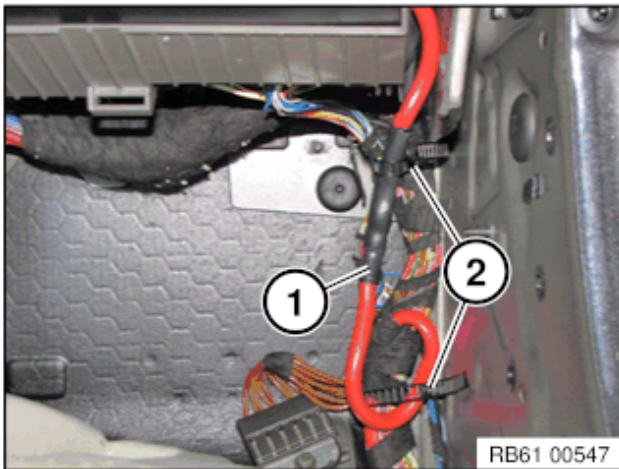
Fasten the repair positive battery cable (3) on the power distribution box (1) at the location indicated by the arrow using a cable strap (4).

Mount the cap (1) flush.

If cap (1) cannot be flush-mounted, the connector contact below it is not mounted correctly.

Fasten the positive battery cable (1) at locations (2).

In this case, release the connector contact as described in the previous operation and connect it again.
