Vehicle Safety Recall - Technical Service Bulletin

Attention: McNeilus Product Owner
Subject: Bridgemaster V nylon reservoir filler neck replacement
Model Affected: Bridgemaster V 93
Model Years: 2008-2018
Date: June 2018

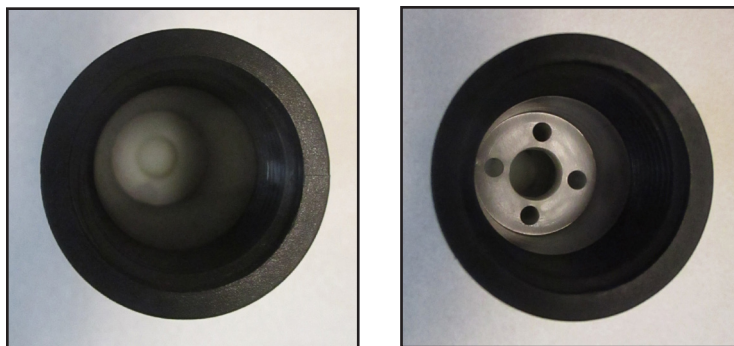
Figure 2

NOTE: The existing filler neck has one visible hole when looking at it from the top while the new filler neck (P/N 1570075) has five visible holes (see Figure 2). If you already have a filler neck with the five holes, and the filler neck is not damaged, there is no need to replace it. Skip to Step 8. If you have a filler neck that does not have five visible holes as shown (Figure 2, right side image), the filler neck must be replaced. Continue with the rest of this bulletin.

Existing Neck - 1 hole

New Replacement Neck
- 5 holes
