# Product Safety Recall

## 18289 Loss of Steering Assist

Reference Number: N182156820

Release Date: September 2018  
Revision: 00

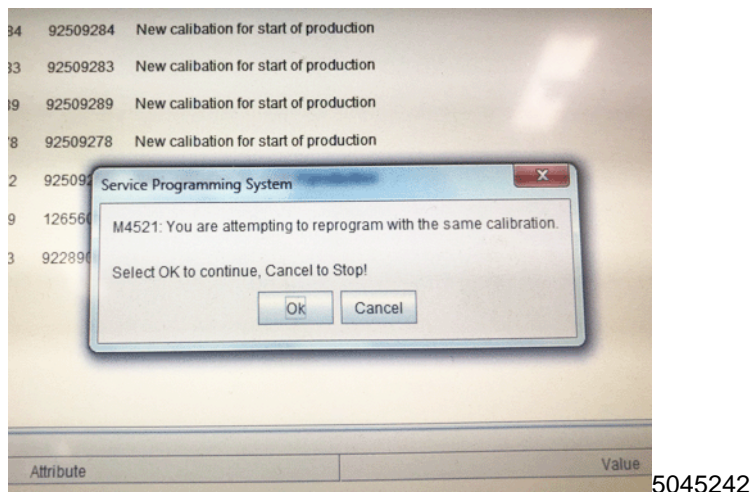
**Note:** If the Same Calibration/Software Warning is noted on the SPS controller screen, select “OK” and continue programming.

1. Reprogram the Power Steering Control Module. Refer to *Power Steering Control Module and Setup* in SI.
2. Record SPS Warranty Claim Code on job card for warranty transaction submission.
