PRODUCT CAMPAIGN BULLETIN

APPLICABILITY: 2010-2014 MY Legacy and Outback (M/T models) **NUMBER:** **WTV-81R**
SUBJECT: Electronic Parking Brake (EPB) Actuator **NHTSA ID:** 18V-626
DATE: 10/30/18
REVISED: **08/26/19**

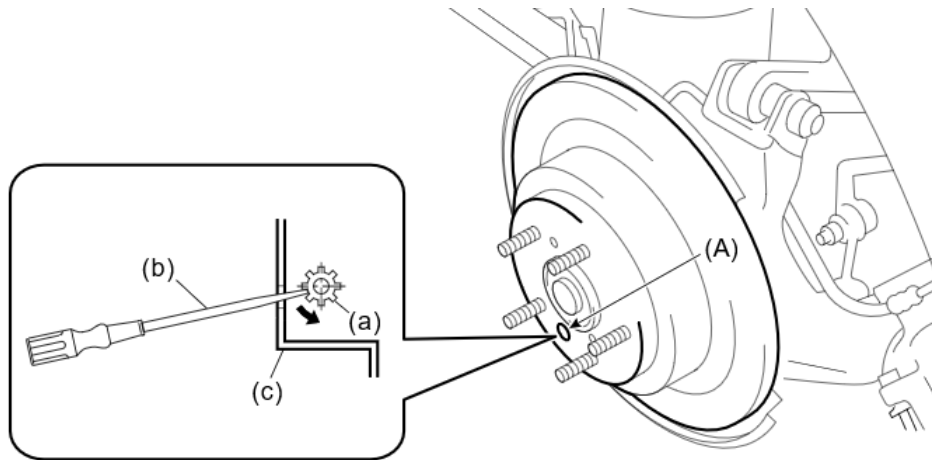
- 1) Remove the adjusting hole cover from the disc rotor.
- 2) Insert the flat tip screwdriver (b) into the brake adjustment hole (A) and rotate the adjusting screw (a) until the brake shoes contact the disc rotor (c).

- 3) Loosen the adjusting screw by 5 notches in the opposite direction of the arrow.
 - Operate the parking brake several times then confirm there is no brake drag.
 - If the adjusting screw is not loosened sufficiently, brake dragging may occur.
- 4) Install the adjusting hole cover to the disc rotor.
- 5) Install the rear wheels, lower the vehicle onto level ground, connect the SSM then proceed with performing the Force Sensor Calibration Mode procedure.
